# Development of Guidance Information for the Repair and Re-building of Houses Following the Canterbury Earthquake Series

**Graeme J Beattie<sup>(1)</sup>**

## **Abstract**

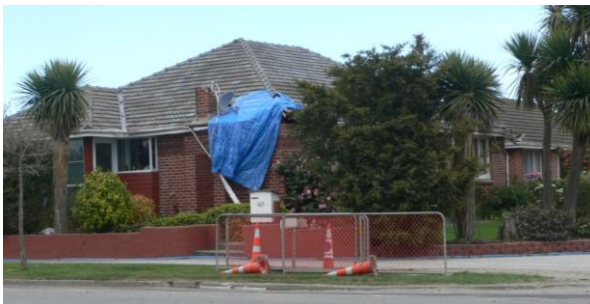
**Figure 1 Collapsed unreinforced masonry chimney**

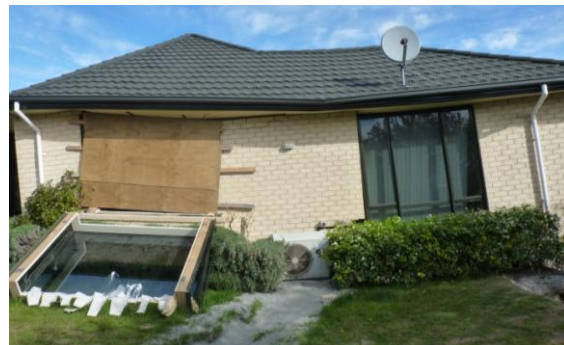
**Figure 2 Liquefaction damage**

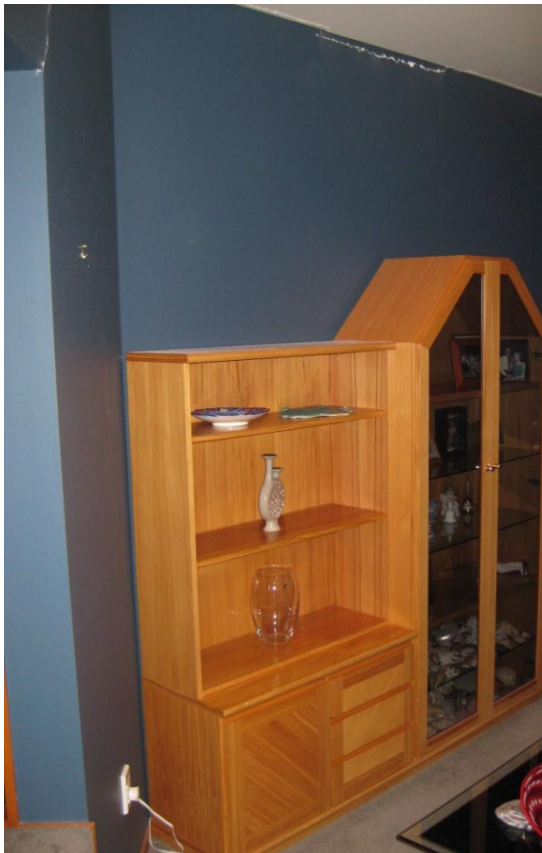
Sheet bracing materials also behaved well, providing stability to the houses while at the same time dissipating earthquake energy in a ductile fashion. In many houses, the visible damage to wall linings was minor (cracking of plasterboard joints - Figure 3(a)) while in others the damage was very significant (diagonal cracking through sheets and detached sheets - Figure 3(b)). In the second case, the repair solution is clear. The lining must be stripped off and replaced. The difficulty is in identifying the underlying damage in the first case and appropriately repairing the wall. In houses with minor damage throughout, the occupants have often commented that the house is “noisier” than it had been before the earthquakes. The reason for this is that in the earthquakes the fixings have moved small amounts in the lining, creating slots and under minor excitations from wind and aftershocks the house is able to flex more. There is no significant loss in strength because this is taken up once the fixings have reached the end of the slots.

(a) Minor cracking

Re-stopping the joints between sheets is not going to recover the dwelling stiffness. The EAG has therefore recommended that if the cracking is evident at the panel junctions and there is also evidence of movement at the skirting boards then the stopping should be scraped out and the panels re-fixed around the perimeter of the sheets. This has been shown by test to substantially regain the building stiffness.

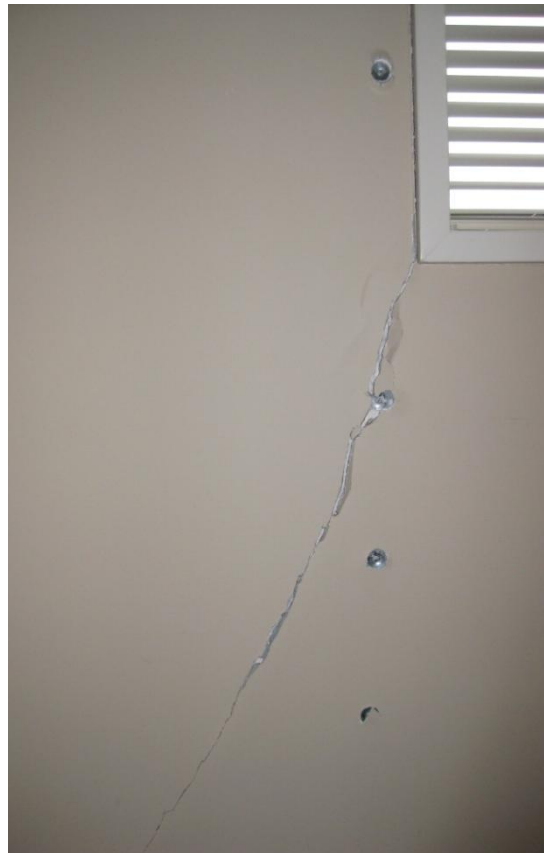
(b) major damage
