# Bridge performance during the 2010/2011 Canterbury Earthquakes

**Rolando P. Orense<sup>1)</sup>, Tam J. Larkin<sup>2)</sup> and Nawawi Chow<sup>3)</sup>**

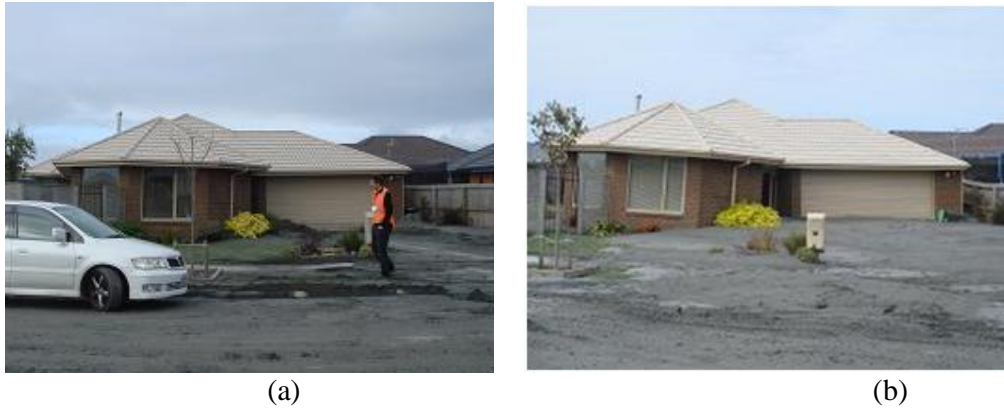
Figure 2: Damage to a residential house due to liquefaction in Seabreeze Close, Bexley: (a) 2010 earthquake; and (b) 2011 earthquake.

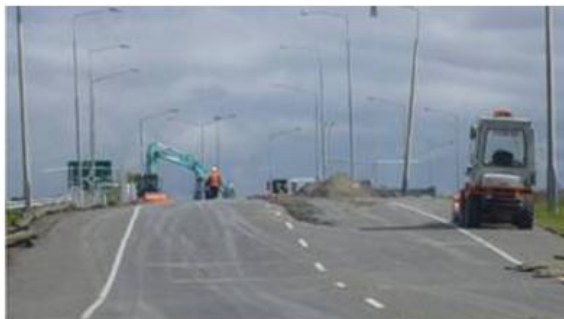
The Christchurch region contains more than 800 road, rail, and pedestrian bridges. Most of these bridges are reinforced concrete, symmetric, and have small to moderate spans (15 - 25 m). Following the 2010 Darfield earthquake, reconnaissance inspections showed that in general, the performance of bridge foundations, abutments, and approach fills in the earthquake was satisfactory, as almost all bridges were serviceable after the event. Information from various authorities revealed that eight road bridges were out of service in the days following the earthquake, and five remained closed for at least 5 days. Except for one bridge with structural damage, these bridge closures were due to damage on the approaches to the bridge, e.g. liquefaction, lateral spreading, and settlement of approach fills. However, none of the road bridges were seriously damaged. The most significant road bridge damage observed was the 70 m - span Bridge Street bridge in South Brighton. The bridge was reportedly closed for about 10 days following the earthquake due to differential settlement at the east abutment. However, it became apparent that repair work was already underway (Figure 4a).

Figure 4: Typical damage to road bridges during the 2010 Darfield Earthquake: (a) Bridge Street bridge; and (b) Gayhurst Road bridge

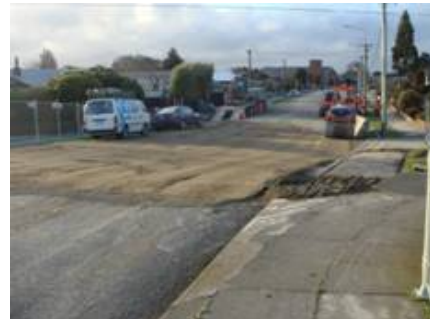
(b)

Another bridge that suffered some damage was the bridge along Gayhurst Road. This bridge is relatively short, about 30 m in length with simple spans. Following the earthquake, road cracks were observed on the approaches to the bridge. These cracks had been backfilled with aggregate (Figure 4b). Cracks had been formed in the retaining walls on both approaches, however, the bridge remained serviceable.

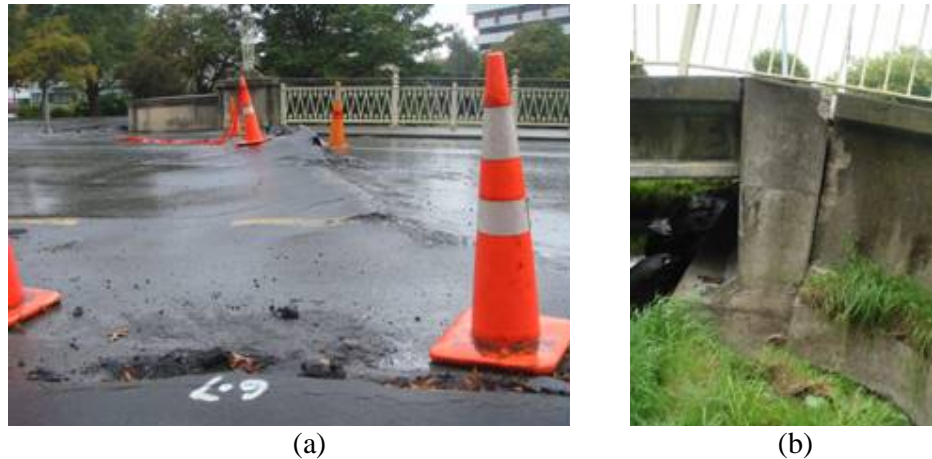
Figure 5: Typical damage to road bridges within or near the CBD during the 2011 Christchurch Earthquake: (a) Colombo Street bridge; and (b) Fitzgerald Avenue bridge

The bridge along Fitzgerald Avenue just outside the CBD suffered minor damage, with its northern pier tilting slightly due to lateral spreading (Fig. 5b). Several tens of meters away from the north approach, a 50 m section of the roadway collapsed into Avon River due to liquefaction.

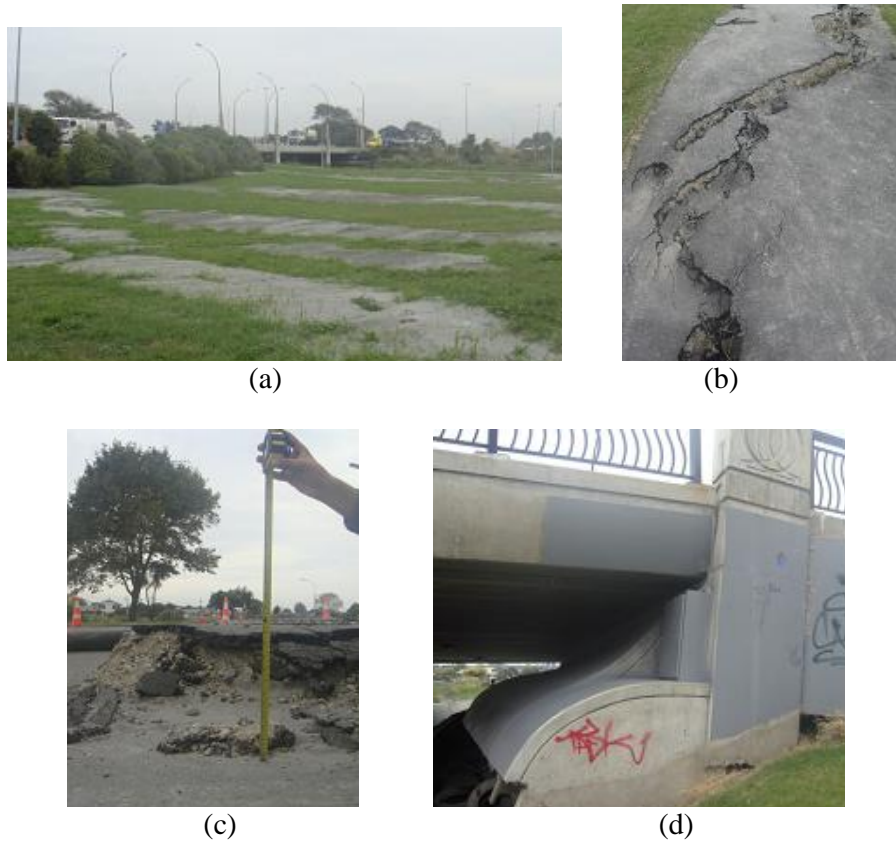
Figure 7 shows the consequence of soil liquefaction on the ANZAC bridge and its surroundings due to the 2011 Christchurch earthquake. The extensive sand boil in the surroundings (Figure 7a), the fissures along the walkway beneath the bridge (Figure 7b)

and the large relative permanent ground settlement, e.g. more than 20 cm (Figure 7c), clearly indicate the soil effect on the bridge site. The damage to the abutment is displayed in Figure 7(d). The rotation of the abutment due to the lateral movement of the ground surface caused pounding-induced damage between the abutment and the bridge superstructure.

Figure 7: Damage to the ANZAC bridge and surroundings due to the 2011 Christchurch Earthquake: (a) sand boils on local site; (b) damage to walkway beneath the bridge; (c) relative ground movement around a manhole next to the bridge; and (d) damage to bridge abutment.
