The Kalgoorlie Earthquake of the 20th April 2010 : Preliminary Damage Survey Outcomes

Abstract

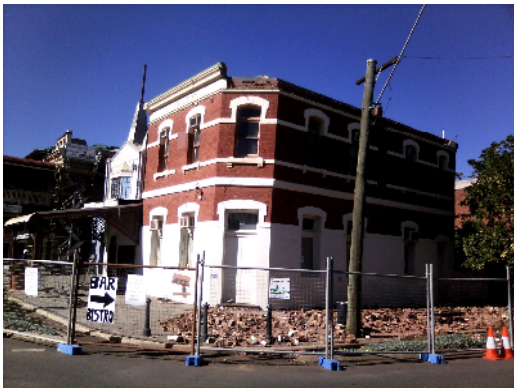
The level of shaking caused widespread damage to pre-World War One unreinforced masonry buildings. Loss of chimneys, gables and parapets was widespread along with extensive cracking of walls (refer Figures 3 and 4). Poor quality materials were also a factor. Weathering of stonework was evident as was poor quality mortar that had degraded to sand in some instances (refer Figure 5).

Figure 3. An example of typical parapet damage.

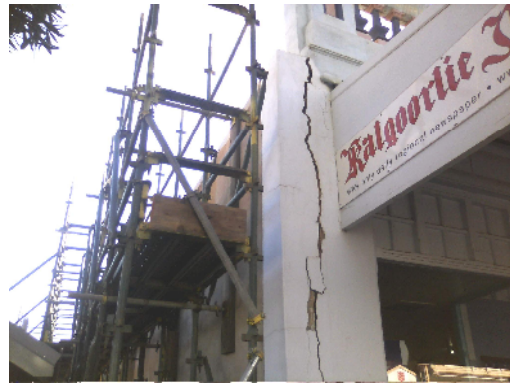
Figure 4. Vertical cracking at building corner showing separation between front and side walls with the side wall temporarily shored.

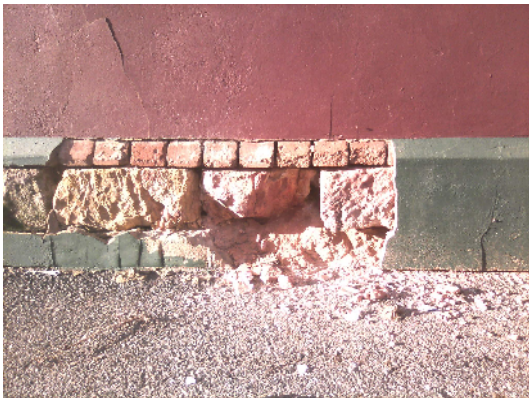
Figure 5. Weathering of mortar and masonry

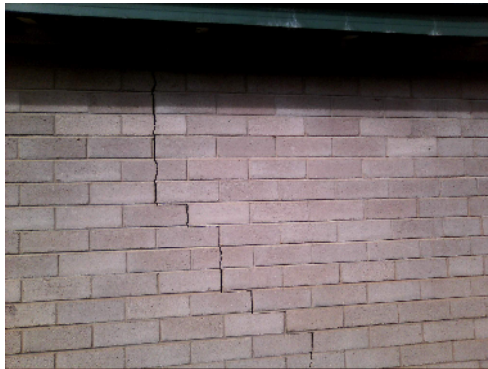
More modern masonry residential buildings also experienced some damage in the vicinity of Boulder. Internal damage in the form of minor wall cracking and cornice

damage associated with relative movement between the roof structure and the internal walls was found to be common in cavity brick homes in Boulder (refer Figures 6 and 7).

Figure 6. Cracking in modern residential brickwork.

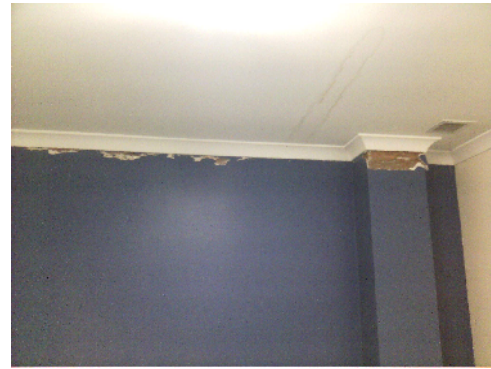
Figure 7. Cracking of cornices in residential construction.
