# Retaining wall performance during the February 2011 Christchurch Earthquake

James N. Dismuke  
Senior Geotechnical Engineer  
Arup  
Sydney, New South Wales  
Email: james.dismuke@arup.com

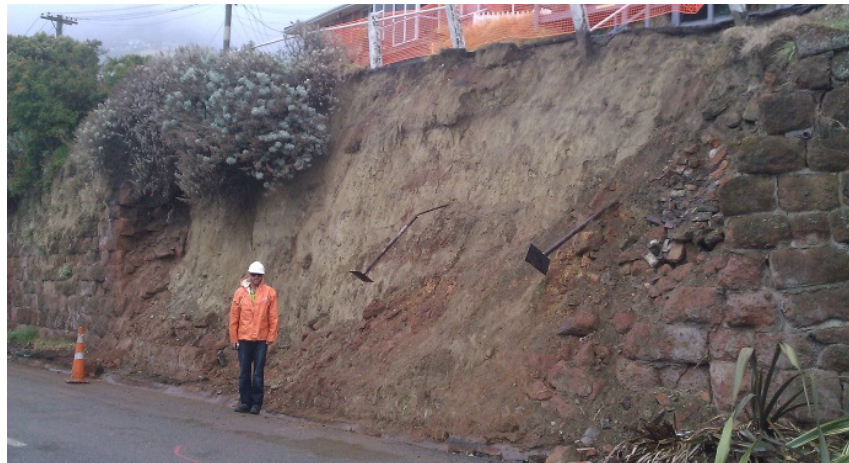
Interest in retaining walls was prompted by the observation of an anchored rock wall in Lyttelton. The wall was observed to be completely destroyed by the earthquake, but the supported native loess slope remained standing at a nearly vertical inclination (Figure 2). Additionally, an adjacent concrete crib wall was observed to be generally unharmed by the earthquake, which provided an interesting juxtaposition with the rock wall and loess slope. In response to the observation in Lyttelton, a performance survey of retaining walls was conducted, the results of which are discussed in this paper.

**Figure 2: Collapsed Rock Wall and Free Standing Loess Slope in Lyttelton**

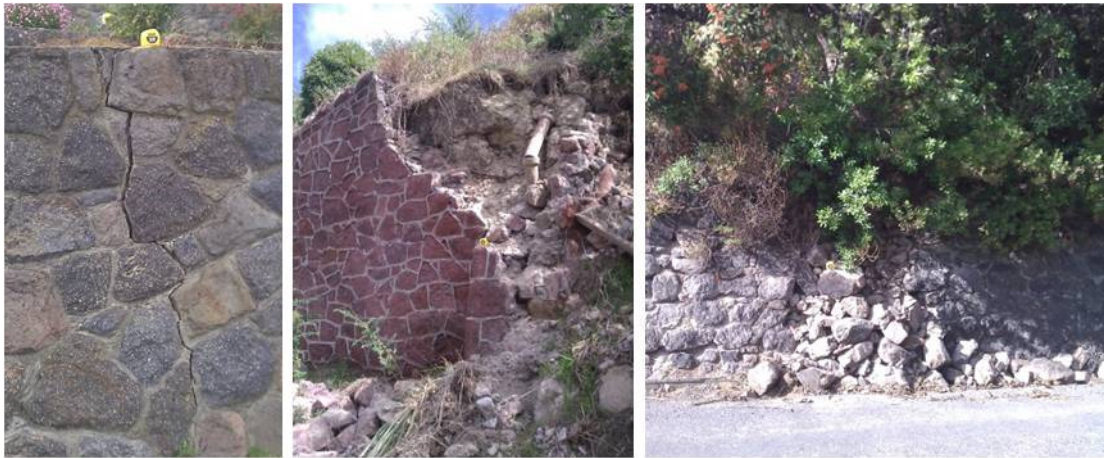
Rock walls were the most common type of wall observed. They were either dry or grouted and were used generally for gardens or as decoration. Dry stone walls were commonly 1m or less in height and nearly all were toppled by the earthquake. Grouted rock walls were observed to be greater height than dry rock walls, with the maximum height observed estimated to be about 6m; however, the majority of grouted rock walls were between 1 and 2m in height. Grouted rock walls were nearly all damaged; they were either cracked through the grout, experienced loss of stones, or completely collapsed. Figure 4 shows examples of rock wall performance.

**Figure 4: Rock Walls (a) cracks along grout; (b) structural collapse; and (c) toppled dry rock wall**

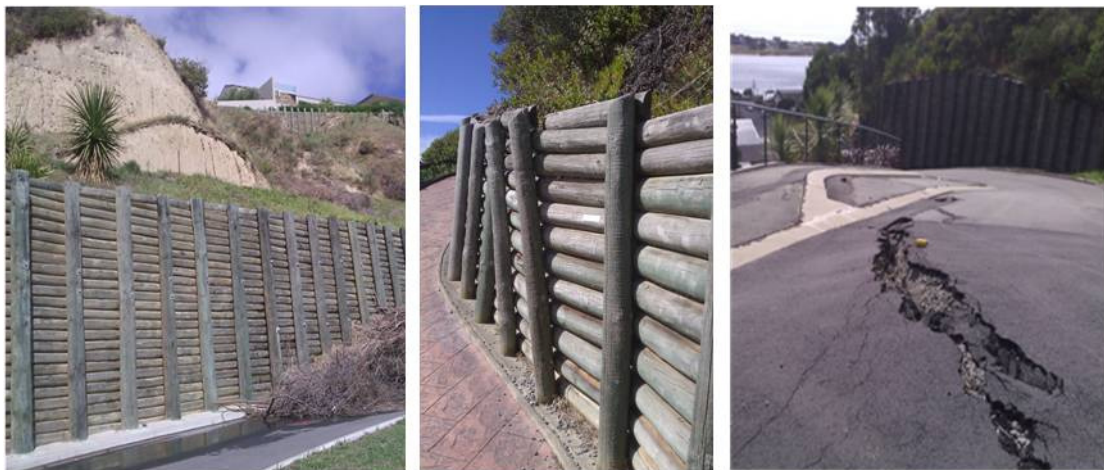
Timber pole walls were also commonly observed, though less frequently than rock walls. Timber pole walls provided a variety of uses, but were regularly observed protecting road reserve. Timber pole walls were frequently on the order of 2m or more in height comprising poles between 175 and 225 mm small end diameter with pole spacing of 0.9 to 1.2m. Taller walls were also anchored. Structurally, timber pole walls performed well. Most timber pole walls experienced rotation and settlement of drainage material, but were rarely observed to collapse. Figure 5 shows an example of timber pole wall performance.

**Figure 5: Timber pole walls (a) good performing timber pole wall with unsupported loess slope; (b) rotated timber poles; and (c) settlement of fill behind timber pole wall**

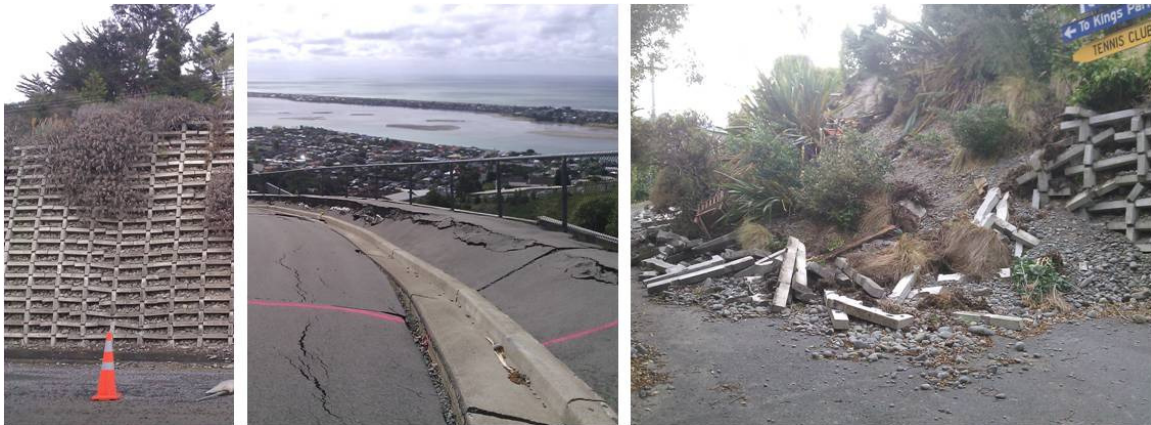
Crib walls were initially thought to be a common wall type in Christchurch because the March 2011 survey was conducted from the roadway, where most crib walls are located. After further observations, crib walls, both timber and concrete, were found to be uncommon compared to other wall types because they were not typically used within the properties. The crib walls observed were generally tall, on the order of 2 to 4m. Nearly all crib walls were broken and contained displaced cribs. Many had collapsed. Settlement of fill behind crib walls was also a common feature. Figure 6 shows some examples of crib wall damage.

**Figure 6: Crib walls with (a) displaced and settled concrete cribs; (b) settlement of fill behind timber crib wall; and (c) collapse of concrete crib wall**
