The Padang Earthquake 2009 – Lessons and Recovery

Paul Grundy

Department of Civil Engineering, Monash University

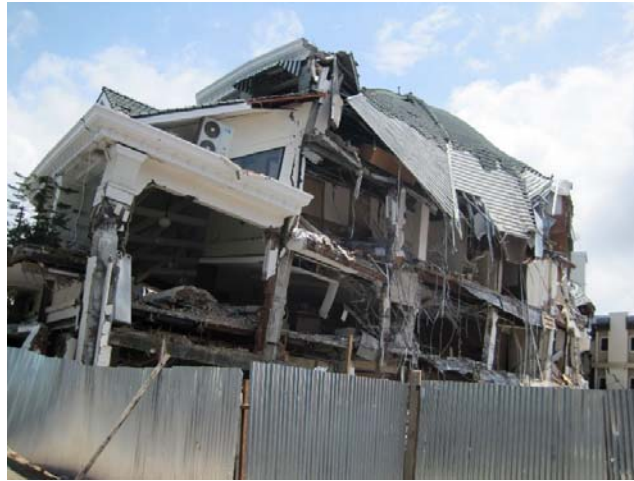
Many buildings in the public sector collapsed through the soft storey syndrome, exacerbated by poor detailing of reinforcement, especially at the joints, and poor quality concrete. (Figs 2-4)

Figure 2 – 6-storey Ambacang Hotel

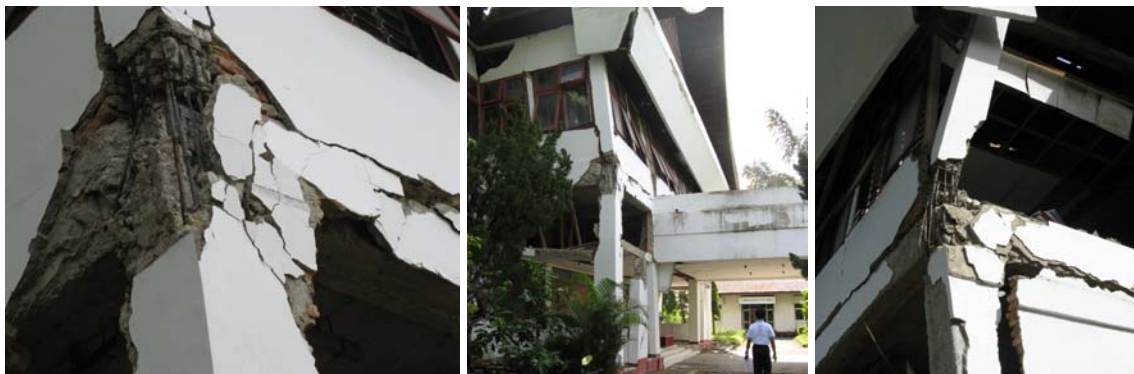
Figure 3 – Food Security Agency Building, Padang

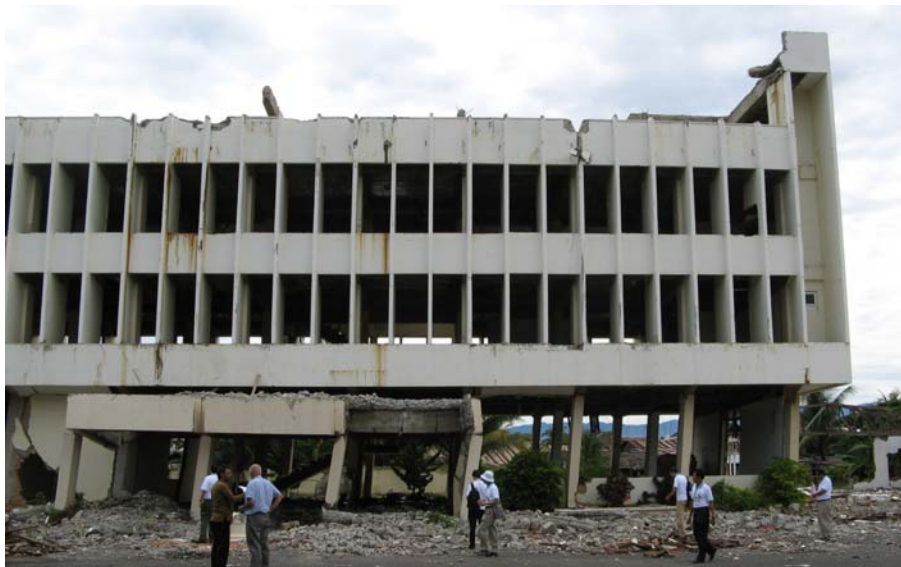
Figure 4 – Provincial Public Works Office, Padang
Evidence of soil liquefaction at this site

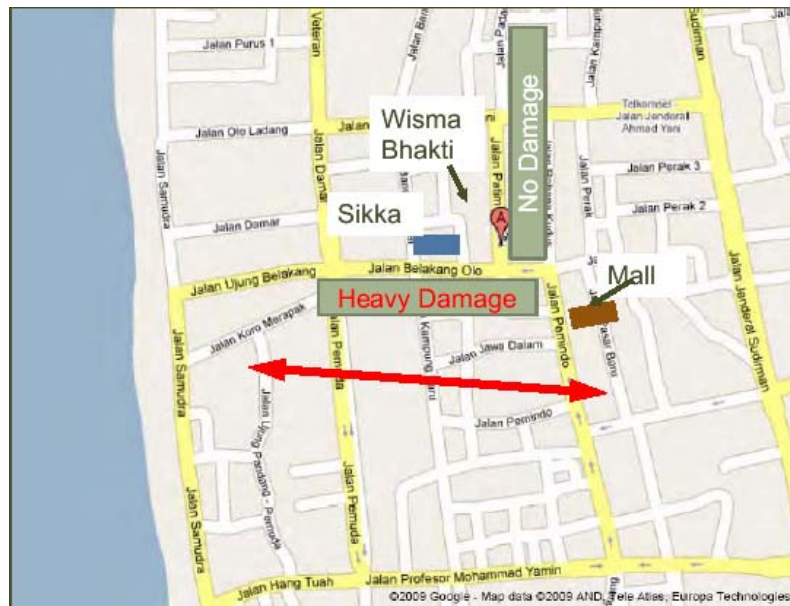
In the commercial district failures were most significant in buildings on streets aligned east-west, with relatively few on streets north-south (Figure 5). The strong motions were in the east-west direction. The relatively robust performance of the buildings facing east or west is attributed to the long party walls of load bearing masonry or brick infilled reinforced concrete frames, without openings.

Figure 5 – Directional vulnerability of commercial buildings (Sarwidi, 2010)

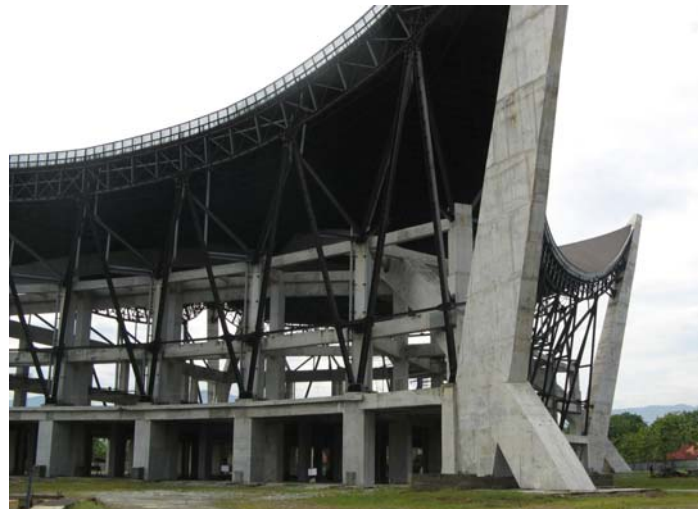
One structure which survived with very superficial damage was a mosque under construction (Figure 6). This was being funded from international sources. The basic design was a seismic resistant form, with strong columns compared with beams, large buttresses and piling to prevent failure through soil liquefaction. Concrete strengths used were higher than usual for the district, and the finished concrete quality was very good.

Figure 6 – Mosque under construction which survived intact

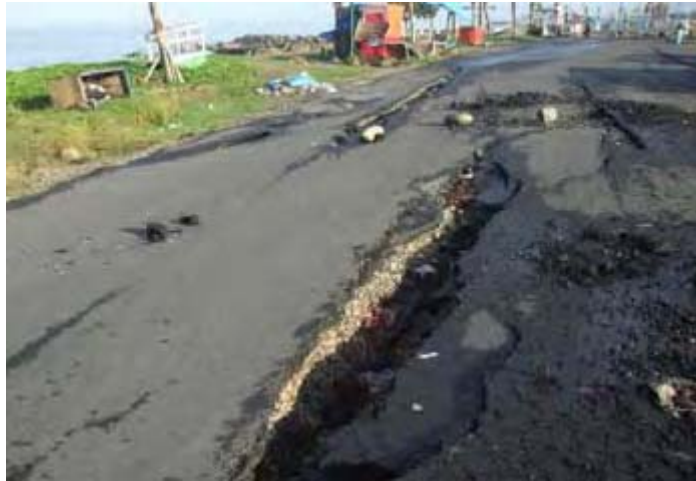
Sand 'boiling' occurred in some locations and there were many cases of subsidence (Figure 6).

Figure 6 – Ocean boulevard liquefaction.
Note low elevation affording minimal tsunami protection

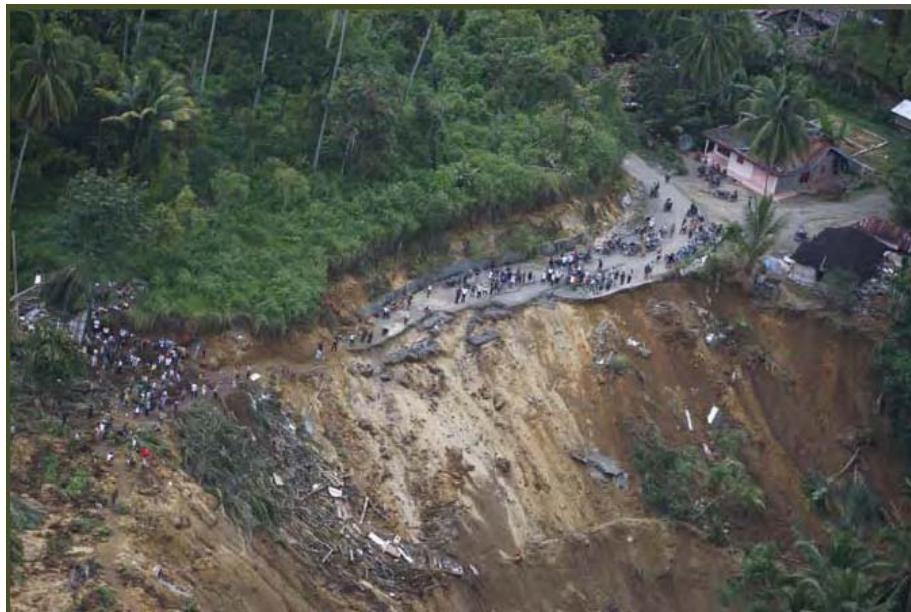
Many landslides occurred in the mountainous hinterland (Figure 7). In many cases poor slope stability was exacerbated by cut and fill for roads. In most instances villagers rebuilt in adjacent areas where a landslide had not occurred.

Figure 7 – Pariaman District Landslide (AP Photo/Dika Alangkara)

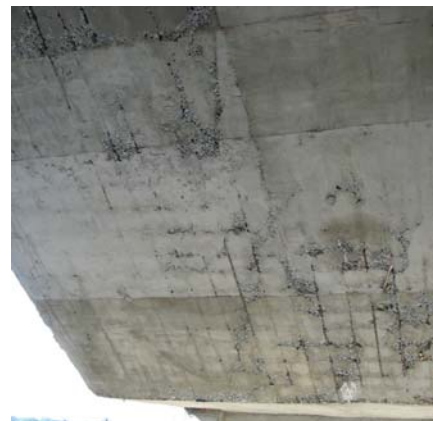
It is unlikely that the standard of disaster resilience built into this building could have been achieved using familiar local construction methodology in reinforced concrete. It takes at least a decade of reform and a change in cultural perception to eliminate detrimental practices. This is illustrated by the quality of the reinforced concrete stairways in this building (Figure 9) which reflect local standards practice in concrete construction – the reinforcement is not properly supported on bar chairs and the concrete is not properly compacted.

Figure 9 – Stair flights in the new building after stripping of the formwork
