Seismic Performance of Masonry Buildings in the Christchurch Earthquakes 2010-2011: A Progress Report

Lisa M. Moon¹, Dmytro Dizhur², Jason M. Ingham³ & Michael C. Griffith⁴

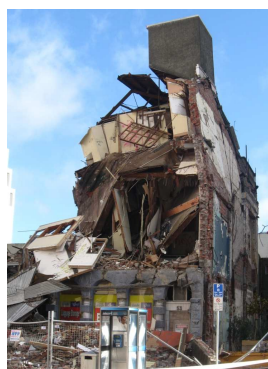
a) Unretrofitted URM building

Figure 4 - Typical URM building (a) and URM building retrofit (b) in Christchurch CBD following 22nd February 2011 earthquake

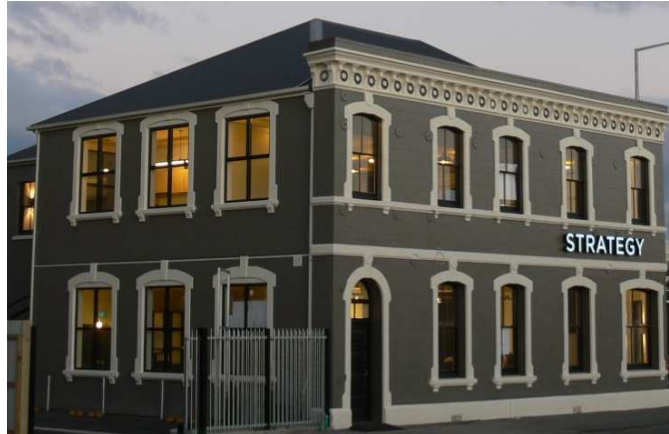
Figure 7 - Successfully retrofitted Christchurch URM building (May 2011)
