# Lessons from the February 22<sup>nd</sup> Christchurch Earthquake

Helen M. Goldsworthy

Senior Lecturer, Department of Infrastructure Engineering, The University of Melbourne,  
Parkville, Vic 3010.

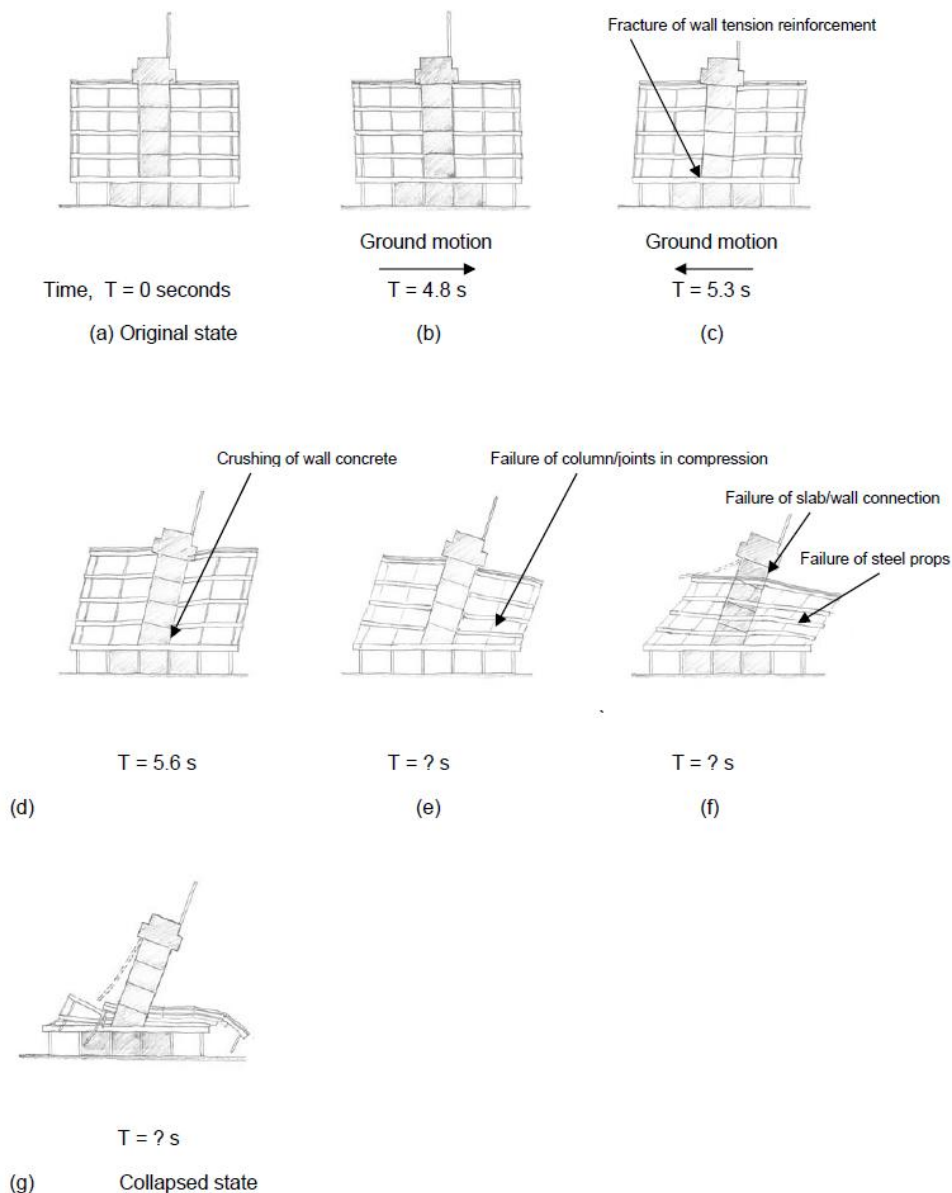
In the case of the five-storey Pyne-Gould building which was built in 1963 to 1964, the sequence in which the failure occurred has been investigated thoroughly and reported in a preliminary report from the Royal Commission. It is shown in Figure 6 (Beca, 2011). In that case the longitudinal reinforcement in the western core wall fractured in tension followed by a catastrophic compressive failure of the eastern wall. The columns, and/or joints between the columns and the beams, in the non-ductile perimeter frames (with no ties in the joints) then failed due to excessive lateral drifts. The slab-to-wall connections were unable to withstand the rotations, shears and tensions resulting from the forced displacement of the shear core, leading to a sequential collapse of the floors. Photos of the collapsed Pyne Gould building are included in Figure 7 and Figure 8 (Kam, 2011b).

Figure 6. The failure sequence of the Pyne-Gould building

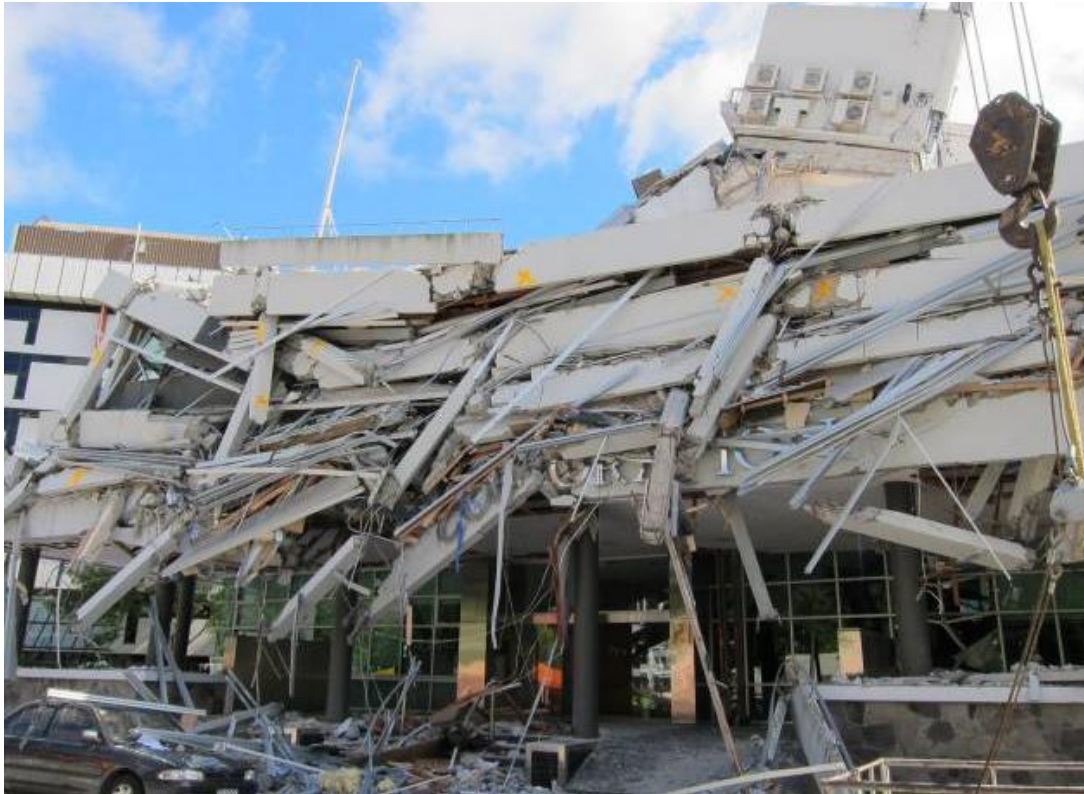
Figure 7. Pyne Gould collapse from the southern side

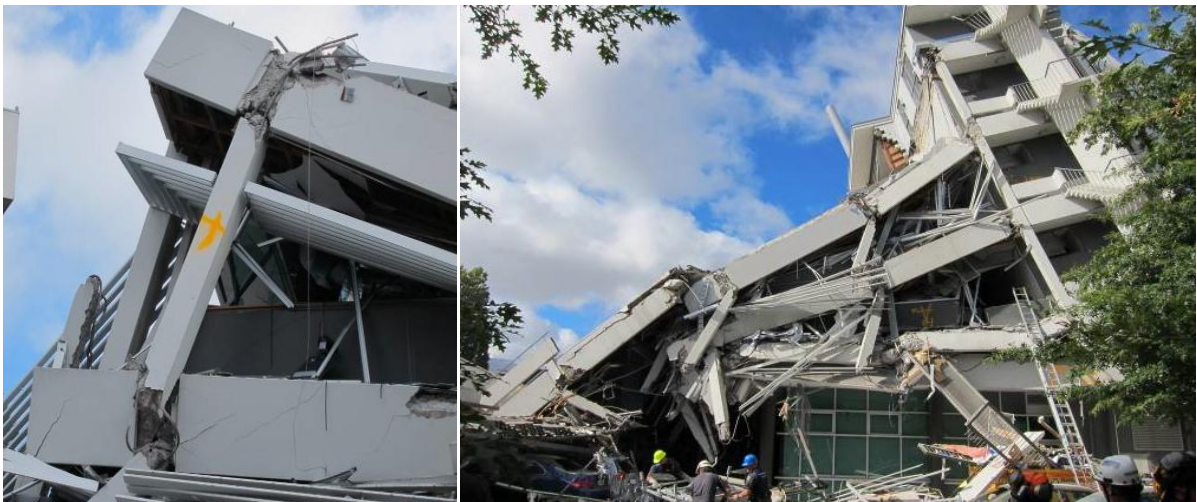
Figure 8. (a) Detail of joint failure in the Pyne Gould perimeter frame, (b) Collapsed Pyne Gould building from the northern side

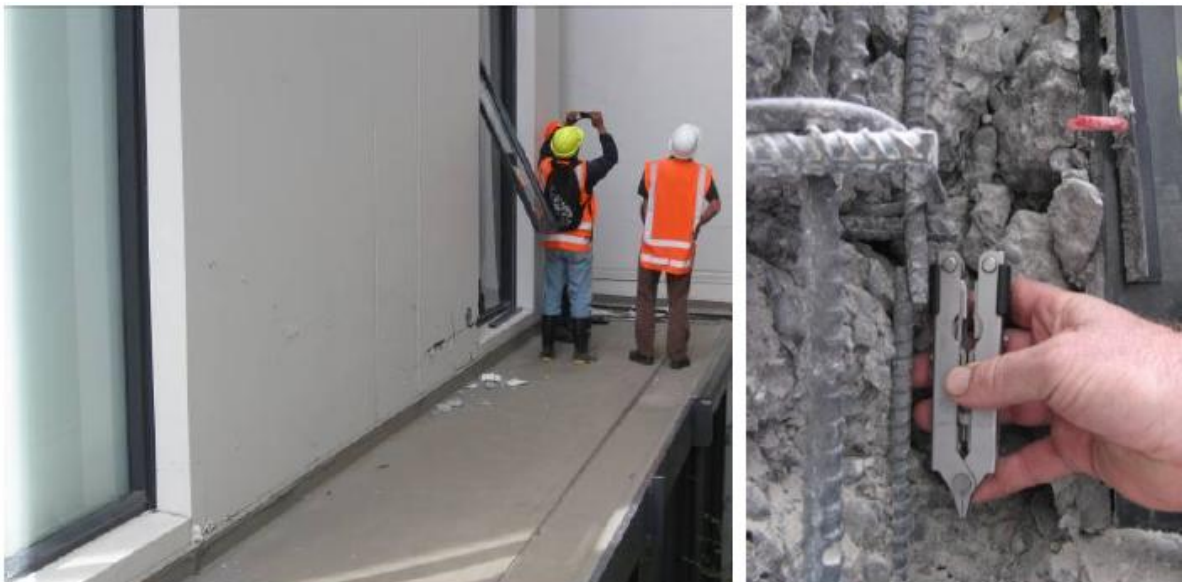
- Although capacity designed buildings usually behaved as expected by structural engineers, there is a disconnect between societal expectations and the actual extent of damage and disruption. Concerns are also expressed about low cycle fatigue and the current ability of engineers to assess the reliability of buildings that have experienced several cycles of plastic deformation in the plastic hinge regions. More research is needed (SeSoc, 2011) in this area. Something that has compounded this problem is the field observation that yielding in the plastic hinge regions was often concentrated in one or two wide cracks rather than being distributed within several narrow cracks as observed in laboratory tests. In some elements this was observed to lead to fracture of the longitudinal bars as shown in Figure 9 (Buchanan et al, 2011). This is probably due to concrete strengths being much higher than the design characteristic values, or possibly to the  $R_u$  to  $R_e$  ratio (the strain hardening ratio) of the reinforcement being unacceptably low. The estimation of the extent to which the cyclic plastic capacity of the bars has been exhausted is critical in determining whether low-cycle fatigue could be an issue in future earthquakes.

Figure 9. (a) Small cracks in base of a tall wall. Note the minor damage at far end of wall. (b) Damaged end of wall after breaking out some concrete. The vertical bars have yielded then fractured.

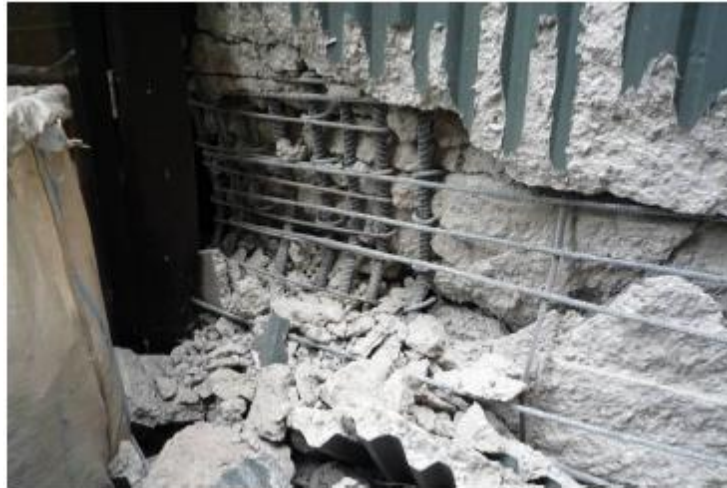
- Compressive failures in walls were often excessive with loss of concrete and buckling of reinforcing bars in the plastic hinge zones as shown in Figure 10 (Buchanan et al, 2011). These observations indicate that additional sources of loading need to be considered and the confining steel may need to be spread out over the length of the wall rather than just concentrated at the end zones. Importantly, according to (SeSoc, 2011) "It is debatable whether the current practice of ignoring out-of-plane movement of concrete walls may be unconservative. There may be cases where the combination of in-plane and out-of-plane movements has caused failure of walls, including possibly the Grand Chancellor shear wall." (see further discussion below)

Figure 10. Compressive failures in walls. Loss of concrete and buckling of reinforcing bars in the plastic hinge zones

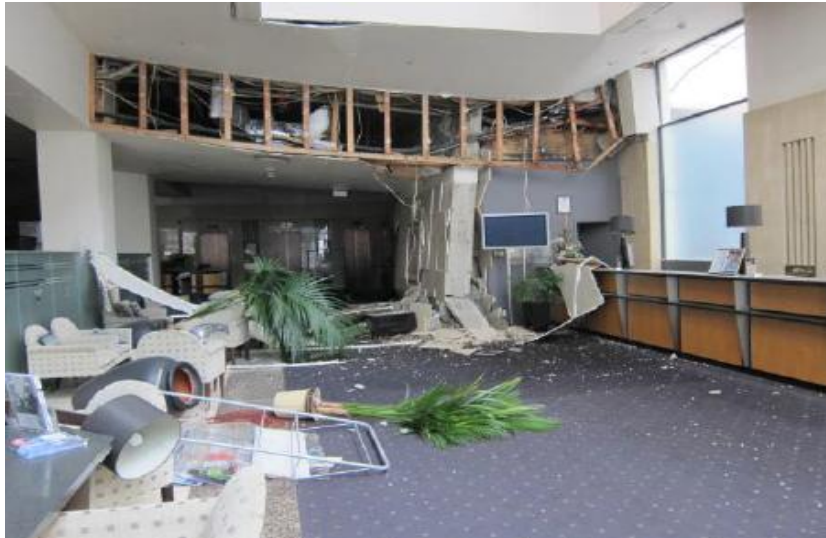
The results of the investigation into the collapse of a shear wall in the Hotel Grand Chancellor Building by the Royal Commission's Expert Panel (Dept. of Building and Housing, 2011) exemplify some of the points made above. This 22-storey hotel was built between 1985 and 1988. The collapsed 4.5 metre long RC shear wall is shown in Figure 11 (Kam, 2011a). Their findings are summarised as follows:

"Extremely high compression loads combined with low levels of confinement reinforcing led to the wall failure. The lapping of vertical reinforcing and the slenderness of the wall also appear to have contributed to the onset of failure. Under the action of high compression loads, a small transverse displacement was enough to initiate failure in the unconfined concrete. The high axial loads arose from the building geometry and induced actions resulting from the severe horizontal accelerations. It is highly likely that vertical accelerations contributed to the high compression loads."

Figure 11. Collapsed Shear Wall in Hotel Grand Chancellor

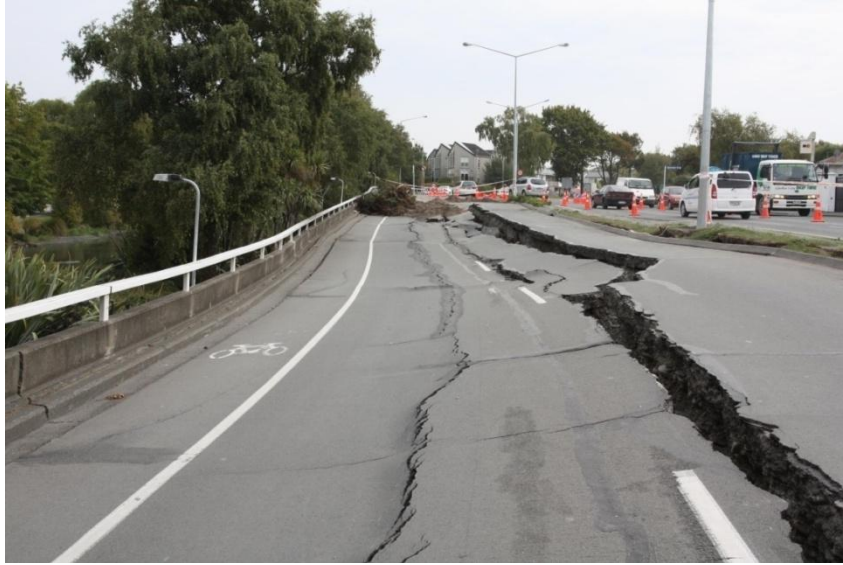
Figure 12. Effect of lateral spreading on the roadway

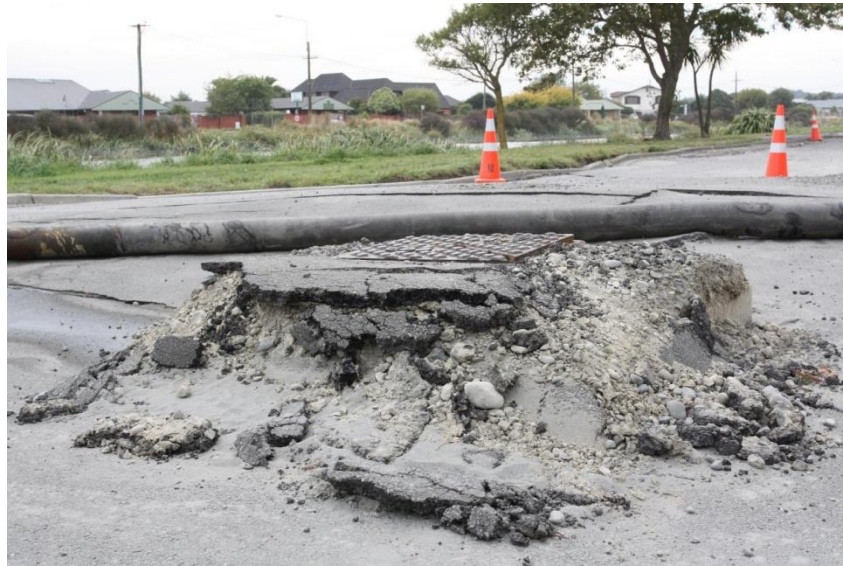
Figure 13. Flotation of pipe below causes the manhole to rise

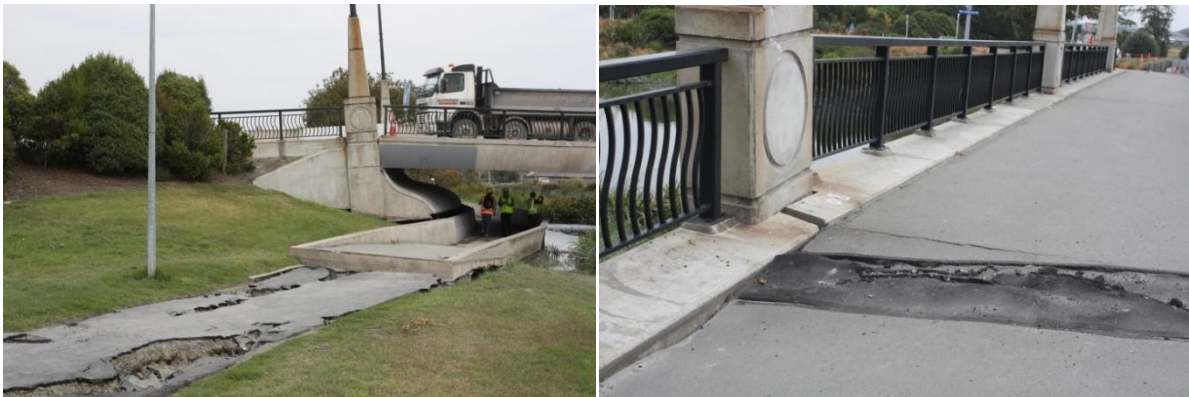
Figure 14. Rotation of bridge abutments and buckling of roadway

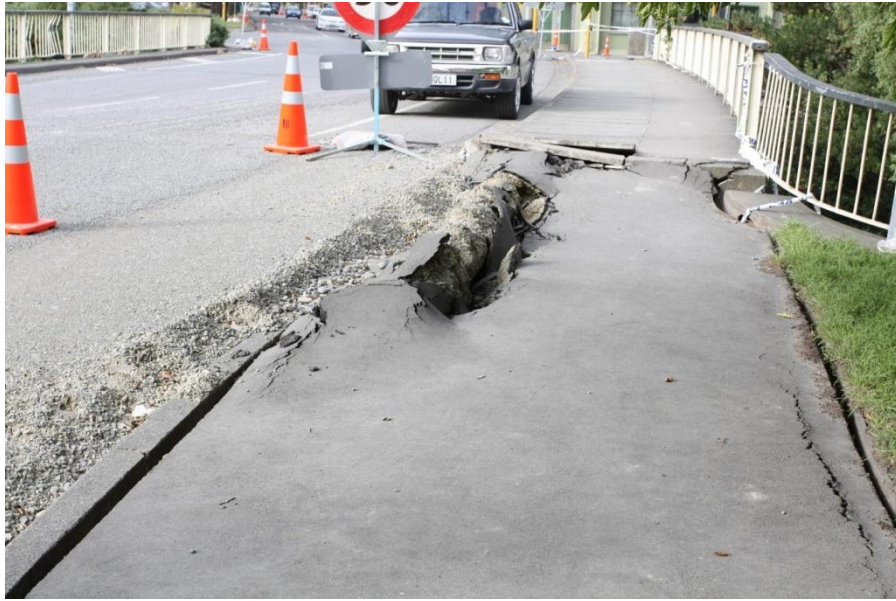
Figure 15. Subsidence of fill behind the abutment

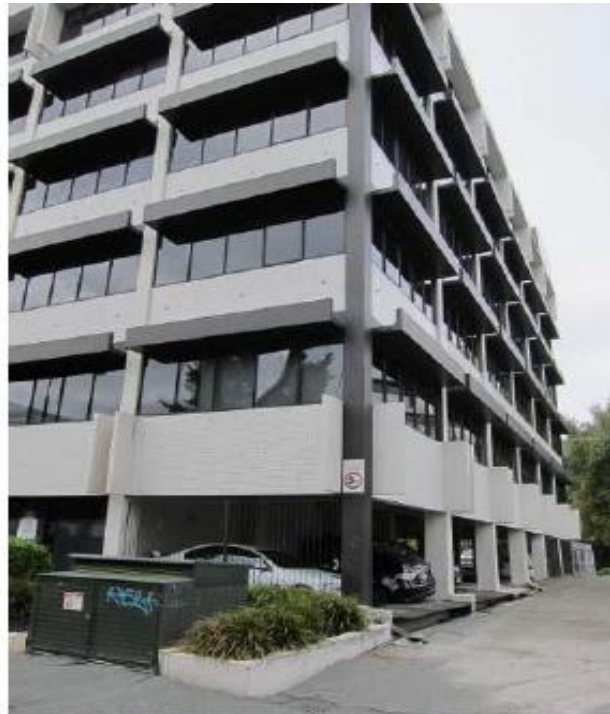
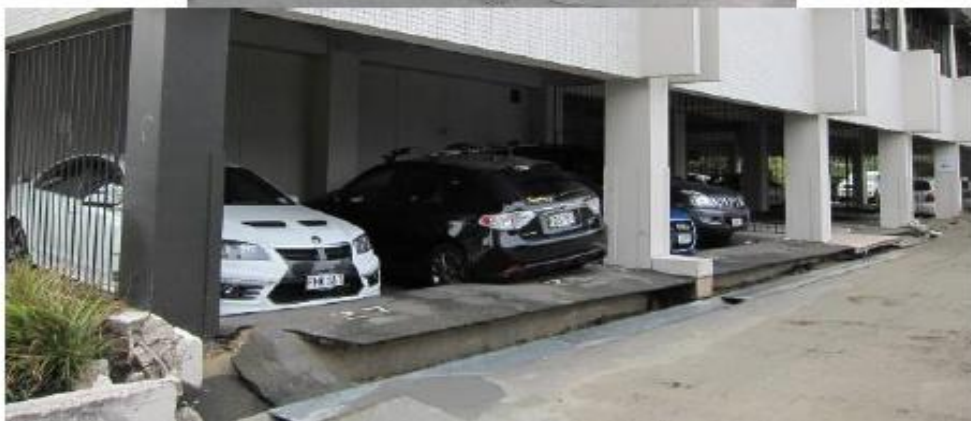
Figure 16. Tilting of building caused by liquefaction (Photo by Wen Kam)

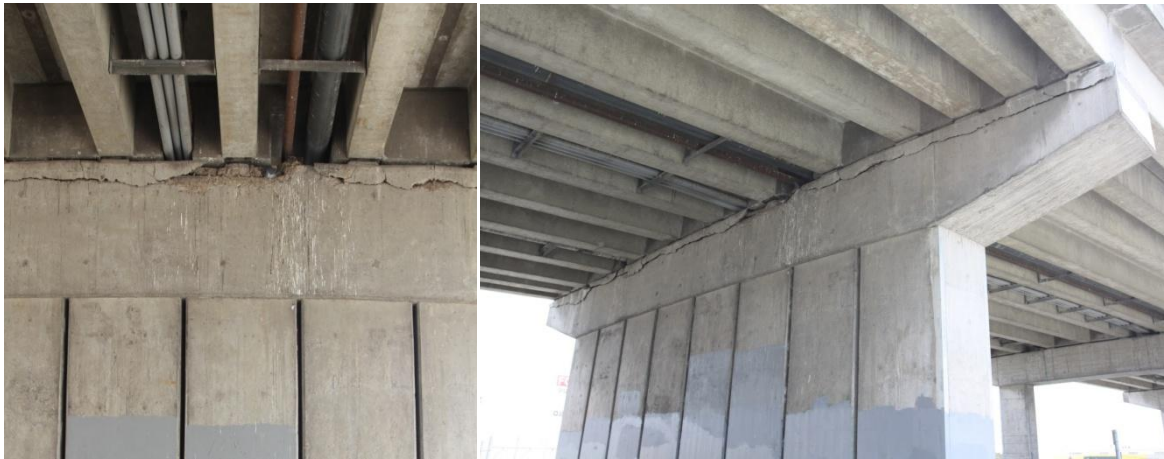
Pounding due to high vertical accelerations was an issue in bridges. This caused crushing of the cover concrete in bridge piers in one case. In another, the edge of a long wall support was knocked off at the top due to intense localized vertical forces from the bridge bearings (as the wall pounded on the bridge deck from below). This is shown in Figure 17.

Figure 17. Crushing of the cover concrete in a bridge pier
