Unsolved engineering problems after 2011 gigantic earthquake in Japan

ABSTRACT: The gigantic earthquake of magnitude=9 in 2011 in Japan caused many unexpected problems in the community. The significant number of problems over a vast area interacted with one another and made the situation much worse. Nuclear issues have developed to political problems and are difficult to solve in a short time. In addition, engineering is encountering such problems as mitigation of the risk caused by the next tsunami attack, protection of people's houses from subsoil liquefaction, and the preparedness for very rare seismic events in future. The balance between life safety and continuation of economic activities is the key issue but the decision is often affected by political and emotional issues. Because of the speakers majoring field, the talk will put emphasis on geotechnical issues. Note that this report is a minor modification of one of the author's recent papers that were published, first, during the Indian Geotechnical Conference (2011) and, second, in an electronic issue of the Indian Geotechnical Journal

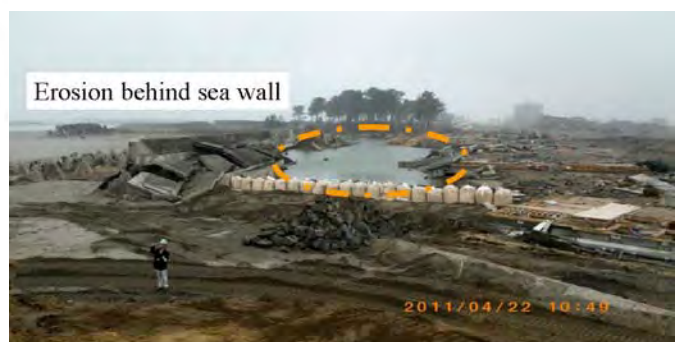
Figure 5 demonstrates a damaged shape of a sea wall. The overtopping of tsunami water significantly eroded the ground behind the wall and this loss of soil there probably reduced the lateral resistance of the sea wall (passive earth pressure). Consequently, walls were translated toward the land, and, when the second and the following tsunamis came, there was no protection any more. Note that tsunami came 4 times.

Fig. 5 Destroyed shape of sea wall (near the mouth of Abukuma River to the south of Sendai City)

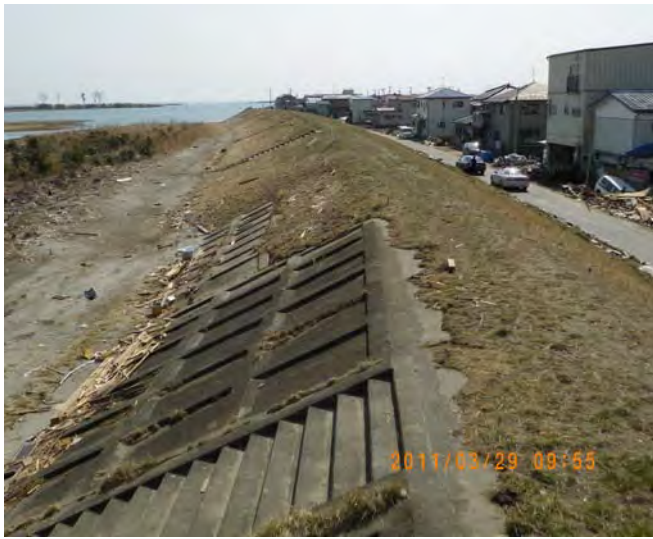
In contrast, many river levees survived the attack of tsunami that propagated upstream through river channels (Fig. 6). This good performance is interpreted either as the tsunami propagated not normal but parallel to the levees or as the ground behind the levees had already been inundated by tsunami water that directly invaded from the coast line and protected ground from eroding impact of overtopping water. Conversely, Fig. 7 illustrates a damaged levee of Kitakami River to the east of Sendai where the channel bent and allowed tsunami to directly hit the levee.

Fig. 6 River levee that survived tsunami in spite of overtopping (Natori River at Yuriage)

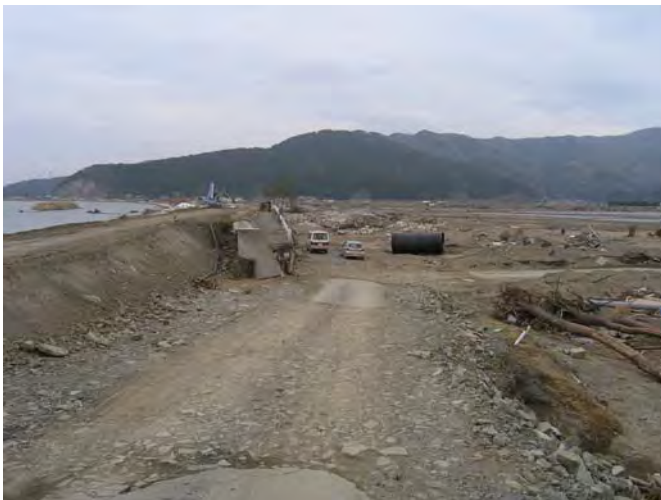
Fig. 7 Damage of Kitakami River levee that was directly hit by tsunami

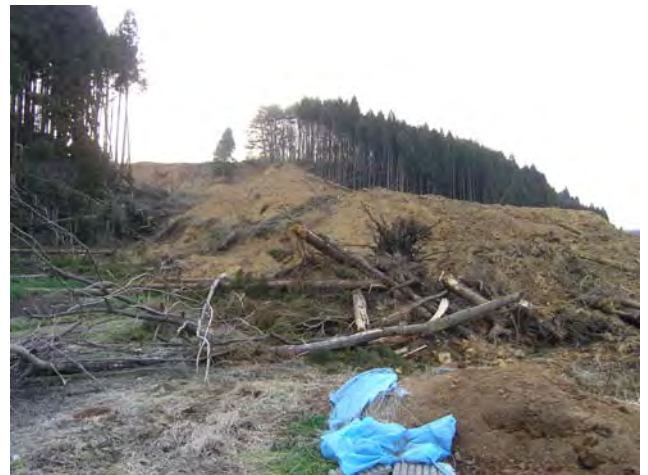
The slope instability problem was not very significant in spite of the size and magnitude of the earthquake. This is probably because, as Fig. 2 implies, most part of the motion had the amplitude of acceleration of more or less 200 cm/s^2 only, except a few high spikes. This is a significant difference of the present earthquake from the 2007 Kashmir and the 2008 Wenchuan events both of which caused tremendous number of slope failures and claimed lots of human lives. One of the few examples of big slope failures is shown in Fig. 8 where a weak volcanic deposit failed under the seismic action. This event buried houses and killed residents.

Fig. 8 Failure of natural slope in Shirakawa City

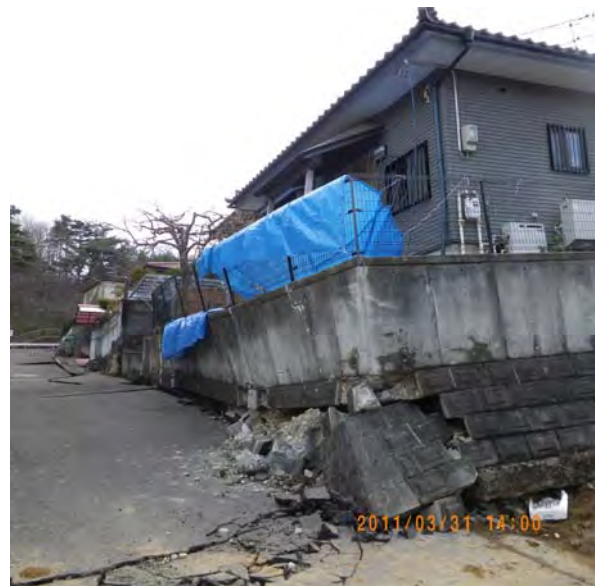
More damaging slope problems, although the size was smaller, occurred in artificial earth fills in hill areas. The residential development in Sendai City has traditionally been conducted in hilly areas where cut-and-fill construction has been the tradition. Fig. 9 reveals a damage example. This occurred in the fill part of the area, causing significant property loss to the residents. Furthermore, Fig. 10 shows the remaining sand at the surface. This sand was an ejecta from liquefaction, because this area was constructed by filling a small water stream. The fill was submerged in water and became vulnerable to liquefaction. In contrast, the cut part of the residential area was of minor damage (Fig. 11).

Fig. 9 Damaged residential fill in Sendai

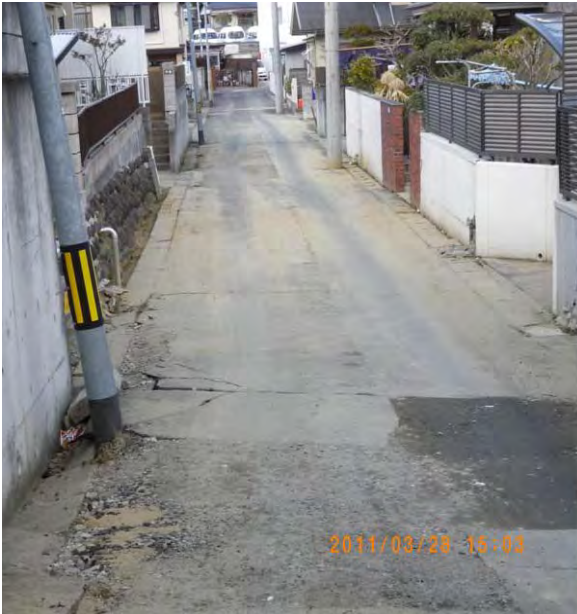
Fig. 10 Remains of liquefied sand at road surface in residential area where former water stream was filled with cut soil

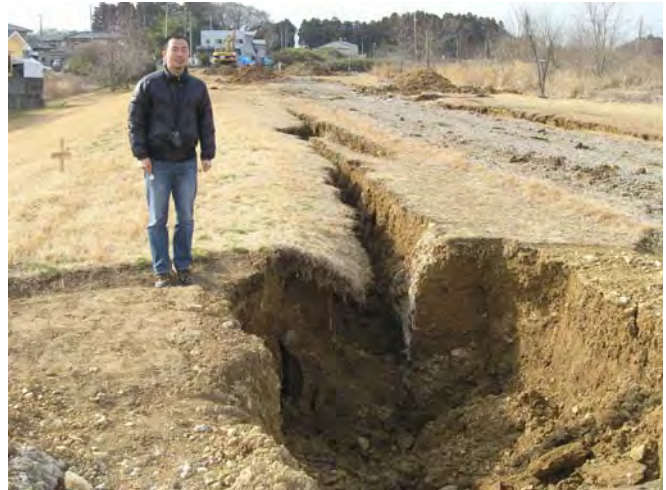
Fig. 12 Liquefaction-induced lateral spread and subsidence of Naka River levee

Many levees are situated on soft soil deposits. In particular, recent artificial change of river channels to a more straight shape resulted in new levees constructed on loose sandy deposits that are likely to liquefy. The number of damaged levees was nearly 2000, inclusive of major and minor damages. Fig. 12 illustrates a damaged shape of the Naka River levee in Mito City, about 100 km NE of Tokyo. The liquefiable sandy soil underlying this embankment caused lateral spreading and the consequent cracks in the longitudinal direction. At the same time, subsidence exceeded 1.5 m.

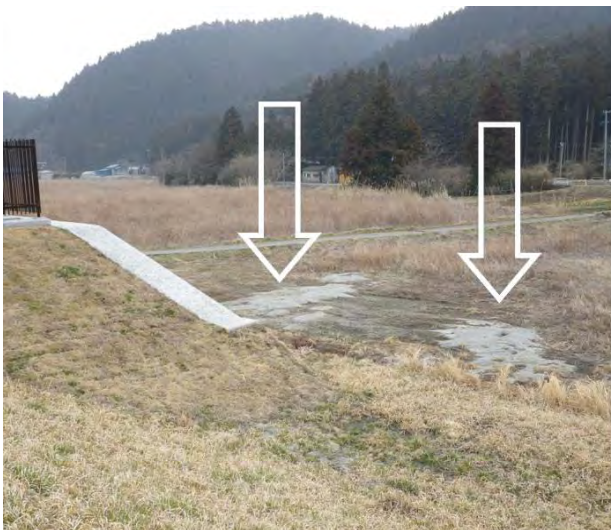
It is widely known that liquefied sand is consolidated afterwards and its density increases. Because the risk of liquefaction decreases with increase in density, people imagine that previously liquefied sites are less likely to liquefy again during future earthquakes. Unfortunately, this idea is too optimistic. The liquefaction-induced densification of sand is not sufficient; relative density increasing only 10% or less, which is far less than what soil compaction works achieve. Fig. 13 illustrates one of the examples of repeated liquefaction that took place for the 4th time since 1978. Note in this photograph that the river channel is situated to the left of the levee in the front and the area to the right is an abandoned river channel where sand is loose and water-saturated. Similarly, liquefactions were repeated in Christchurch, New Zealand, 3 times in September 2010, February, and June in 2011 [2]. Hence, initiation of the reconstruction delayed and was made very difficult.

Fig. 13 Repeated liquefaction at Kita-Wabuchi site of Eai River to the north of Sendai; sand ejecta shown by arrows

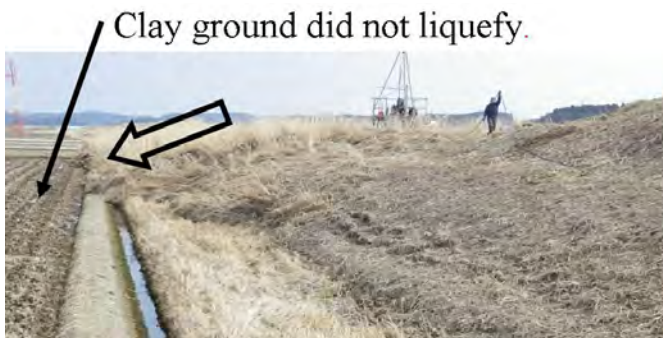
Fig. 14 Damaged levee resting on unliquefiable clayey subsoil (levee of Naruse River, north of Sendai)

A more significant and new problem is attracting a serious concern. Fig. 14 shows the distortion of a levee that rests on unliquefiable clayey deposit. The sliding of the slope surface and lateral bulging as well as the subsidence of the crest had been considered unlikely in the engineering practice when the foundation is composed of unliquefiable material. The reality is more complicated.

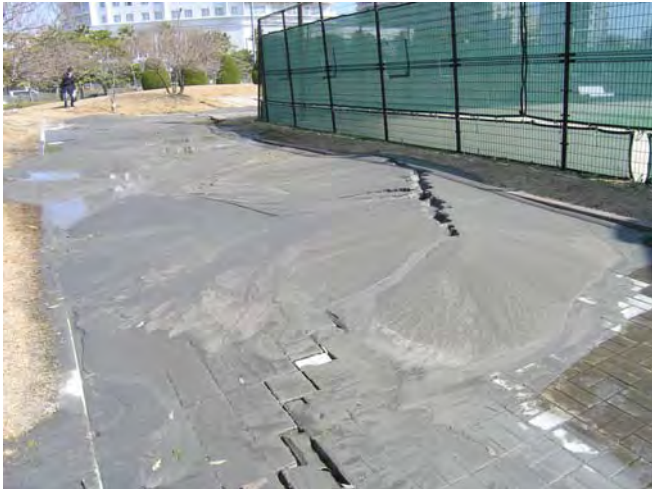
Figure 16 illustrates a site of typical liquefaction in Urayasu City (Fig. 1) to the east of Tokyo. The subsidence of ground after liquefaction is estimated to be 50 cm. The grain size distribution of sand ejecta is shown in Fig. 17. Note that the

Fig. 16 Liquefaction and sand ejecta in Urayasu City

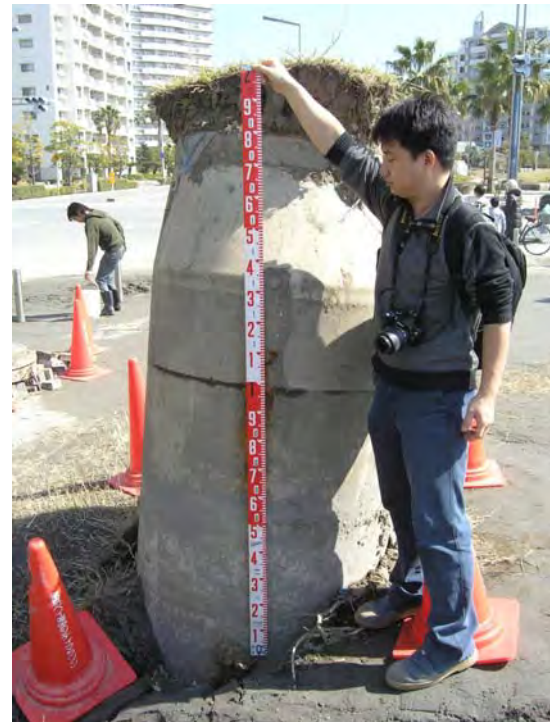
Fig. 19 2-meter floating of manhole

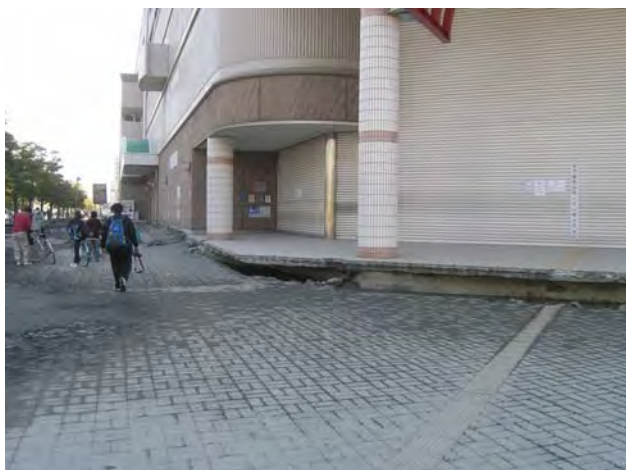
One of the countermeasures against liquefaction effects on buildings is the use of a pile foundation. Fig. 18 illustrates a successful example of pile foundation. However, note the differential settlement at the ground surface, which destroyed the connection of embedded lifelines with the building. Lifeline damage is typically shown by floating of manholes of sewage pipes (Figs. 19 and 20). Connections of sewage pipelines were destroyed by liquefaction of backfill sand.

Fig. 18 Differential settlement between surface of liquefied ground and pile-supported building

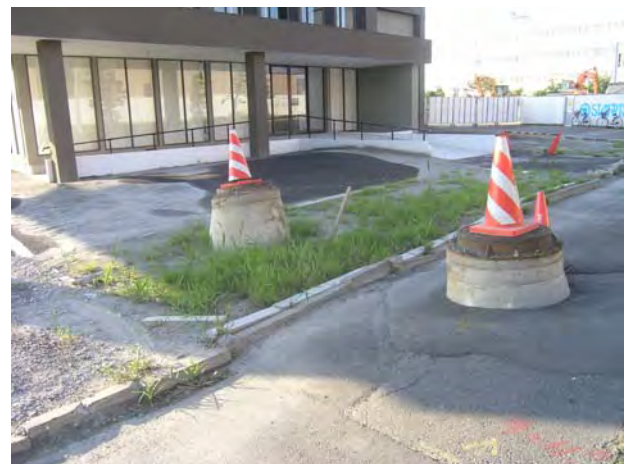
Fig. 20 Floating of a series of manholes

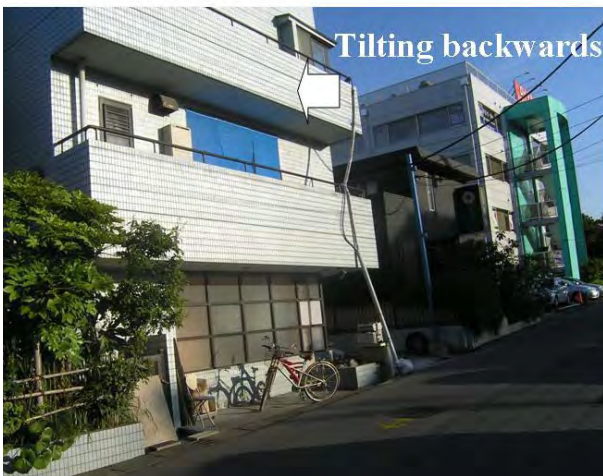
Figure 21 shows a tilted residential building. Due to lack of pile foundation in such a small structure, the subsurface liquefaction resulted in significant tilting and subsidence. Note, however, that there is no structural failure. Thus, the residual deformation and displacement are the essence of liquefaction-induced damage. Liability in such damage to

Fig. 21 Subsidence and floating of residential building

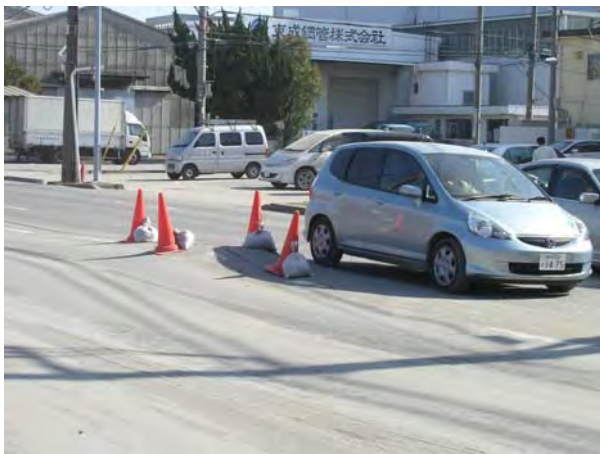
Fig. 22 Satisfactory performance of major road in Urayasu

The major roads in Urayasu City were able to maintain their function after the earthquake. Although some distortion occurred (Fig. 22), emergency vehicles were still able to travel at reasonable velocities. This good performance was achieved by special precautions during the road construction which decided to make pavement thicker than code requirements. It is noteworthy that subsurface liquefaction and the consequent volume contraction of sand under the pavement produced cavities underneath, and that the asphalt pavement started to collapse into the cavity at some places in summer when the temperature rose and the asphalt lost its mechanical strength.

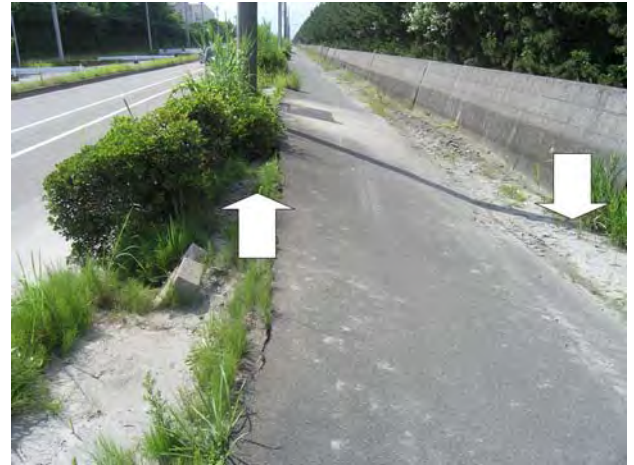
Fig. 23 Liquefaction-induced distortion of sidewalk

Another problem in the road is the heaving of sidewalk (Fig. 23). It is therefore likely that lifeline underneath, if any, is subjected to large distortion. The causative mechanism of this problem is yet to be known but the authors suppose that the subsidence of embankment and other heavy structures behind pushed the subsoil laterally and then upwards towards the sidewalk pavement that was not as rigid as that in the main road (Fig. 22). The contribution of elongated shaking together with a strong aftershock (30 min. after the main shock) requires further investigation.

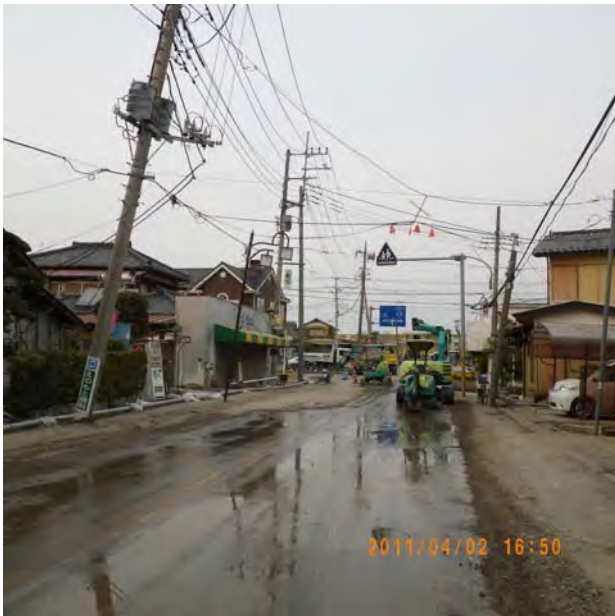
Tone River (Fig. 1) is one of the biggest rivers in Japan and there are many swamps and meandering channels along its main stream. Some of those water areas were filled with soil and formed liquefiable subsoil conditions. Fig. 27 is a liquefied site where flooding in 19th Century created a pond (Fig. 28) that was later filled with sand. The problem was that the liquefaction risk in this area was not indicated in a local hazard map probably because the lack of bore-hole investigation.

Fig. 27 Liquefaction in filled pond (Abiko City)

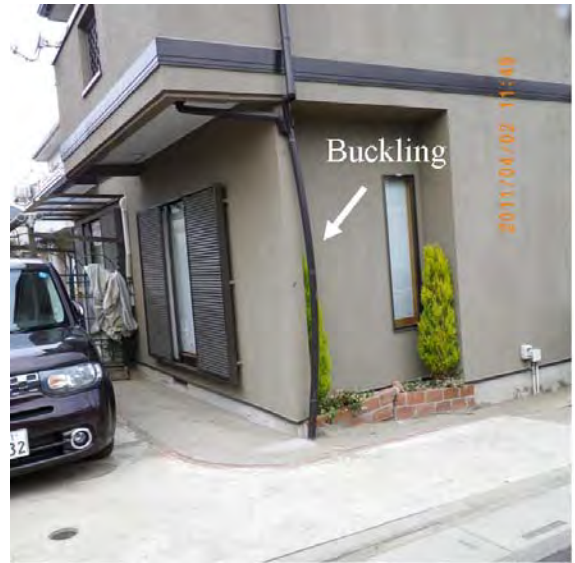
Liability problems occurred in the area of Fig. 29. This area used to be swampy with thick clayey deposit. In 1950s, the local government filled sandy soil above the surface, and this thin sandy layer was naturally saturated with water. Although the liquefaction layer was thus thin, minor tilting in houses (1% or less) has caused residents severe headache and dizziness. The point of argument is whether or not the risk of liquefaction was foreseen in 1950s prior to the 1964 Niigata earthquake and whether or not the recent caution by the local government about liquefaction risk has been sufficient.

Fig. 29 Liquefaction-induced tilting (Kazo City)
