# USAR Engineering Response to the 2011 Christchurch Earthquake

Peter McBean,  
Wallbridge and Gilbert Consulting Engineers

John L Wilson,  
Swinburne University of Technology

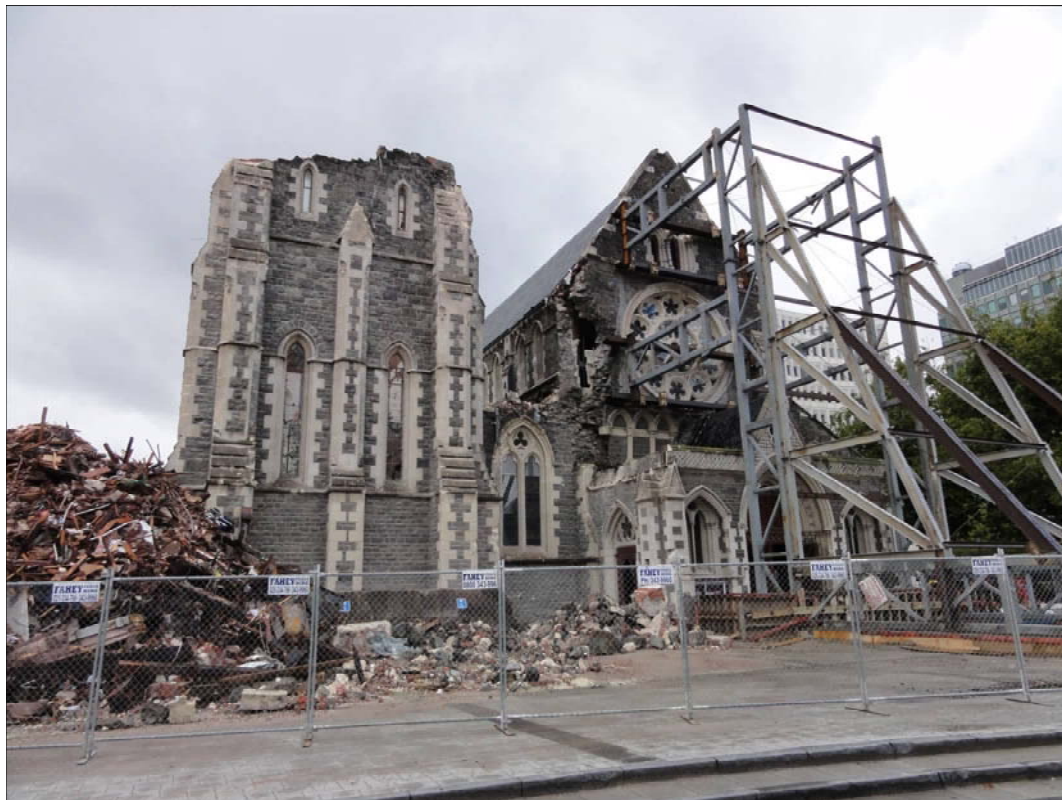
The historic Christchurch Cathedral built in 1864 and located in the centre of the city suffered significant damage with the 60 metre tall masonry spire collapsing into the public square (Figure 1). At the time of collapse, it was feared that a number of people were trapped under the rubble, but fortunately this was found not to be the case, after extensive USAR searching.

Figure 1 Christchurch Cathedral Collapse

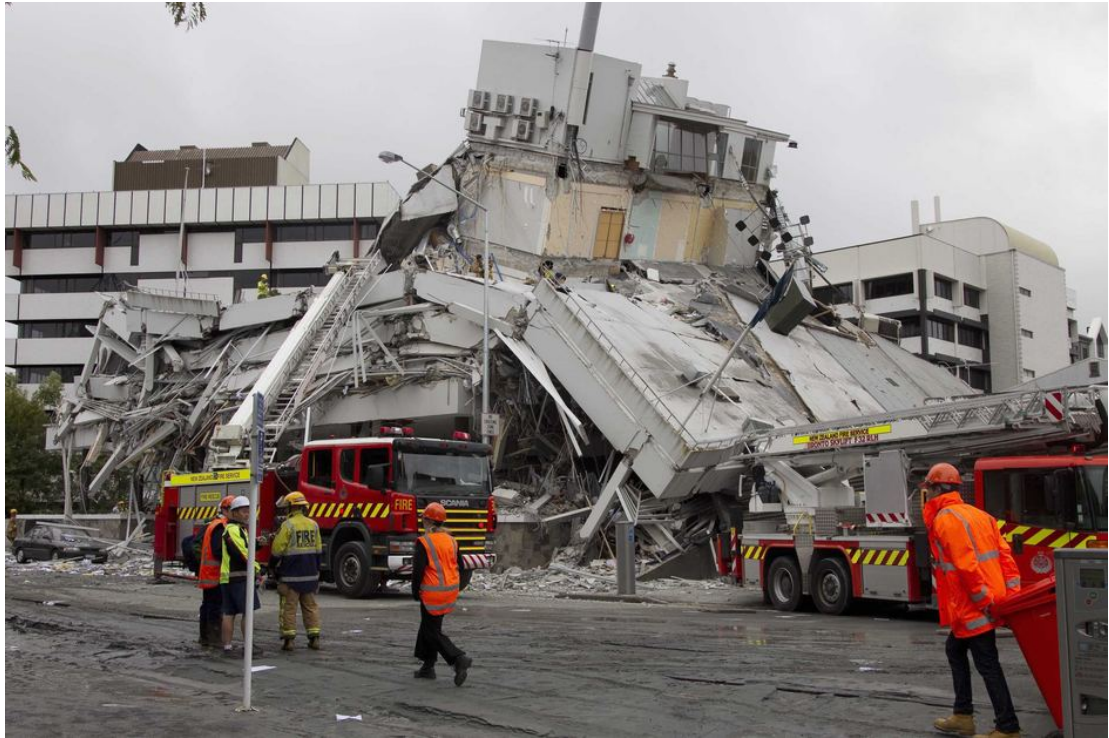
The 5 storey PGC building was built in 1963 with a lift shaft near the rear of the building. The building experienced large drifts caused by local failure in the walls and torsional rotation, resulting in the limited ductile gravity frames and upper floor slabs progressively collapsing onto the intact first floor (Figure 2). Interestingly an adjacent 4 storey office building (Ernst and Young) survived with virtually no damage and the adjacent 'Rotunda' reinforced concrete dome structure survived by rocking on the poorly detailed, but lightly loaded columns.

Figure 2 Pyne Gould Building Collapse

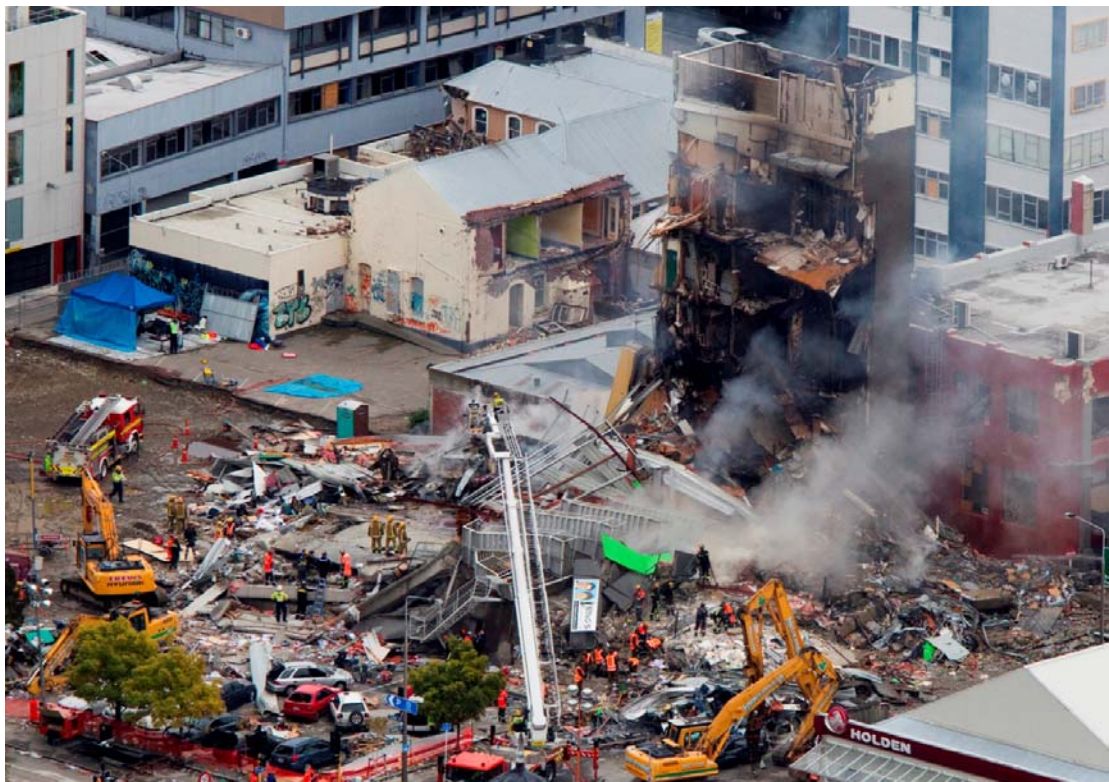
The 6 storey CTV building was constructed in 1986 and relied on core walls surrounding the lift shaft on the north side and coupled shear walls on the south side. The whole building collapsed with only the lift shaft remaining standing and a fierce fire that started in the car park causing many of the deaths (Figure 3). The catastrophic progressive collapse of the building could be attributed to insufficient drift capacity caused by the high axial loads in the columns and shear walls combined with the very high horizontal and vertical ground motions experienced in the area.

Figure 3 Canterbury Television Building collapse

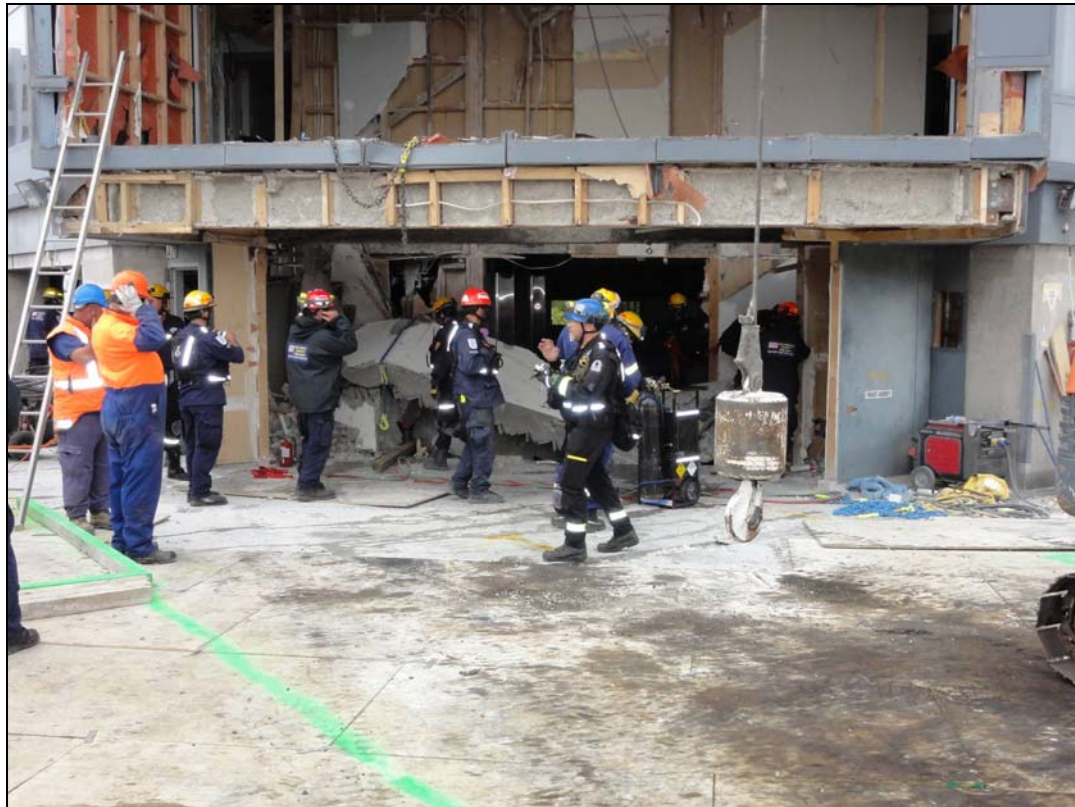
Most contemporary buildings designed with the principles of capacity design and to more recent earthquake standards generally performed well. A common form of modern construction was the reinforced concrete special moment resisting frame building, which performed generally as planned with limited beam hinging and joints intact. An exception was the performance of the 'non-structural' precast stairs, which collapsed in a number of buildings, creating an unacceptable situation where people could not safely evacuate the building. The collapse of the staircases was attributed to insufficient movement gaps provided, which resulted in the staircases buckling in compression when the storey drift was excessive and then becoming unseated on the reverse cycle, resulting in gravity load collapse. A number of people were thought to have been trapped in such staircase collapses, particularly in the around 20 storey Forsythe Barr building where 10 flights of stairs had collapsed from around Level 5 to 15 (Figure 4). Fortunately, after extensive and difficult searching which involved removal of each of the 9 tonne precast stair units, no fatalities were discovered. Similar stair details were used in other buildings including the Grand Chancellor (partial stair collapse) and the Brannigan's Bar building (damaged staircases).

Figure 4 Forsythe Barr Building Staircase collapse

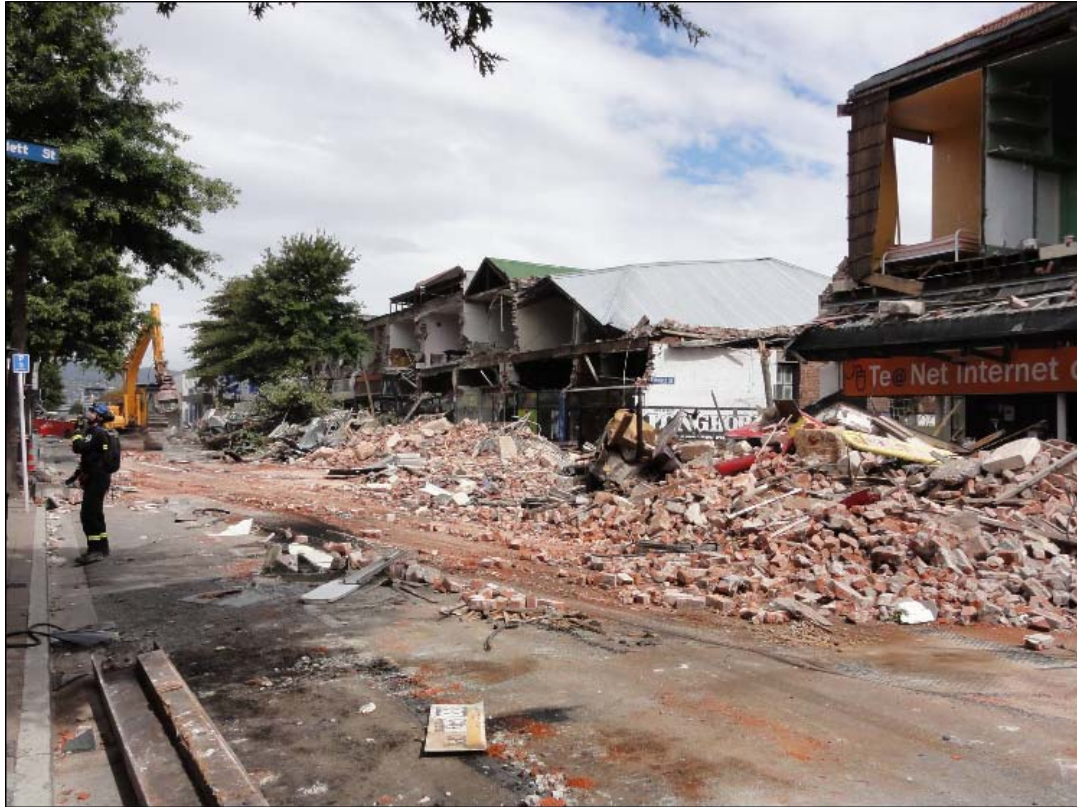
Figure 6 URM damage and debris in streets

Christchurch city was secured by the police and army with a cordon established creating a 2km by 2 km secure block with security passes required for access. The cordon was established to provide security against looting (all the shops were left open) and to prevent public access from a safety perspective. The USAR team assisted in making the city safer so that the cordon could be reduced in size over time. The city safe operations involved identifying and reporting hazards, supervising contractors where deconstruction had been approved to remove the hazard, removing debris from the streets and assisting strengthening some buildings where the structural support system had been damaged (Figure 6).

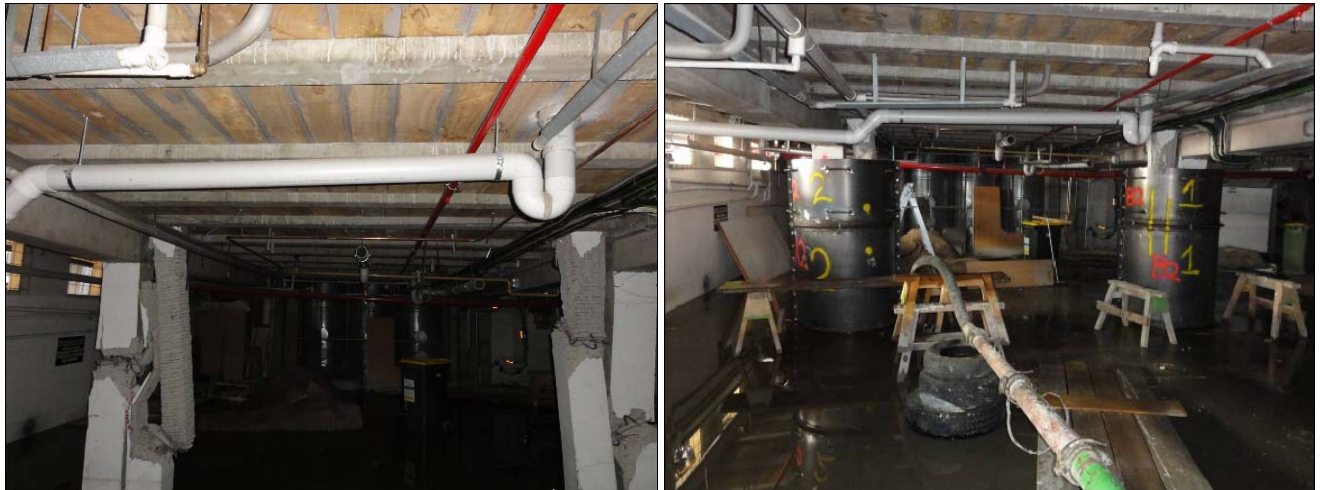
Figure 7 Retrofit repairs of partially collapsed columns

In some cases, USAR engineers worked with contract engineers to stabilise buildings where partial collapse of the building had occurred. For example, temporary strengthening works were developed and installed for the Copthorne Hotel and Grand Chancellor buildings together with constant monitoring to detect movement as an early warning mechanism. In the case of the Copthorne Hotel, a number of columns had partially collapsed in the basement which were stabilised by installing steel tubes around the column and filling the tubes with concrete (Figure 7). These works were completed by USAR teams in conjunction with external contractors for the steel fabrication and concrete supply and installation. The objective of such strengthening works was to secure the building from collapse, particularly from aftershocks, thereby making the surrounding space safer and to allow value engineering studies to be undertaken to assess the longer term future of the building (ie. building retrofit or demolition using conventional techniques).
