Implications of the 2010 Darfield (Christchurch, NZ) earthquake for Australia – are we ready?

Mike Griffith¹, Jason Ingham², Lisa Moon³

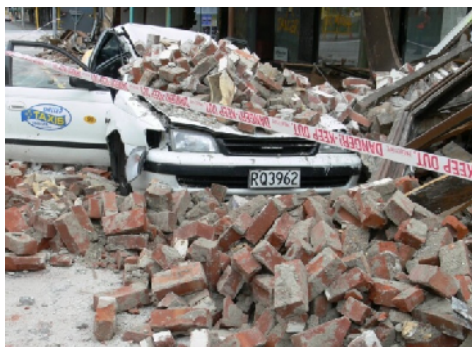
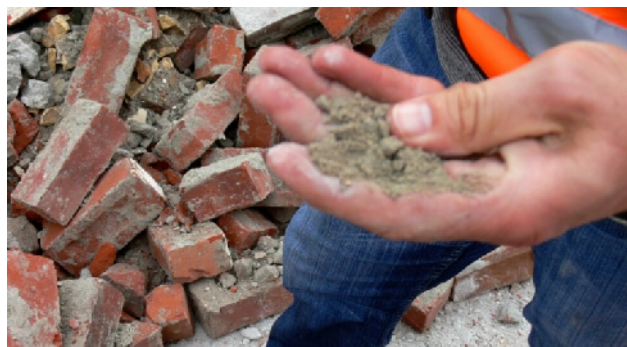
Figure 5. Masonry rubble from collapsed wall.

The general observation from the debris of collapsed URM walls was that the kiln fired clay bricks were generally of sound condition, but that the mortar was in poor condition. In most cases the fallen debris had collapsed into individual bricks, rather than as larger chunks of masonry debris and the mortar readily crumbled when subjected to finger pressure (refer Figure 5). However, it appears that superior mortar was often used in the ornate parapet above the centre of the wall facing the street, as this segment of the collapsed parapet often remained intact as it collapsed.

(a) relatively 'clean' bricks

(b) weak mortar crumbles between fingers

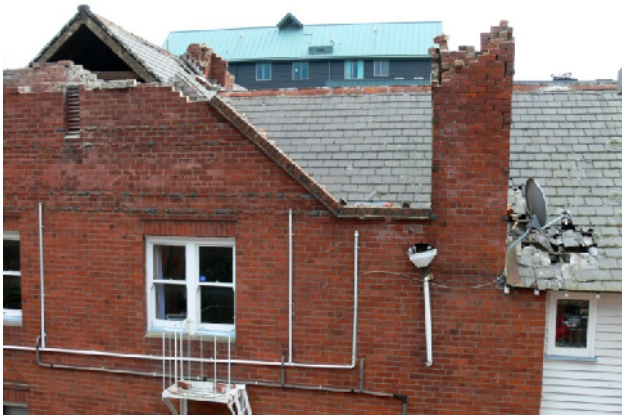
Unsupported or unreinforced brick chimneys performed poorly in the earthquake (Figure 6), with numerous chimney collapses occurring in domestic as well as small commercial buildings and churches. Many examples of badly damaged chimneys that were precariously balanced on rooftops were also seen (Figure 6b) and it was reported that one week after the earthquake, 14,000 insurance claims involving chimney damage had been received, from a total of 50,000 claims (NewstalkZB 2010). Removal of damaged chimneys to minimise further risk placed significant demand on emergency services personnel (Figure 6c). In contrast, Figure 6d shows an example of a braced chimney that performed well.

(a) Two damaged chimneys and gable wall.

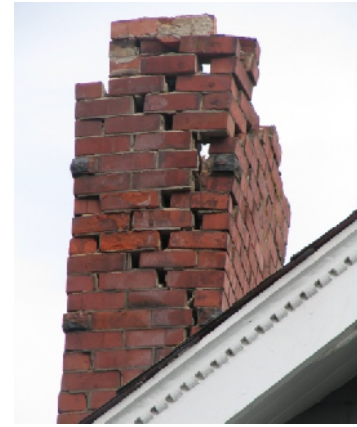
(b) Unstable damaged chimney

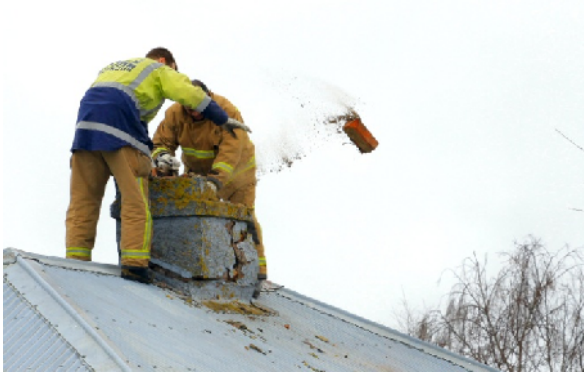
(c) Emergency services remove chimney.

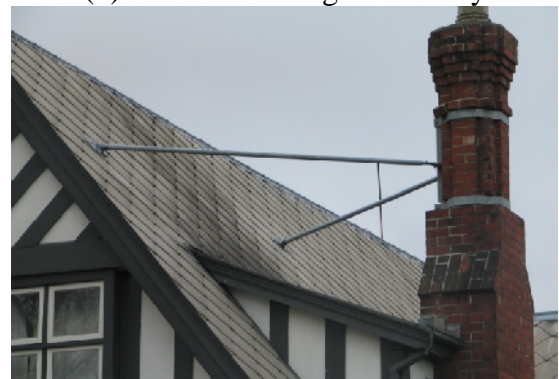
(d) Braced chimney performed well

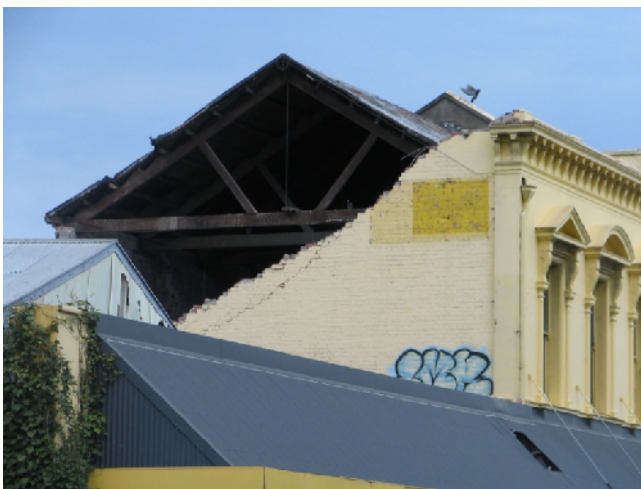
(a) 93 Manchester St

Many gable end failures were observed, often collapsing onto or through the roof of an adjacent building as seen in Figure 7. However, there were also many gable ends that survived; many more than might have been expected, with the majority having some form of visible restraints that tied back to the roof structure. These examples are shown and discussed later (refer Figures 15-17).

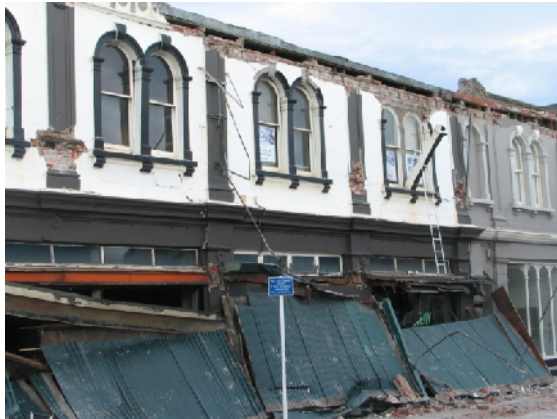
Numerous parapet failures were observed along building frontages and along their side walls, and for several URM buildings located on corners, the parapets collapsed on both perpendicular walls (refer Figure 8). Restraint of URM parapets against lateral loads has routinely been implemented in New Zealand since the 1940s, so whilst it is difficult to see these restraints unless roof access is available, it is believed that the majority of parapets that exhibited no damage in the earthquake were provided with suitable lateral restraint. In several cases, it appears that parapets were braced back to the perpendicular parapet, which proved unsuccessful.

(a) Multiple front wall parapet failures

Falling parapets typically landed on awnings which overloaded the awning tie rods causing collapse (Figure 8). Most awning supports comprised a tension rod tied back into the building through the front wall of the building. In most cases the force on the rod exceeded the capacity of the masonry wall anchorage, causing a punching shear failure in the masonry wall identified by a crater in the masonry (refer Figure 8a).

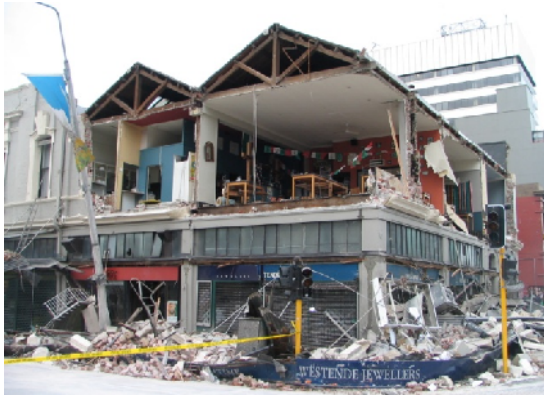
(a) Corner Worcester and Manchester St.

Out-of-plane wall failures were typically the result of poor or no anchorage of the wall to its supporting timber (floor or roof) diaphragm. Several examples of wall failure are shown below. Figure 9(a) shows a corner building that had walls fail in the out-of-plane direction along both directions. Figure 9(b) shows a 3-storey building where walls in the upper two stories suffered out-of-plane failures. In both of these instances, it appears that the walls were not carrying significant vertical gravity loads, other than their self weight, since the remaining roof structures appear to be largely undamaged.

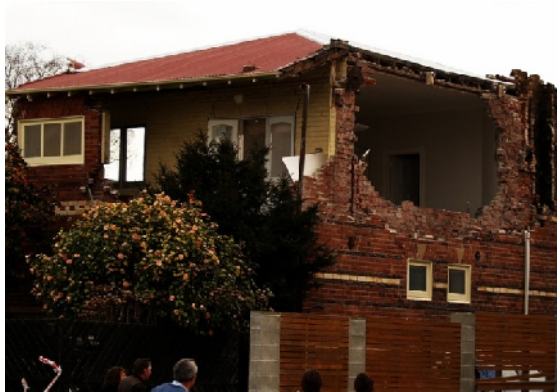
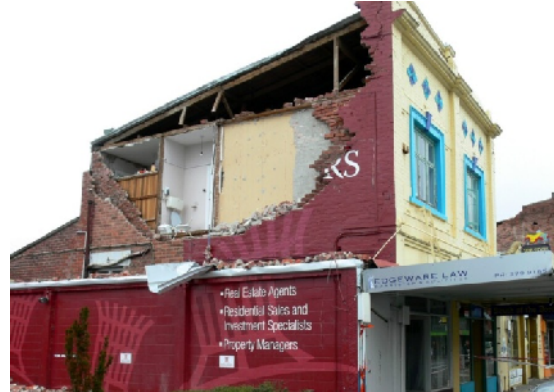
Figure 10. Examples of out-of-plane failures in cavity walls.

Cavity wall construction is generally believed to be much less common in New Zealand than is solid multi-leaf (or multi-wythe) construction. However, cavity wall construction can be extremely vulnerable to out of plane failure in earthquakes in situations where the cavity ties were poorly installed, or more commonly have corroded over time, as the wall is then comparatively slender and less stable than for solid construction. Figure 10 shows examples of cavity wall buildings that suffered out-of-plane wall failures. In most cases, cavity ties were present but were insufficient to prevent the outer leaf from failing.

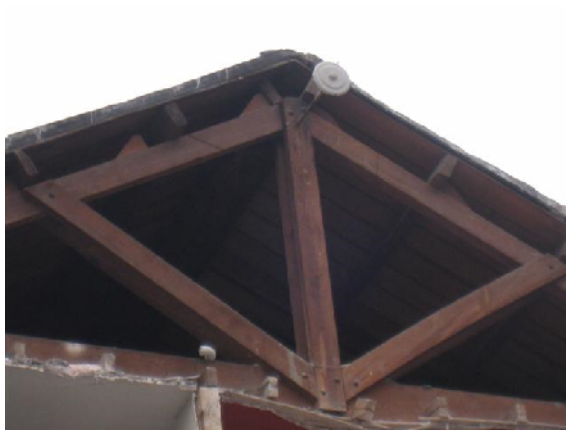
In some cases wall-diaphragm anchors remained visible in the diaphragm after the wall had failed, again indicating that failure had occurred due to bed joint shear in the masonry (refer Figure 11). Figure 11(b) shows a situation where a diaphragm anchor had been embedded within the wall. It can be seen that the anchor successfully prevented the restrained wall from failing, but was not able to prevent toppling of the masonry above the anchor.

(a) Gable wall failure despite anchor

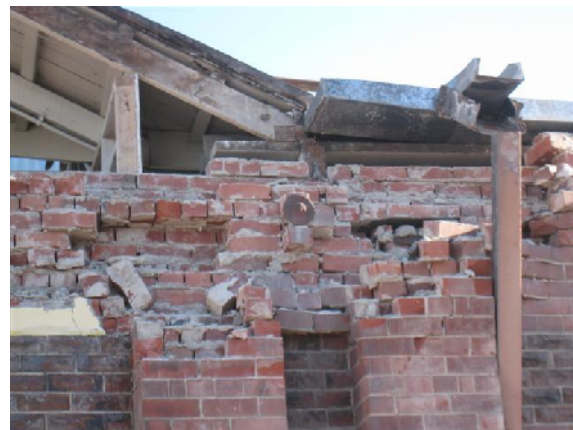
(b) Wall anchor still intact

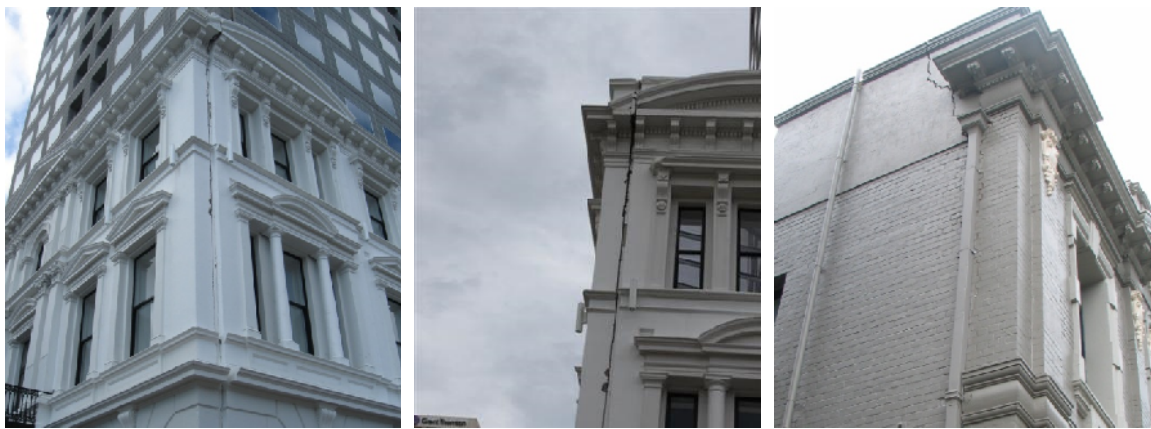
Figure 12. Examples of wall separation at corners of buildings.

Many buildings exhibited substantial cracking between their front wall and side (return) walls. This damage is not necessarily a catastrophic problem if stiff horizontal diaphragms are well connected to the walls in both directions, but where there is not good diaphragm connectivity, there is the potential for complete out-of-plane collapse of one or both walls. Figure 12 shows some examples where major cracking was observed between the side return walls and the front parapet and wall without collapse.

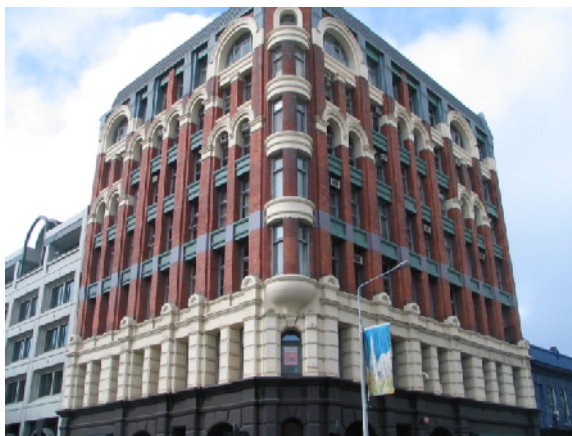
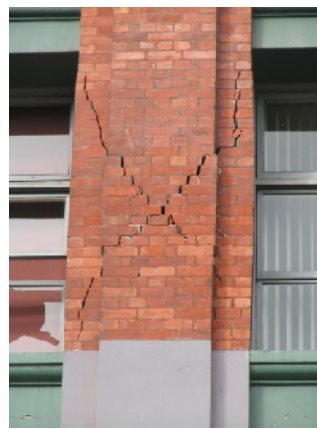
Figure 13. Manchester Courts building.

160 Manchester Street is a 7-storey, heritage listed (NZ Historic Places Trust 2010), URM office building that was built in 1905 (Figure 13). The building suffered significant damage to its masonry piers at levels 3 and 4. After much debate, the city council gave approval to demolish the building as it poses a significant falling hazard to the dozen or so businesses and buildings within the 70 m radius ‘fall zone’.

(b) North wall pier, level 3.

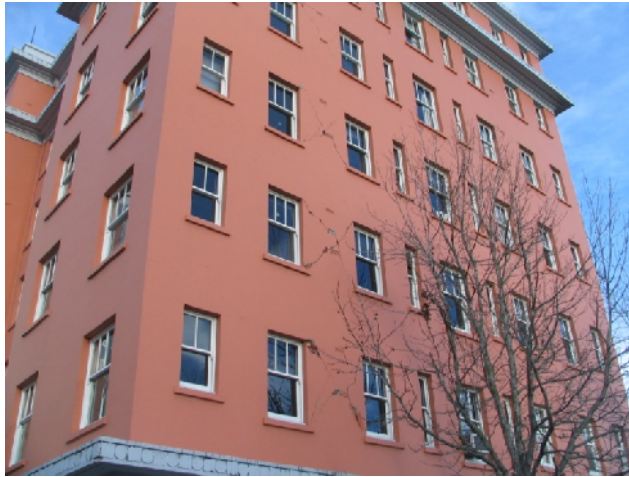
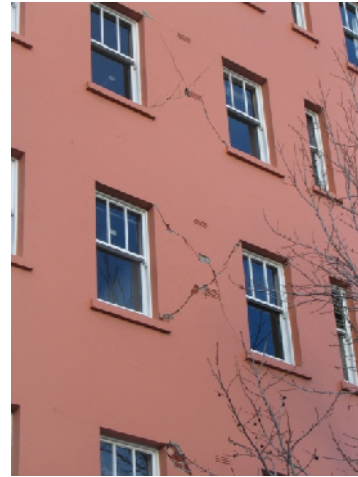
Figure 14. Views of St Elmo Chambers building in Montreal Street.

St Elmo Chambers is also a 7-storey building, reported to be a reinforced concrete frame building with external clay brick masonry piers. Owing to the absence of control joints between the masonry and concrete frame, the masonry piers attracted sufficient seismic in-plane forces to cause shear failure (refer Figure 14). Judging by the extent of cracking in the brickwork, it appears that the storey drifts were less than 1%, implying that the concrete frame was not pushed to its maximum capacity (strength or drift).

(b) damaged brickwork

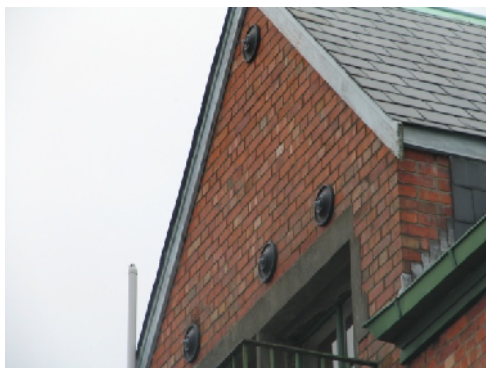
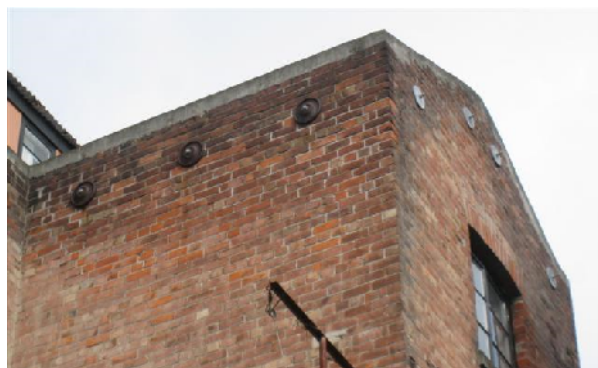
Figure 15. Successful gable end wall and side wall anchorages.

A significant feature of the earthquake was the number of occasions where wall-to-diaphragm (floor or roof) anchors performed well. Photographs showing this are presented in Figures 15-16. A typical wall-to-diaphragm anchor typically consists of a long 20 mm bolt with a large circular disk of about 150-200 mm diameter between the wall exterior and nut that clamped the disk to the wall.

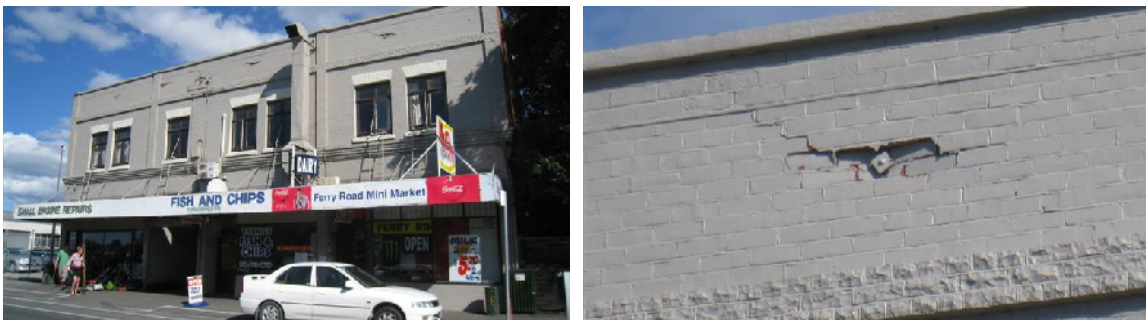
Figure 17. Onset of wall-roof anchorage failure.

Another interesting feature of this earthquake is the observation of walls that only partly failed, allowing for identification of the specific failure mode at its onset. An excellent example is a 2-storey URM building on Ferry Road (see Figure 17) where the front, street facing, wall of the building had started to fail out-of-plane despite the presence of wall-roof diaphragm anchors. As shown, the anchors were on the verge of pulling through the masonry wall. Internal inspection of the building revealed that the front wall had separated from the long side walls of the building and moved approximately 50 mm towards the road with respect to the ceiling/roof diaphragm.

(b) Detail of partial anchorage failure

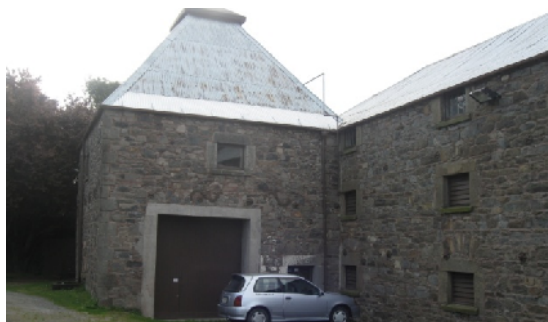
Figure 18 – Malthouse Theatre

Diaphragm stiffness has a significant effect on the behaviour of a building during earthquakes, as observed at the Malthouse Theatre (Figure 18). Prior to the earthquake, the stone masonry building from 1867 underwent an extensive seismic retrofit involving stiffening of floor and roof diaphragms and connecting it to the external walls.

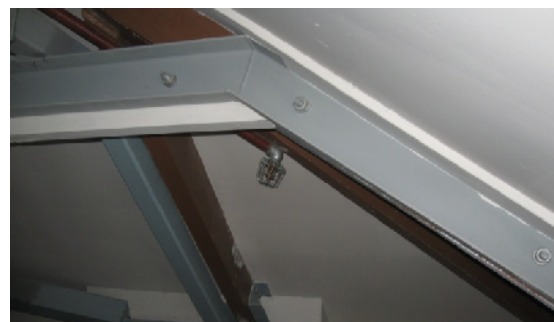
Figure 19 – Steel frame in roof

The roof diaphragm was stiffened through the addition of an internal steel frame (Figure 19). The frame was attached to the original timber roof trusses, and connected to the external walls. The floors were stiffened through the addition of blocking between joists (Figure 20a), and steel plates were added to connect some of the joists to the masonry walls (Figure 20b). Externally, diaphragm ties were visible on all sides at floor levels indicating that the floors had been anchored to the walls (Figure 20c).

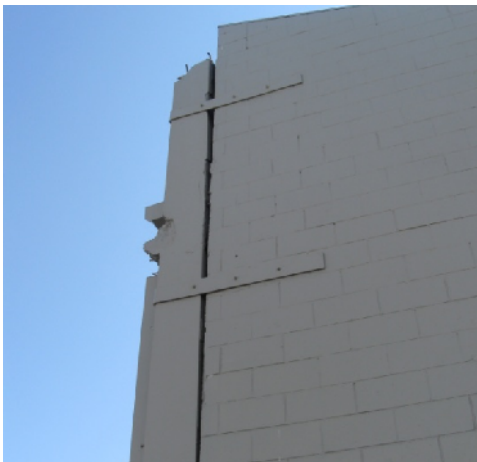
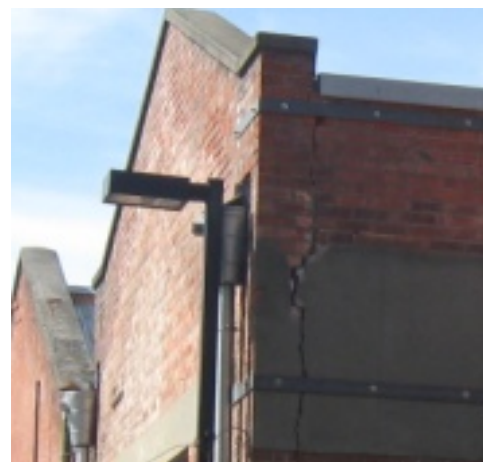
Figure 21 – Examples of corner ties

In some buildings steel plates were observed connecting the front and side walls. Such ties prevent building facades collapsing as well as increasing the in plane and out of plane capacity of both walls. While it is not clear whether the two examples shown in Figure 21 were installed before or after the recent earthquake, the technique has the potential to improve the seismic performance of the buildings by ensuring greater interaction between return walls.
