# **Earthquake Damage Characteristics and Assessment of Lifeline Systems on May 12th, 2008, Sichuan Earthquake**

**Aiping Tang<sup>1,2</sup>, Lianfa Wang<sup>2</sup> and Guidong Zou<sup>3</sup>**

## **Abstract**

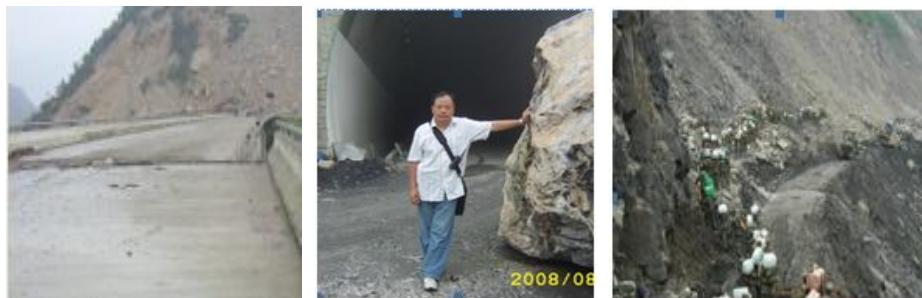
(a) Tunnel entrance is covered by rock landslide (b, c) traffic is blocked by falling rocks

According to site investigation, 90 percent of traffic interruption in meizoseismal area was attributed to landslide, debris, falling rock and uneven foundation subsidence and ground rupture. Four highways to Yingxiu town are completely interrupted due to heavy landslides and debris. In Hongkou and Xiaoyudong, several bridges were damaged duo to large ground displacement or deformation related to fault motions. A railway system for coal transportation was found to be damaged due to foundation slope failure (Fig. 2, e, f).

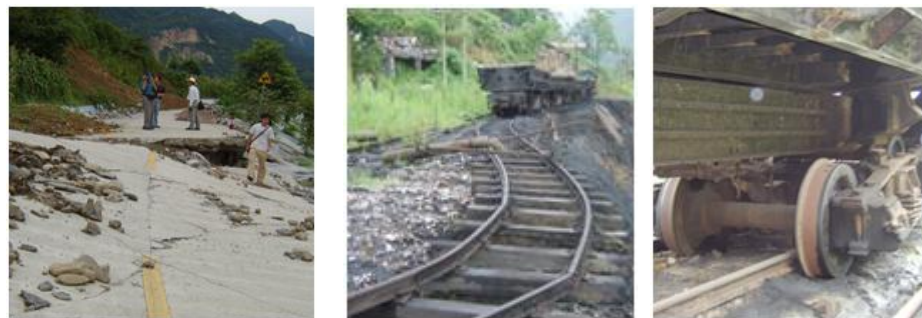
Fig.2. geotechnical disasters and transportation system

d) Failure of highway foundation (e) damaged railing track (f) carriage off the track

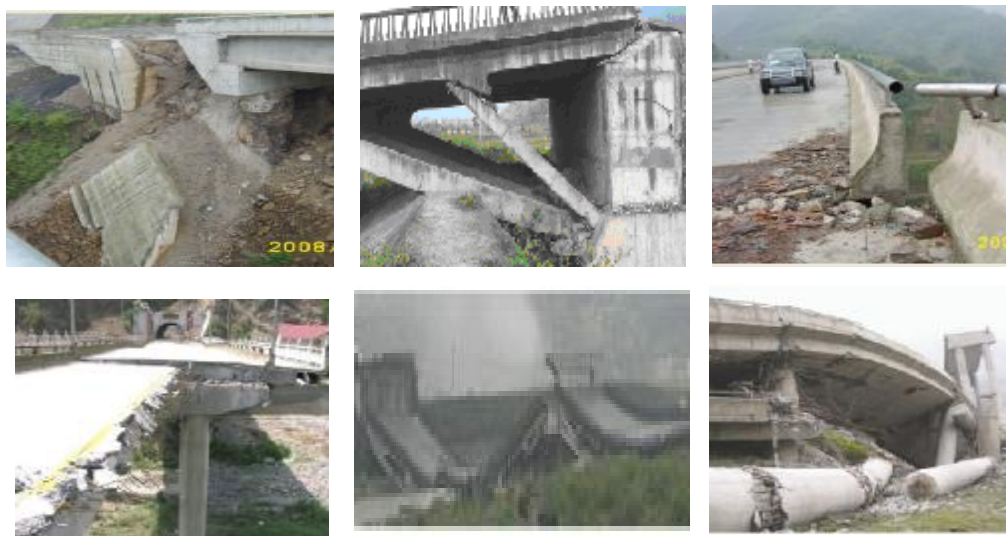
Fig.3. typical earthquake damaged bridges [7]

Although most of bridge subsystem are intact or slight damaged, but some important bridges are also severely damaged in this earthquake because they were not adequately designed for earthquakes, resulting in the loss of many river crossings. (Table 1, 2), which made the emergency rescuing very difficult. The fault and near-fault strong motion, and geotechnical disaster triggered by fault motion were three of the important factors. The typical damaged bridges in details are shown in Fig.3.

a) Jianjianghe Bridge

b) Xiaoyudong Bridge

c) Baihua Bridge

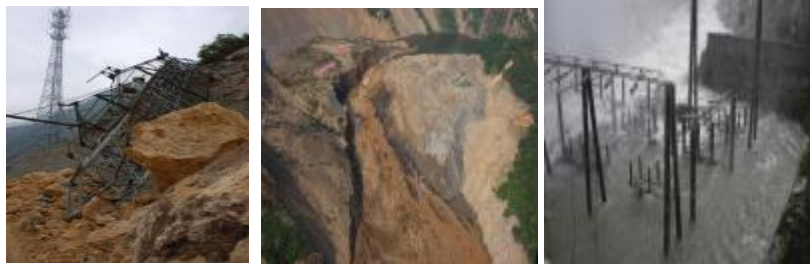
Power systems were damaged due to pulse velocity near fault, landslide and rock collapse. In Yinxiu town, a hydro-power station was buried by debris. There were many high-volt electric poles installed in slope to tilt down because of slope failures of foundations (Fig. 4, a). There are 470 hydropower stations to be affected in this earthquake, and parts of them completely lost their functions because of landslide and debris to be full of the entire reservoirs' volumes or split and subsidence of dams (Fig. 4 b). Some Power transmission equipments were inundated and dam was overtopped because of barrier lakes formed by landslides, landslide or collapse (Fig. 4 c).

(a) electric-pole tilt down (b) reservoirs filled by landslides (c) inundated power equipments  
 Fig.4. Power supply system typical earthquake damage

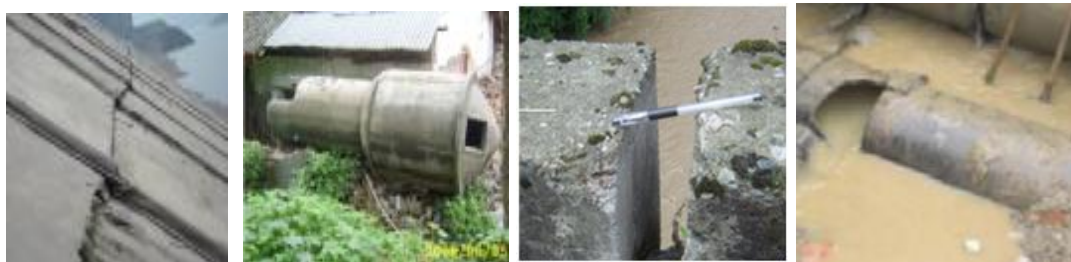
Fig.5. damaged water supply system

The Chinese Earthquake Administration estimated that 18,000 miles of buried water pipelines were subjected to reasonably strong ground motions due to the PGA 0.10g or higher. About 14,000 miles of pipelines had restored water service after 20 days of the main earthquake. The out of service and extensive damage to buried pipes was mostly due to landslide, strong ground shaking, differential movement at bridge abutments, fault, housing collapse, lack of manpower and parts to perform repairs, and water treatment plants out of service due to structural damage and water pollution.

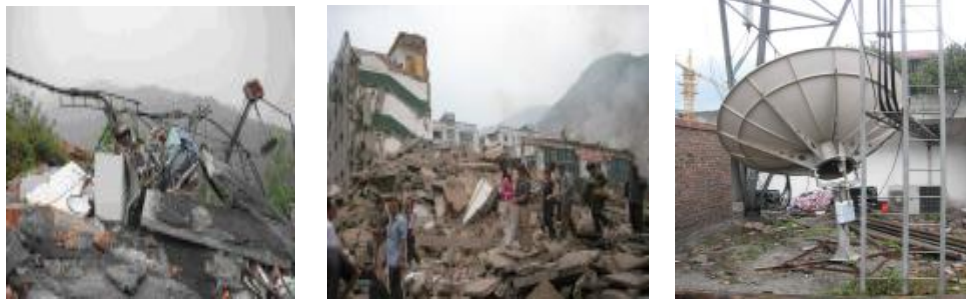
The telecommunication system was also damaged. In Sichuan, Gansu and Shanxi provinces, there were 3,897 telecommunication offices, 29,064 cell phone stations and 28765 km long line to be damaged. There were 142,078 telecommunication poles broken or collapsed due strong earthquake motion, landslide and debris. Telecommunication building, equips and apparatus was found to be damaged by falling rock and landslide in Yingxiu town (Fig.6). The backup systems for emergency response were buried by landslide, debris and collapsed building. The

(a, b) Damaged unreinforced masonry and equipments (c) Satellite dish under the tower [C, 7]

Fig.6. damaged telecommunication system (About 2300 mobile stations were damaged)

- 2 A secured telecommunication and transportation system were very important in cities as well as rural communities. The service providers should initiate a plan of actions to reduce repeated disruption and economic losses. Dispersed network redundancy in the rural areas would be an excellent option to prevent communities from total telecommunication and transportation isolation. The service providers and governments should do their best to upgrade telecommunication and transportation network components, such as bridge, tunnel, equipment building, towers, transmission and distribution network, equipment anchorage, backup power generators, increase backup battery duration, and concentration.

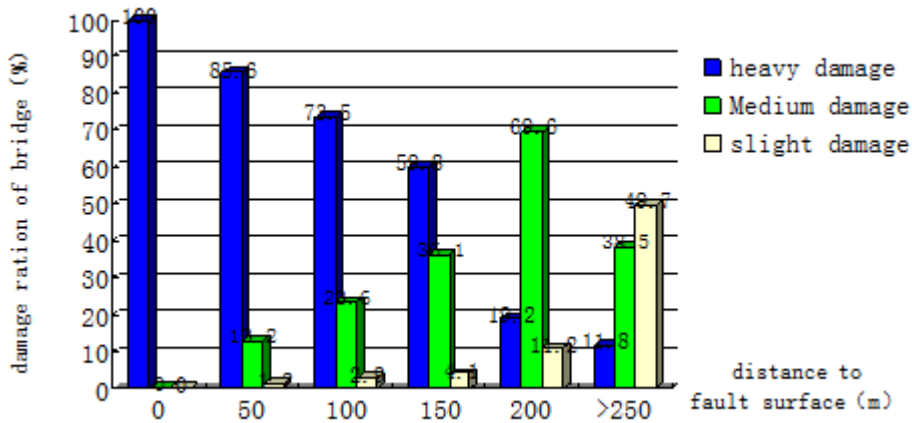
Based on the site investigation, typical damage characteristics to bridge were span collapsing, sliding between bearing and girder, shear key failure, damage of expansion joint, pounding of adjacent girders, and tilting and cracking of abutments. Almost all of the medium and severely damaged were near fault, where there are strong ground motion recorders. Table 3 illustrates two typical examples. It is obvious that the nearer the bridge located to the fault, the severer the bridge was damaged. This damage phenomenon is particularly obvious within 10 m in both side of fault. According to statistics of lifeline earthquake damage, this safety distance to the fault

Fig. 7 the relationship of bridge damage to distance

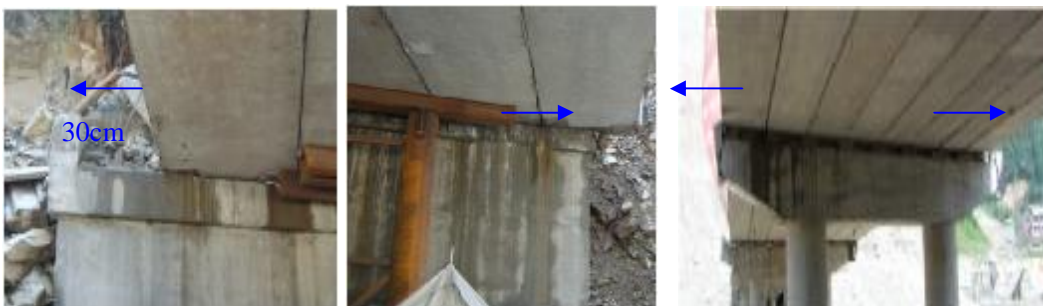
There were same damaged phenomena in all of the damaged bridges near fault: 1) the girder rotated in horizon, so, the protection to anti-falling of deck was damaged. The rotation direction was clockwise, in accordance with the fault rupture direction ((Fig.8, right-lateral strike fault). 2) The girder took place the snake-deformation in horizontal direction and waving of deck in vertical direction, which meant wave propagation effect (Fig.9 a). 3) Obvious pressure deformation in axial direction of these bridges, which meant pulse-like motion which exposed the structure to high input energy (Fig.9, b, c).

Fig. 8. Mingjiang Bridge in Yingxiu town (clockwise rotation)

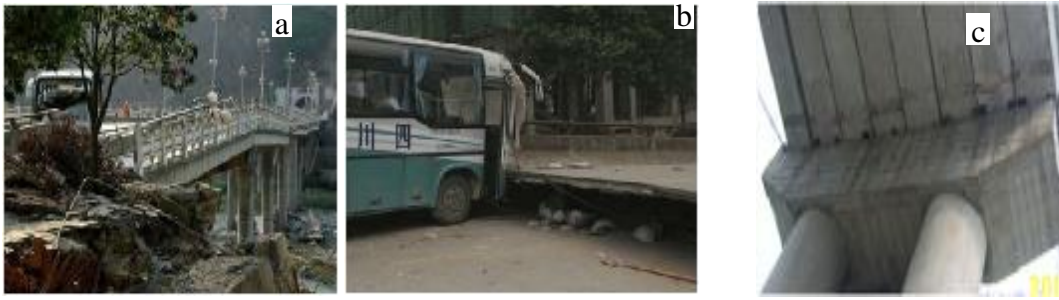
Fig.9. Jianjianhe bridge in Beichuan City(a,b) and Gaoyuan bridge in Hongkou town (c)
