Earthquake damage in wastewater systems and post-earthquake repair methods; limitation and practice

M. R. Zare¹, S. Wilkinson², R. Potangaroa³

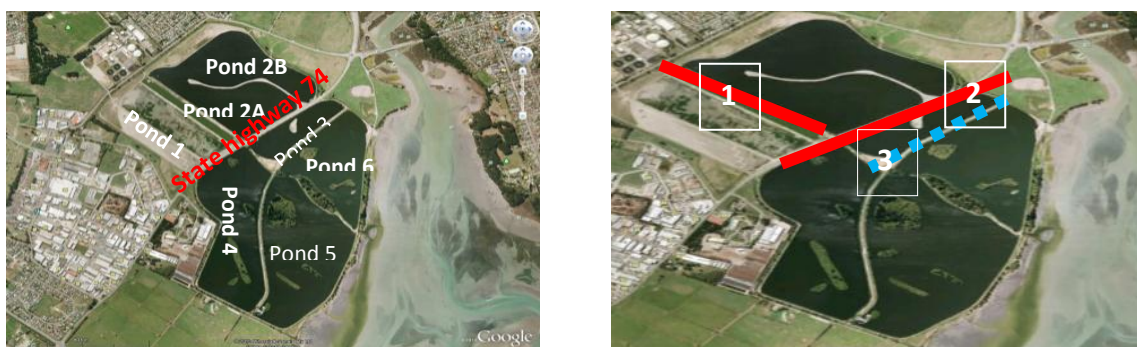
Figure 1: Christchurch wastewater treatment plant ponds location and damage (Google map)

Significant earthquake induced damage in the Bromley WWTP can be divided into damage to the ponds, connection pipelines and pipeline inside the pond area. The 2010 earthquake significantly affected the pipes installed within the pond area; especially the connecting pipes between Ponds 2 and 3, and also the bypass pipeline in Pond 1. The earthquake severely

damaged the under-road 900 mm concrete pipes which connect the treatment ponds on both sides of the State Highway between Pond 2 and Pond 3. Joint separations and pipe crushing in joints and body were the main types of damage in the pipes underneath of State highway 74. The pipes failure created some significant sink holes in the main road and forced Highway 74 to be closed for two weeks. Failure of the bypass pipeline is another significant pipe failure in the pond area. The joint separation and misalignment (horizontally and vertically) were the main types of failure in the concrete bypass pipes.

Further significant damage caused by the 2010 earthquake to the Christchurch WWTP was pond damage. After the earthquake, some stop banks slumped to the ponds or outside the ponds, and caused severe cracks in some particular regions including State Highway 74, stop bank between the ponds 3 and 6, stop bank shared by the ponds 4 and 5 and stop bank between the Pond 1 and 2. The earthquake induced damage between Ponds 3 and 6 and also damage in ponds 4 and 5 were serious because of the significant difference in water levels in both sides of the shared stop banks. The right photo in Figure 1 shows the main damaged regions (lines 1 and 2) and also installed sheet piles which were installed to protect the severely damaged stop bank (line 3). After the earthquake, in order to decrease risk of dike failure and also protect of the downstream ponds, first, the water level in the Ponds 3 and 4 was decreased, and then two series of sheet piles of 250 and 170 meter in length were installed in the shared dikes 3-6 and 4-5, respectively. Some minor cracks were also seen near the recently constructed pumping stations underneath Pond 6 and also stop banks of Pond 2. On top of the direct damage in the ponds, power outage after the 2010 Darfield earthquake affected the wastewater treatment plant. For instance, on the second day after the earthquake, the Christchurch WWTP came to service again (Gordon 2010).

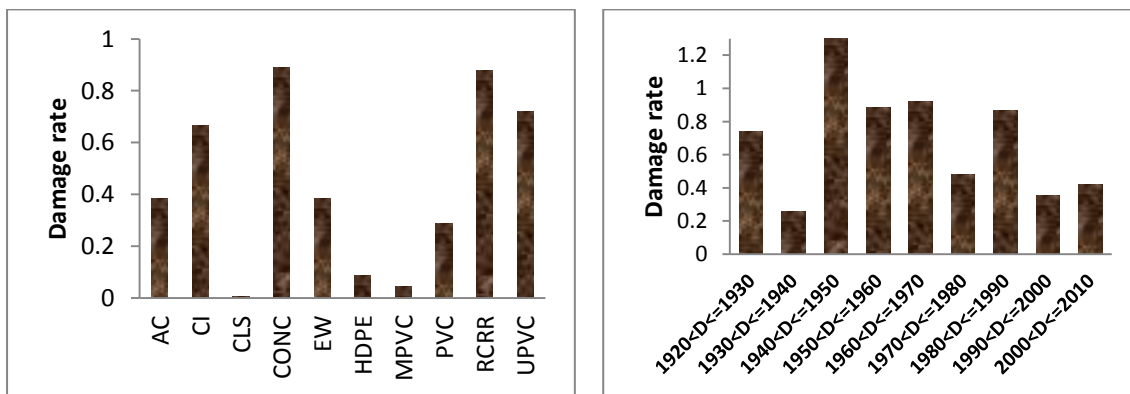
joint (RCRR), the unplasticized poly vinyl chloride (UPVC), the earthen ware (EW), the concrete (CONC) and the asbestos (AC) pipes shown in the left graph on Figure 2. Damage rate is defined as number of defects in unit length of pipelines. The GIS data base of the damaged wastewater reticulation is used to calculate damage rate. Damage rate in each type of pipes is calculated by total length of each type of pipes in terms of material, diameters, pipe age and etc. divided by number of defects in that particular type of pipe. Damage rates in concrete and reinforced concrete pipes are significant and the damage rate is approximately about 0.9 per unit length of each type of pipe. High damage rate in concrete pipes shows the pipes were probably affected by corrosion in the Christchurch wastewater reticulation. If the damage rate in each pipe diameter is observed, the 150 and 225mm diameter pipes show the highest damage rate in the Christchurch wastewater reticulation with damage rates of 1.3 and 0.42, respectively.

GIS data base in Christchurch shows approximately 69% of the Christchurch wastewater reticulation has been developed since 1950, that 31% of the sewers in Christchurch had been installed before 1950. Furthermore, about 46 % of the sewers in Christchurch were installed more than 50 years ago. Comparison of the earthquake damage in sewers installed in different decades shows sewers built between 1960 and 1970 were reported to suffer the maximum amount of damage after the earthquake, however, the maximum damage rate belongs to sewers installed between 1940 and 1950. The right graph in Figure 2 indicates that the Christchurch sewers constructed between 1920-1930, 1950- 1970 and 1980-1990 suffered severe damages after the 2010 Darfield earthquake.

Figure 2: Distribution of damage in the Christchurch WW network
