Performance of Tall Reinforced Concrete Chimney Structures in the 2010 Chilean Earthquake

John L Wilson

Faculty of Engineering and Industrial Sciences,
Swinburne University of Technology

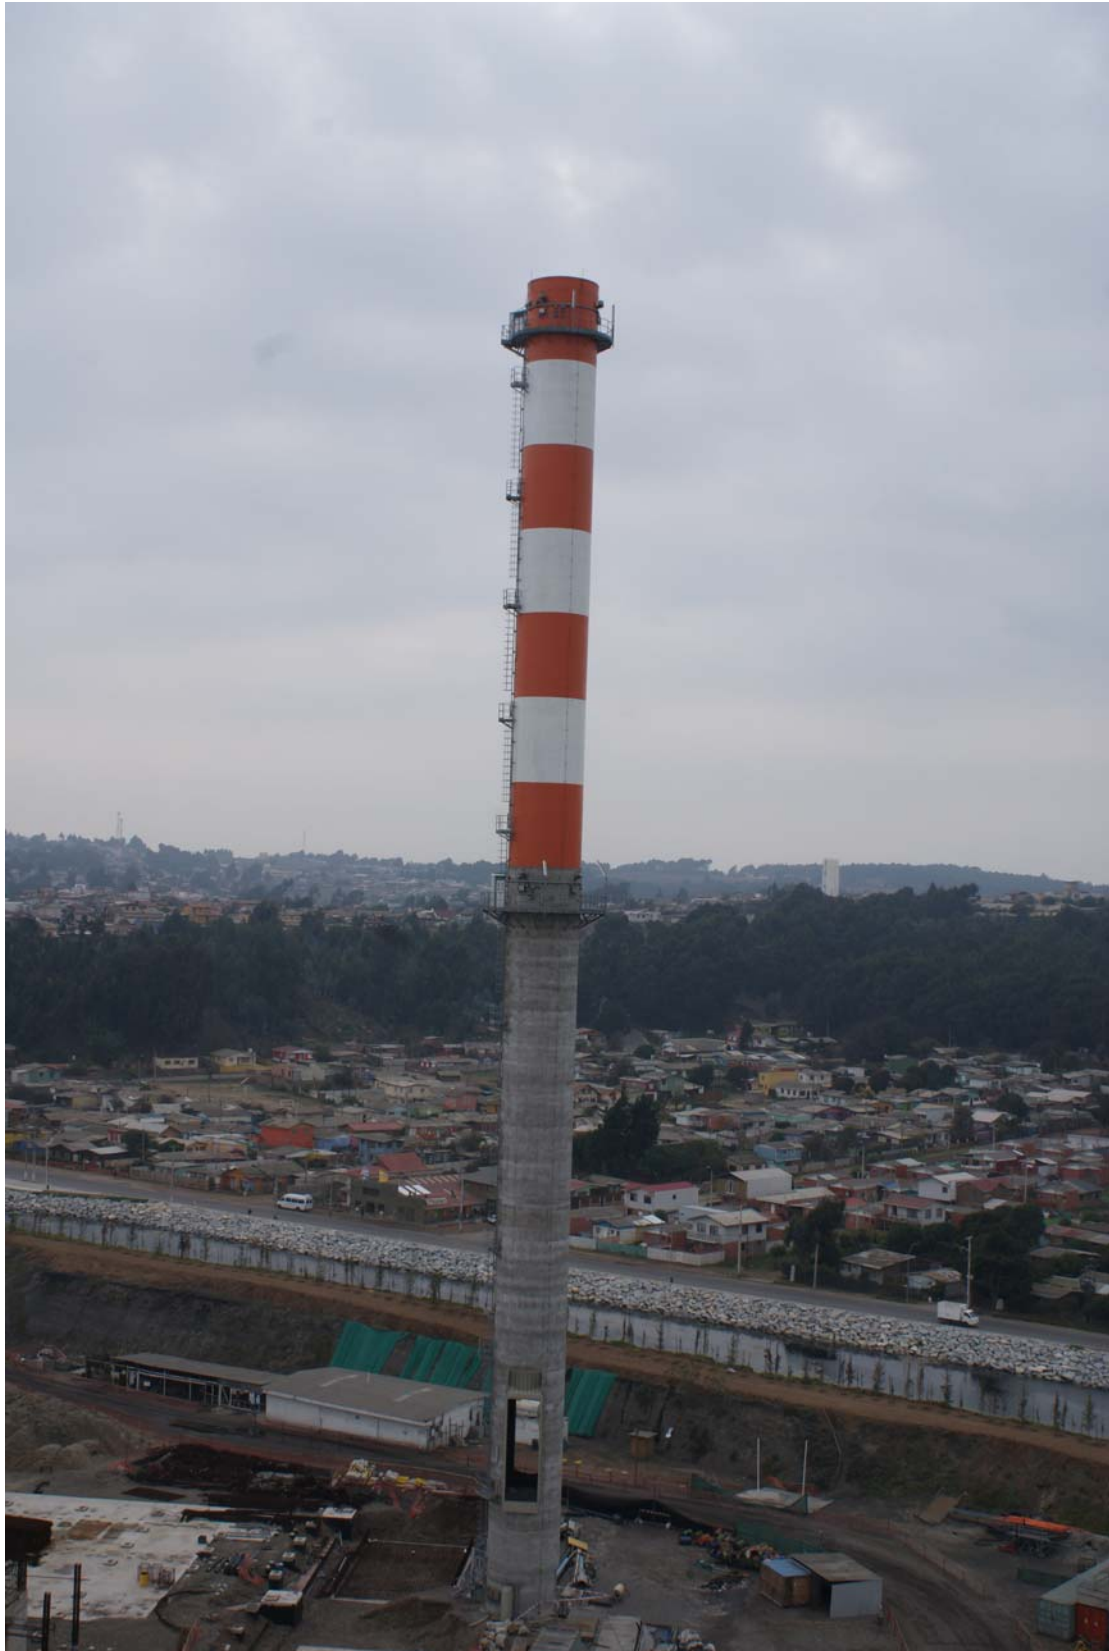
Figure 6 **Campiche 95m tall Chimney**

The northern power station chimneys consisted of the Campiche Power Station (still under construction with work suspended due to a legal dispute, but chimneys completed, refer Figure 6) and the Ventanas Power Station (being commissioned at the time of the earthquake and now in operation, refer Figure 7). The ground shaking in this region was estimated to be in the order of 100 mm/sec , based on an intensity of around MMI 7. Such an intensity appeared consistent with the level of ground shaking experienced by the people interviewed, the level of damage experienced in this region and the considerable distance of around 100km to the zone of fault rupture. For example, one of the construction engineers experienced quite violent shaking on the 11th floor of his apartment which lasted over 60 seconds, pictures fell from the wall, a TV fell off a table, he had difficulty standing which would have been compounded by the darkness associated with the electricity blackout. However, in the morning there was only very minor cracking in the building joints between the walls and windows suggesting drifts in the order of $1/750$ and ground motions with a PGV in the order of 100mm/sec , which would create velocities around 300mm/sec at the top of the building.

Damage to the power station structures was reported to be only minor to one of the main bracing connections in the boiler house structure and some pressure pipes in the membrane wall of the boiler. No damage was reported in the Turbine House, Bunker Bay, Precipitators, Transformer Bay and Switchyard. No cracking was reported in the Ventanas chimney whilst minor cracking was reported in the Campiche chimney at a height of around $45\text{-}55\text{metres}$, including fracture of the externally mounted copper lightning conductor. The chimney designer recommended that the minor horizontal cracking in the Campiche chimney be repaired with epoxy injection.

During the study visit, the Campiche chimney could only be inspected at the base with no cracking evident. Access up the chimney was prevented due to a legal dispute that had suspended construction of this power station. Similarly, no cracking over the lower half of the Ventanas chimney was evident during the study visit, although access above the platform at mid-height level was not permitted due to operational constraints.

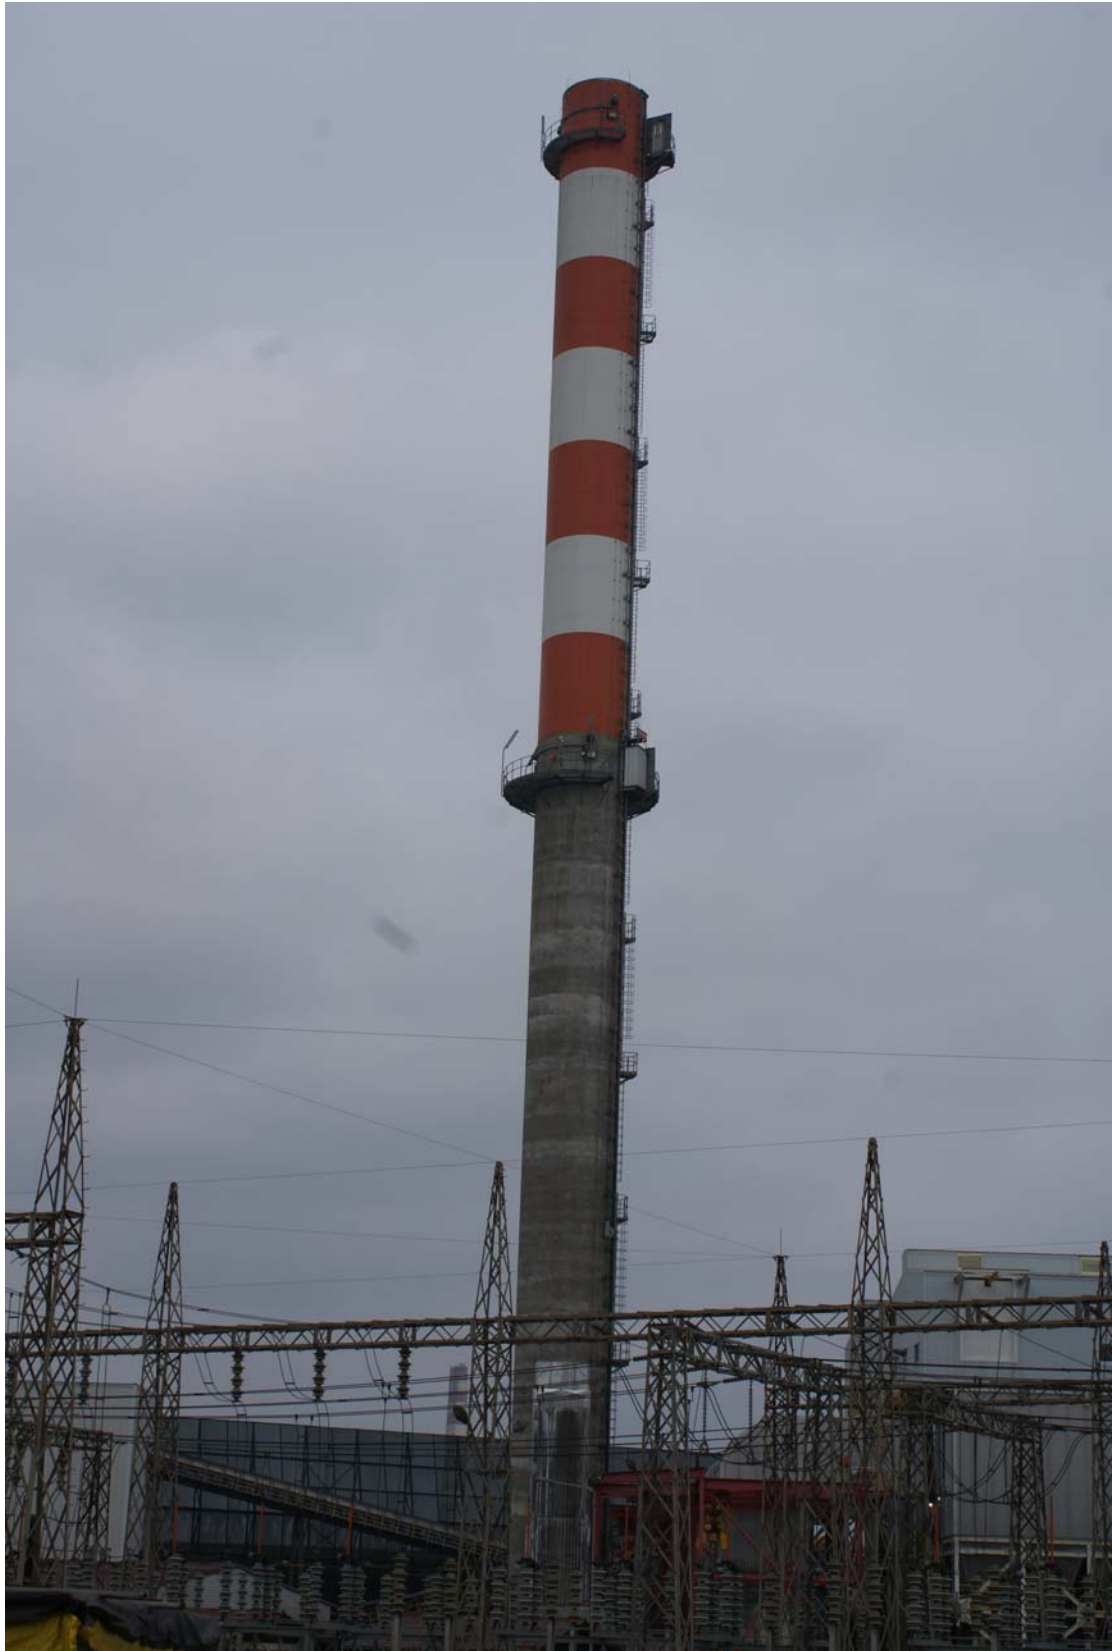
Figure 7 Ventanas 95m tall Chimney

No damage was reported to the 'Pennguard Block' lining system in either chimney indicating excellent performance to this relatively strong ground shaking, with maximum chimney drifts in the order of 0.1-0.2%.

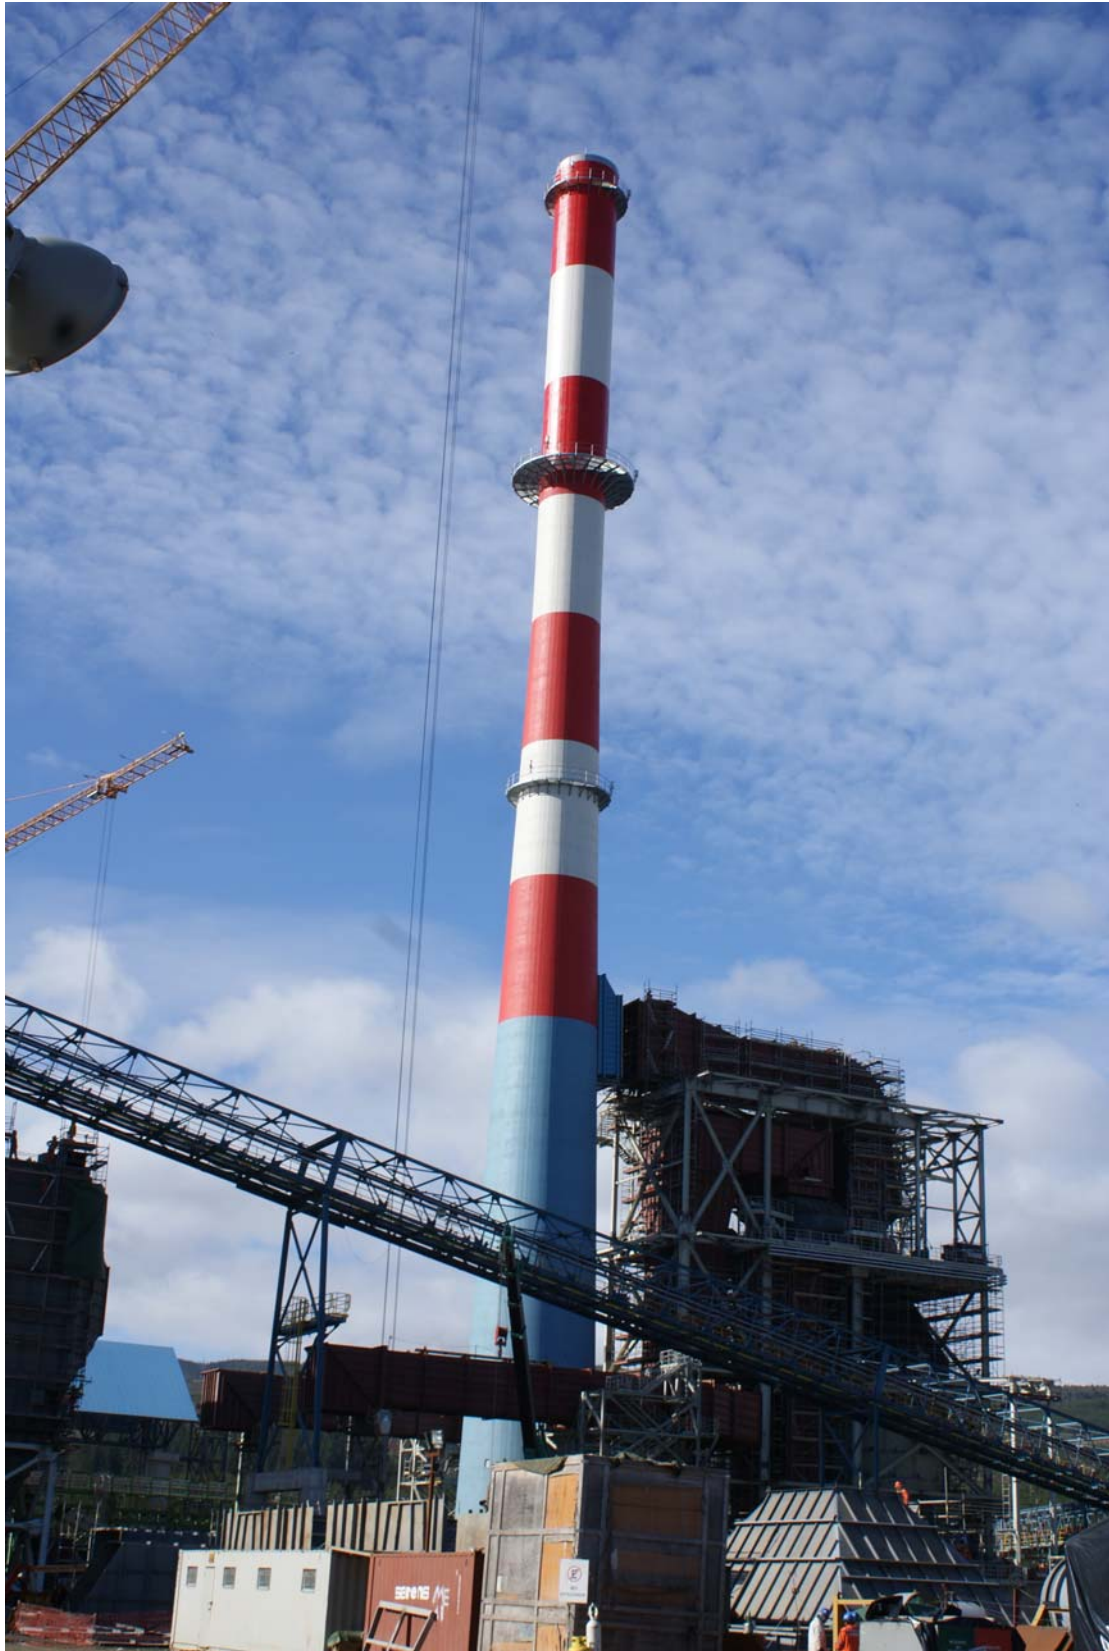
Figure 8 Colbun 130m tall Chimney

During the study visit, the 130 m tall Colbun chimney was inspected over the lower half and no cracking was observed. Access to the upper half of the chimney was denied due to some access safety concerns, however, the power station contractor confirmed that no cracking was observed in the upper half of the chimney following an earlier post earthquake inspection they had completed.

An analysis of the chimney indicated that the response of the structure to earthquakes was dominated by the first 3 modes, with the contribution from the second mode being very significant. The analyses clearly indicated that cracking was more likely to occur in the upper levels between 60-110m compared with the base due to the tapered configuration of this chimney. The calculations indicated that the chimney was on the verge of cracking in the upper levels with an estimated ground motion of PGV of around 200mm/sec. The level of ground shaking experienced was estimated to be around 50% of that needed to develop the ultimate strength capacity of the chimney. This result was just consistent with the no observed cracking in the chimney from the field studies, although cracking was expected to be very close to occurring.

Importantly, no damage was reported to the 'Pennguard Block' lining system indicating excellent performance to this strong ground shaking, with drifts in the order of 0.15%.

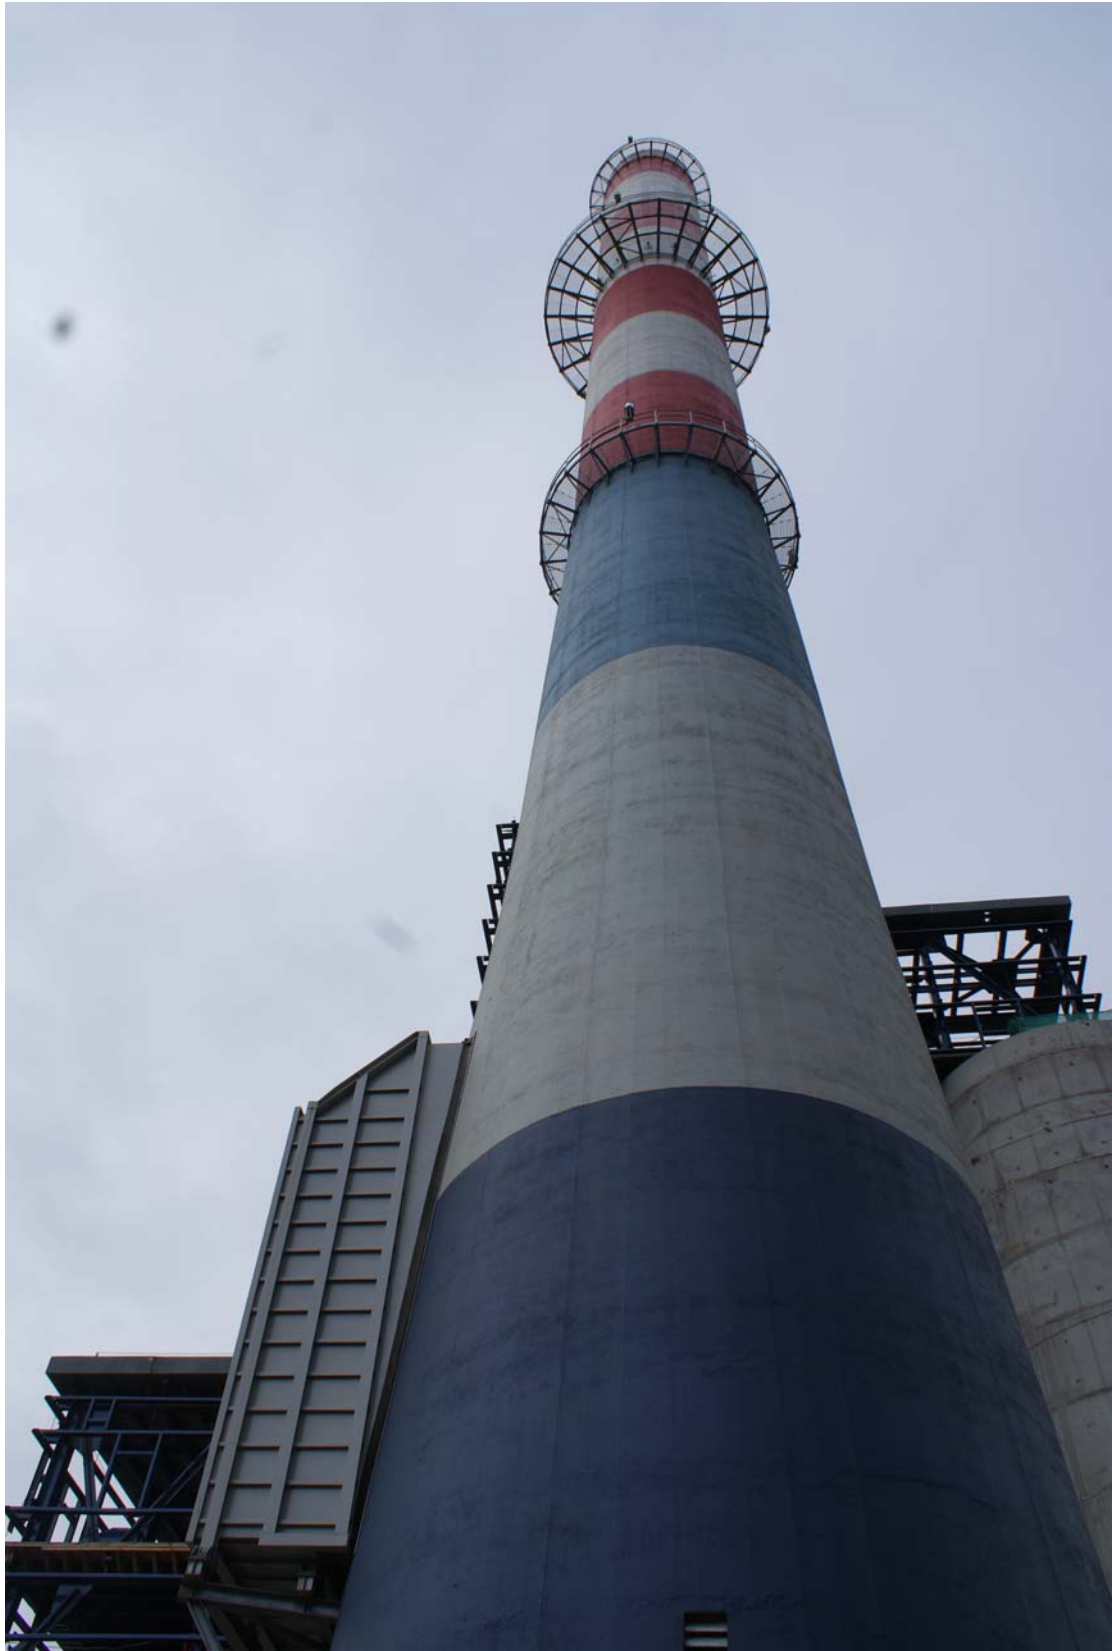
Figure 9 **Bocamina 100m tall Chimney**

The Bocamina chimney is 100 metres tall, with a constant outside diameter of 6.25m and thickness of 250mm over the upper 60m and flaring to a diameter of 10.50m and a thickness of 350mm at the base. The chimney is generously reinforced with vertical reinforcement ratios varying from 1.0-2.0% over the chimney height. The chimney is founded on a circular pile cap with piles passing through 10m of soft clay before being socketed into the soft rock below. The chimneys were originally designed using the response spectra specified in the construction contract which was generally consistent with the Chilean earthquake design code for industrial structures (Ref 3) with a structural reduction factor of $R=3$. The design moments were then scaled by a factor of around 1.2 to achieve a minimum base shear force of $V=15\%W$, although the resulting rebar ratio specified in the chimney provided a nominal ultimate base shear capacity of around $V=30\%W$, thus creating a very strong chimney with excellent post cracking performance.

An analysis of the chimney indicated that the response of the structure to earthquakes was dominated by the first 3 modes, with the contribution from the second mode being very significant. The analyses clearly indicated that cracking was likely to occur between the base and level 75m, with a heavier frequency of cracking around levels 25-65m with an estimated ground motion of PGV of around 250mm/sec. The higher PGV at Bocamina compared with Colbun can be explained due to the presence of a 10m soft clay layer that would tend to amplify the ground motions compared with a rock site. The cracks were considered fine with a maximum crack thickness of around 0.2mm. Local yielding of the reinforcement would not be expected from this level of shaking which was estimated to be around 60% of that needed to develop the ultimate

strength capacity of the chimney. This result was generally consistent with pattern of cracking observed from the field study.

No damage was reported to the 'Pennguard Block' lining system, except locally at the duct opening interface with the windshield, indicating excellent performance to this strong ground shaking, with chimney drifts in the order of 0.3-0.4%. The expected concrete strains experienced by the 'Pennguard' adhesive would probably be in the order of 0.2%, assuming a maximum crack width of around 0.4mm during the earthquake. The localised damage (cracking of the 'Pennguard' block) observed at the interface between the duct liner and the windshield at a chimney opening, was suspected to have been caused by the vertical excitation of the steel cantilevered ductwork, causing some local overstress at the connection interface. These cracked 'Pennguard' blocks at the base of the openings would need to be repaired, with access easily provided from within the ductwork and flue base.

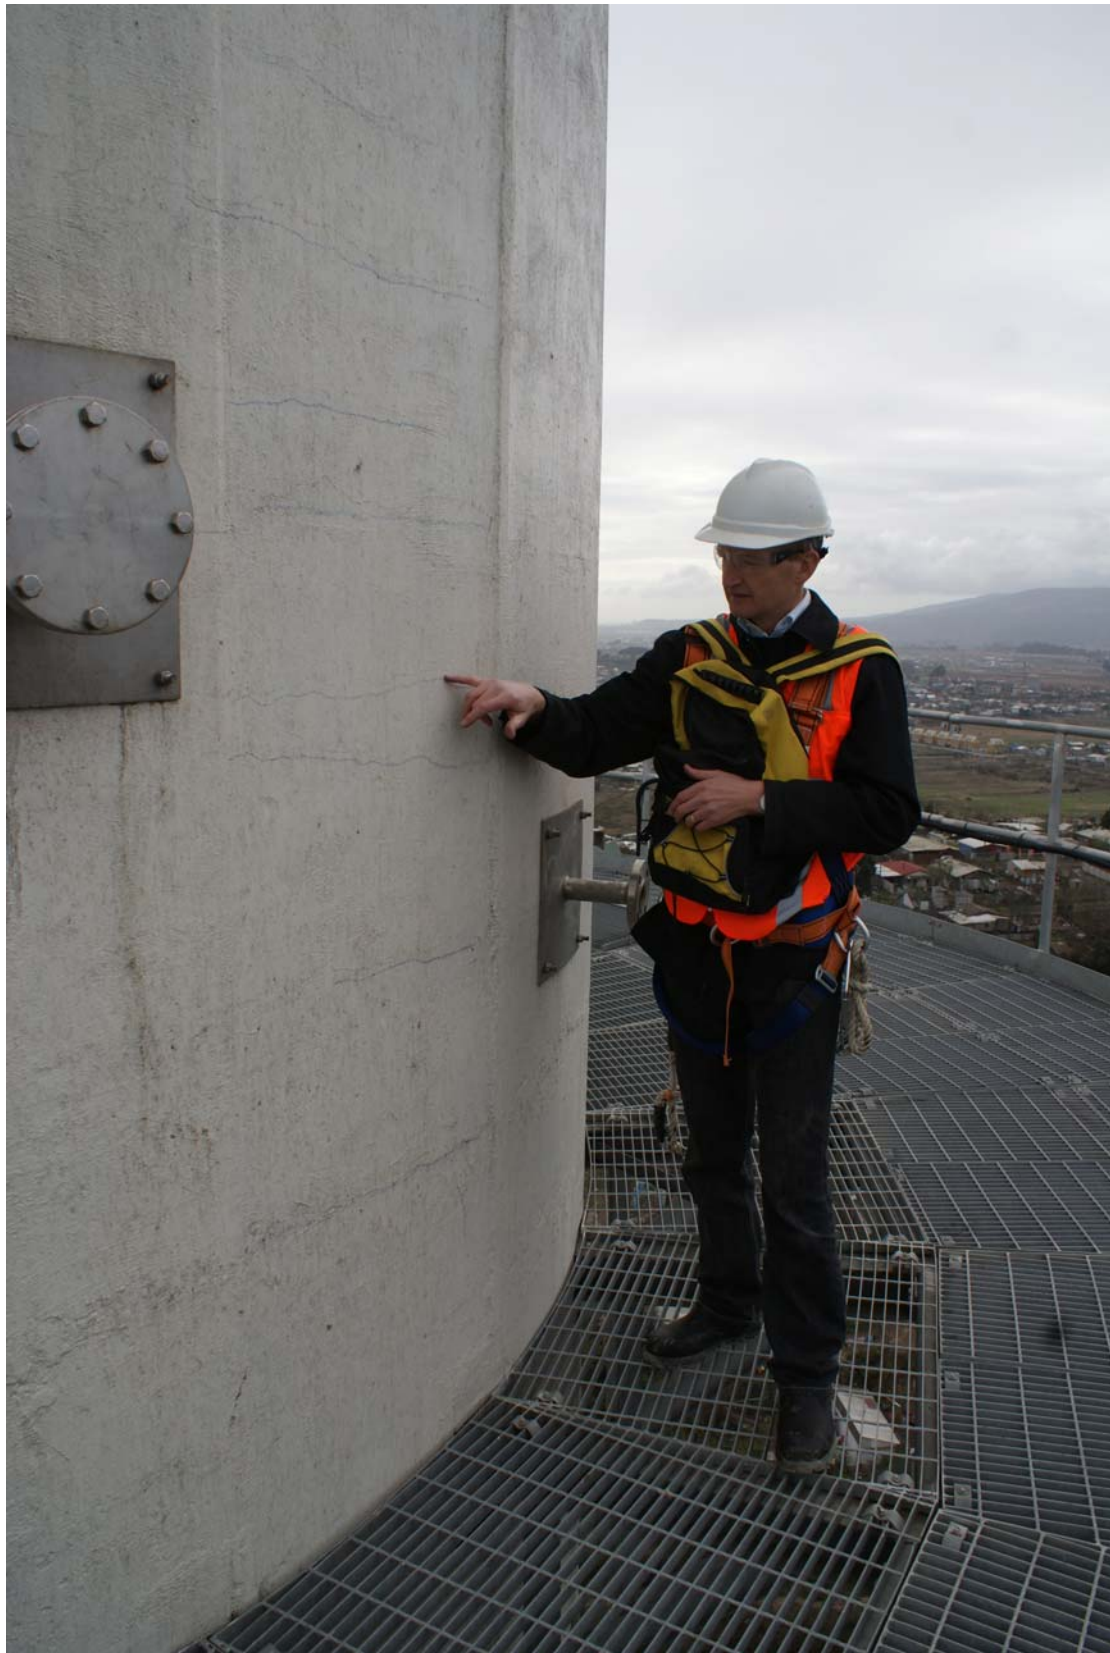
During the study visit, the 100m tall Bocamina chimney was inspected over the full height and many fine cracks were observed as follows; one circumferential crack at the base, 6 circumferential cracks between 35-50m and around 50 circumferential cracks between 50-90m. All cracks were very fine and did not exceed 0.2mm in width (Figure 10).

Figure 10 **Circumferential Cracking to Bocamina Chimney**
