AEES Newsletter

BRIEF REPORT ON THE HANSHIN EARTHQUAKE - 1995

REPORT ON THE JANUARY 17 1995 GREAT HANSHIN (KOBÉ) EARTHQUAKE

Dr. Mike Griffith
Civil Engineering Department, University of Adelaide

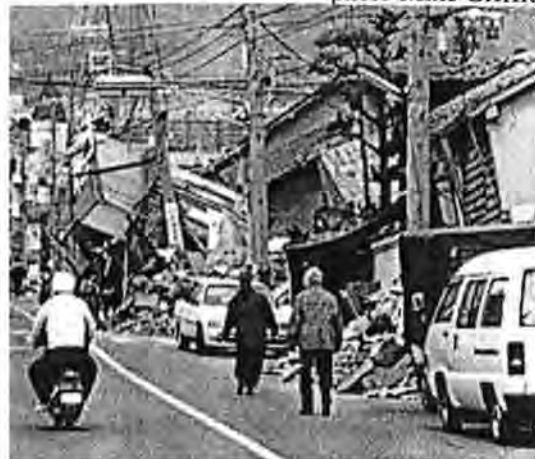
Traditional houses, because of their heavy brittle construction, suffered significant damage including many lower storey and complete collapses (Figure 1).

Fig 1 Collapsed housing around Nishinomiya

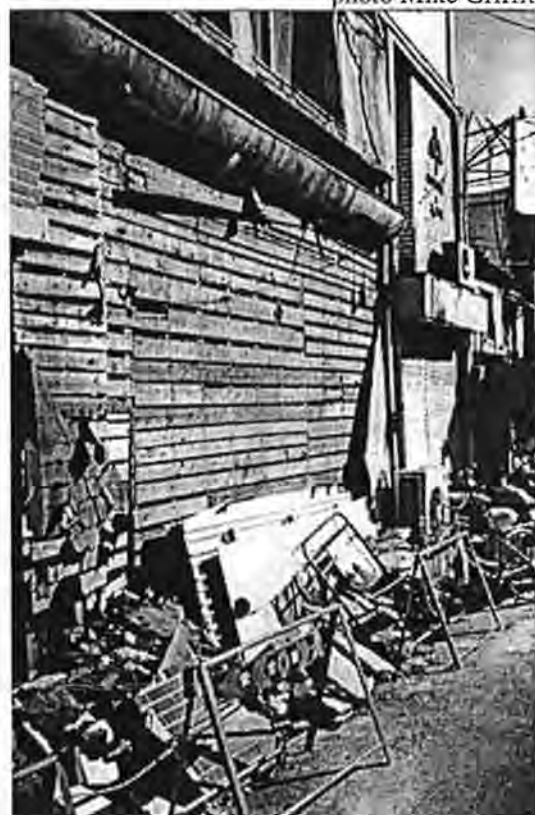
These buildings typically consisted of "post and beam" construction and heavy clay tile roofs. Their lateral resistance was provided by a brittle cladding system consisting of a timber lath and paper backing with plaster cladding. Many examples of plaster peeling off timber backing were observed (Fig 2).

Fig 2 Cladding failure reducing lateral stiffness

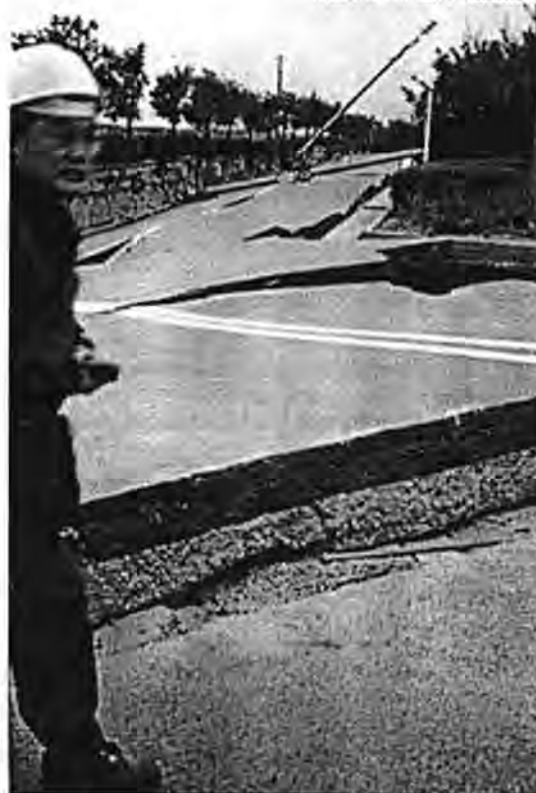
Fig 3 Lateral spreading - Rokko Is in port area

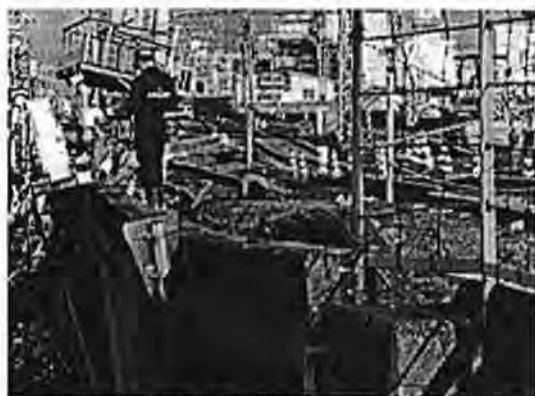
Fig 4 Damage to elevated section of railway

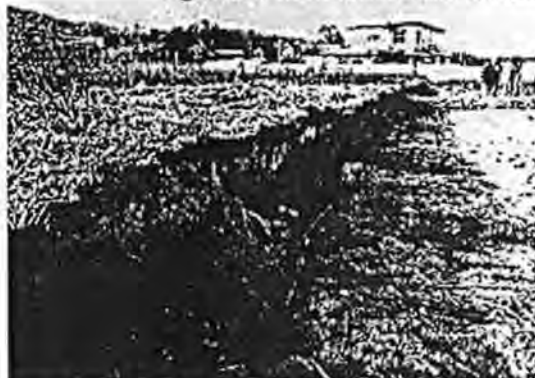
Fig 5 Part of the fault scarp on Awaji Is showing there was both vertical and lateral movement.

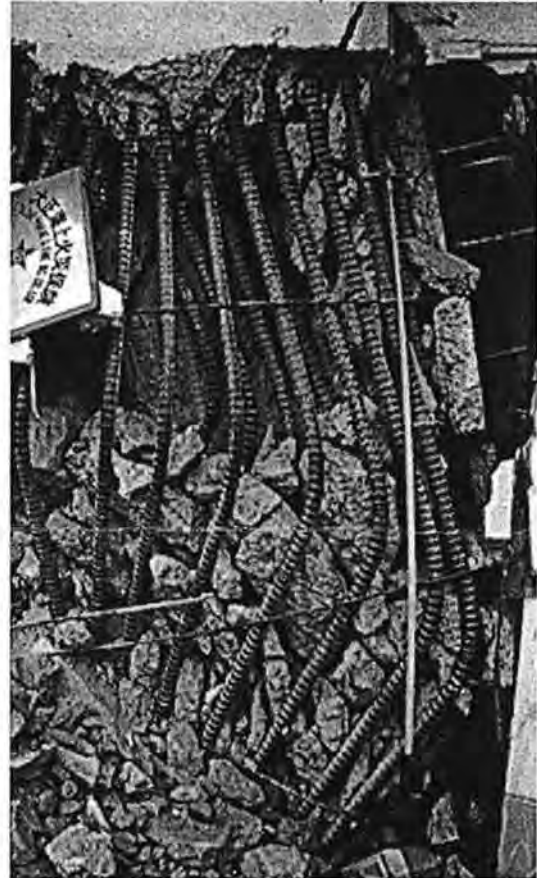
Reinforced concrete commercial buildings up to 4 or 5 storeys high were typically of moment frame construction. As for the steel buildings, the concrete buildings performed poorly in the areas of strong ground motion where there were many bottom storey collapses. Insufficient confinement steel (250 to 300mm spacing of ties) in the columns appeared to be the major cause of this brittle behaviour (Figure 8).

Fig 8 Large tie spacing led to many failures

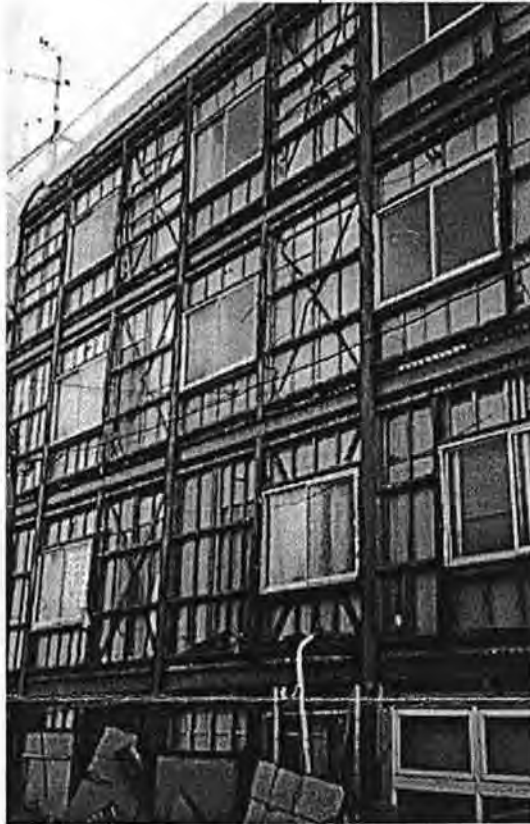
Small 3-4 storey steel commercial and apartment buildings fared little better despite the use of cross-bracing and/or portal frame action to provide the main seismic resistance. Many of the cross-braced frames

had grossly under strength braces which must have yielded repeatedly during the earthquake permitting large lateral drifts, often resulting in collapse or significant permanent offset in the structure (Fig 4). In the case of portal frames, the welded and bolted connections were much weaker than the framing members which became the weak links and resulted in the framing systems having brittle characteristics under overload (Figure 5). It should be noted here that while there were approximately 500 fires in the Kobe region which resulted in the complete destruction of

Fig 7 cross-braced steel frame with failed cladding

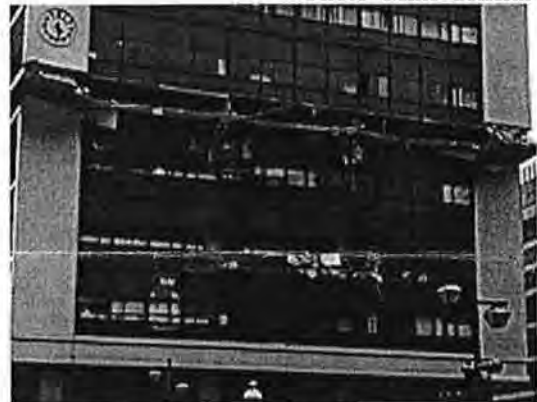
Interestingly, taller commercial and apartment buildings in the range of 5-20 storeys high behaved in a similar manner, except that a significant number of intermediate storey collapses occurred (Figure 9). In many of these buildings, composite construction (SRC) was used in the lower storeys and reinforced concrete (RC) was used in the upper storeys. SRC is a form of construction commonly used in Japan which consists of steel members encased in concrete. The cause of most of the upper level storey collapses is suspected to be associated with either a change from SRC to RC construction or changes in building geometry such as set-backs. However, this has yet to be confirmed.

Fig 9 Collapsed upper storey of old Kobe City Hall building
