# Effects of the Newcastle Earthquake of 1989 on the New South Wales High Voltage Transmission System

**Rod Caldwell**

At the time of the Newcastle Earthquake, the author was  
Regional Engineer / Newcastle, Electricity Commission of NSW

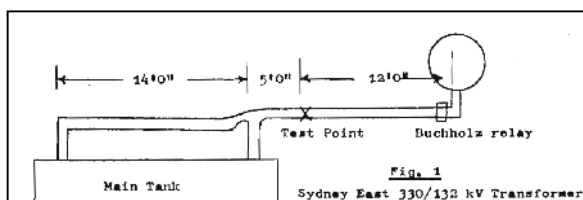
**3.1 Transformer Trips.** The initial consequence of the tremors impacting the NSW system was an almost-instantaneous disconnection (trip) of some of the severely shaken transformers at network sites. These widespread trips were an unplanned occurrence, caused by sloshing of the sensitive mercury switches in “Bucholz” relays (protection devices which are fitted to detect oil surges indicating serious internal faults, see figures 3 & 4).

Figure 3: Sketch of the location of a 'Bucholz' relay on a 330/132 kV transformer tank.

Figure 4: Sketch of the mercury switch and contacts in a 'Bucholz' relay.

- **Bucholz Relays.** Whilst being responsible for the unplanned, system-wide transformer trips, Bucholz relays can be modified to correct their seismic instability. The mercury switches can be replaced by an improved design of reed relay that performs much better under seismic disturbances. An urgent program was immediately initiated to replace the mercury switches, starting at main system transformers and other priority supply points across the network.

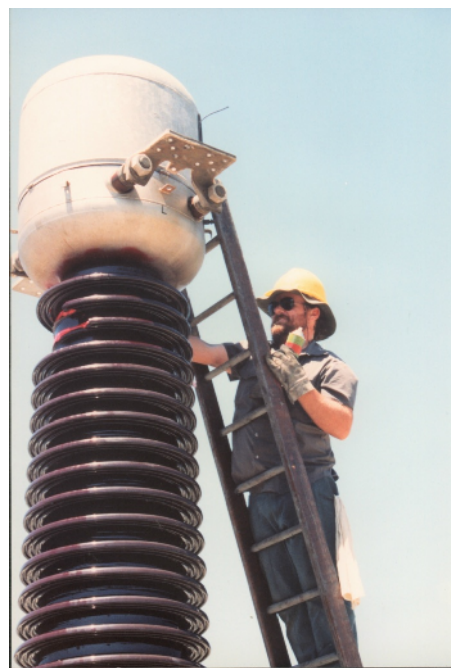
Figure 3: Fitter applies dye to the chipped porcelain insulator of a 330 kV current transformer.

into any crack but will be drawn out into the chalk coating as it dries, to show up as a clear dye-line. Maintenance staff regained confidence and became very skilled with this little marvel. (see Figure 3) De-energised bays were routinely checked, even if no damage was visually evident in that bay.

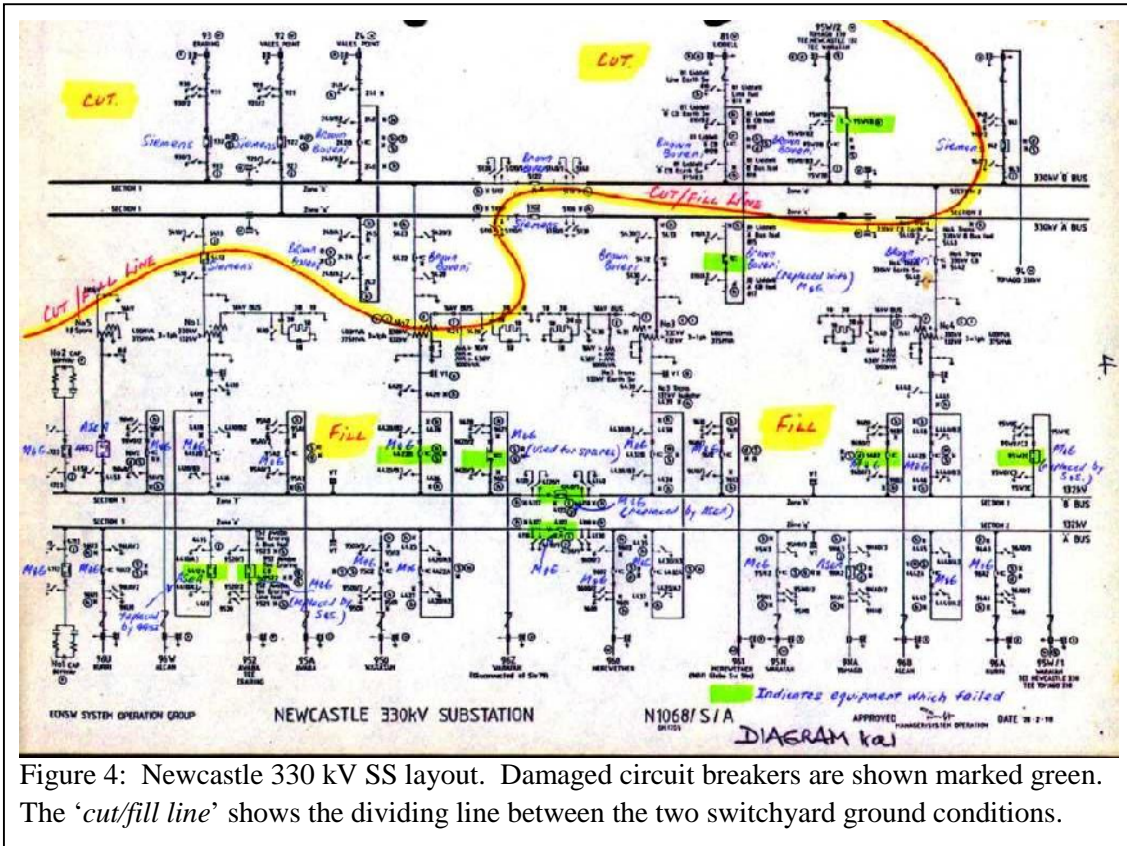
- **Ground Conditions.** The site of Newcastle SS Switchyard had been constructed by the 'cut and fill' method. The dividing line between cut and fill ran across the main switchyard, see Figure 4.

Figure 4: Newcastle 330 kV SS layout. Damaged circuit breakers are shown marked green. The 'cut/fill line' shows the dividing line between the two switchyard ground conditions.

The task force found that there was a very good correlation between different ground conditions and the extent of damage to plant suffering porcelain insulator damage. This finding agreed with most of the earthquake effects seen in the larger community: Infrastructure located on fill, sand, or soil of unstable nature suffered more damage than on a high strength bench, or solid rock. Unstable footings can amplify the dynamic forces, possibly by up to five, or eight times. The task force concluded that consideration should be given to selection of a site with high strength sub-soils when laying out substation switchyards.
