EARTHQUAKE DAMAGE REPAIR AND STRENGTHENING OF CHRIST CHURCH CATHEDRAL, NEWCASTLE NSW

B.J. (Barney) Collins¹, J.W. (Bill) Jordan²

1. EJE Architecture Pty Ltd, Chartered Architects, Newcastle, NSW
2. Bill Jordan & Associates Pty Ltd, Consulting Engineers, Newcastle NSW

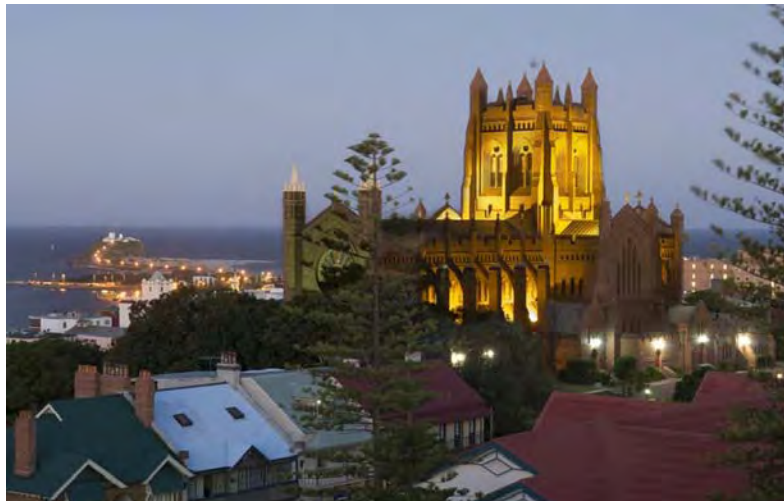
The effect of the earthquake on the building was largely as would be expected: high-set stone crosses and other decorations were dislodged and fell to the ground or lower roofs; flying buttresses were dislodged, but none fell completely away; shear cracking occurred in the nave walls which lie roughly parallel to the direction of the seismic wave and out-of-plane movements occurred in the east wall and dislodged windows. The degree of damage varied with the state of the brickwork with very little occurring in the tower structure, completed in 1979.

Figure 1: Christ Church Cathedral, Newcastle NSW

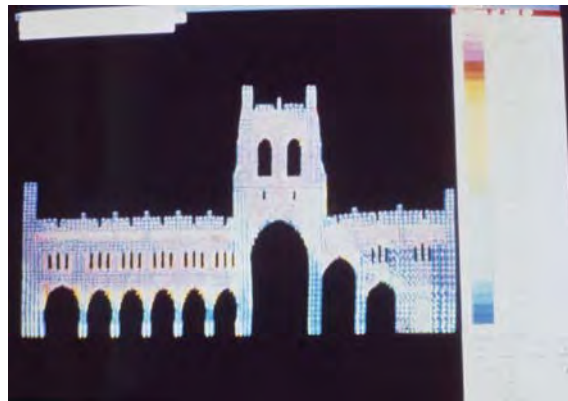
Figure 13: Typical FEA output

With the design parameters set (see Appendix) a two-dimensional finite element analysis was carried out using a readily available computer package ("Strand 6"). Different combinations of reinforcement strength and spacing were considered and costed and, in the end, a high strength Grade 316 stainless steel deformed bar was used in sizes from 16 mm to 32 mm diameter. In order to limit the amount of drilling that had to be carried out "Hi-Proof" bar with UTS in range 790 to 920 MPa [N/mm^2], depending on size, was specified. The total length of reinforcing installed was 3770 metres.

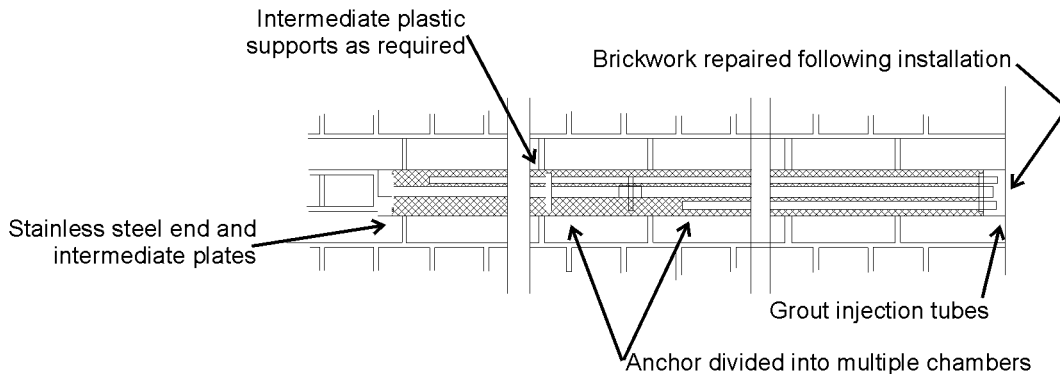
Figure 14: Typical anchor using 25 mm deformed bar in 85 mm diameter hole

The Cintec anchor system has three basic elements: the anchor body which carries the load, the cementitious grout formulated using micro-cement technology and the woven fabric sock which controls the grout. Details of the sock and grout can be found in company literature (Cavity Lock Systems Ltd, current).

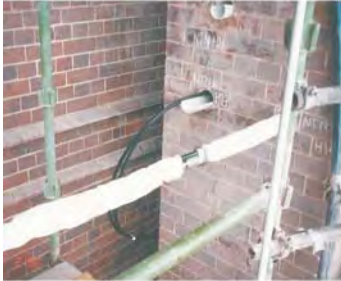
Figure 15: Horizontal anchors assembled during installation

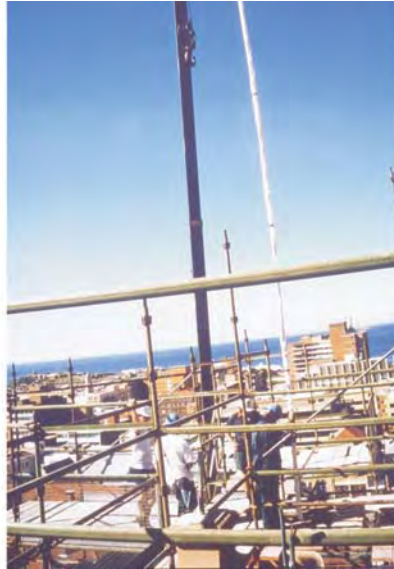
Figure 16: Vertical anchor installation by crane

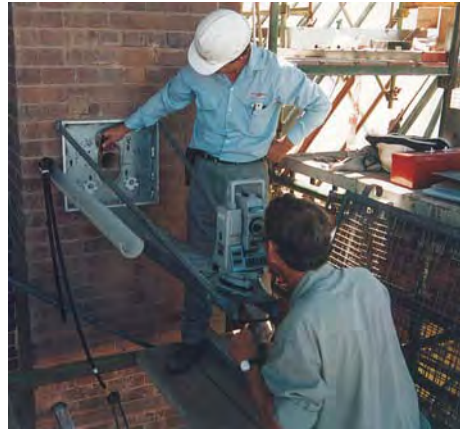
- down-the-hole video was used to verify the integrity of every drill hole;
- the documents provided for drilling to be undertaken in masonry having a compressive strength of up to 70 MPa generally and included the onus of proof on the Contractor to provide for test data confirming any higher compressive strength;

Figure 18: Drill hole survey
