# Earthquake Loadings and Steel Structures

L. Pham

CSIRO Division of Building Construction and Engineering, Australia

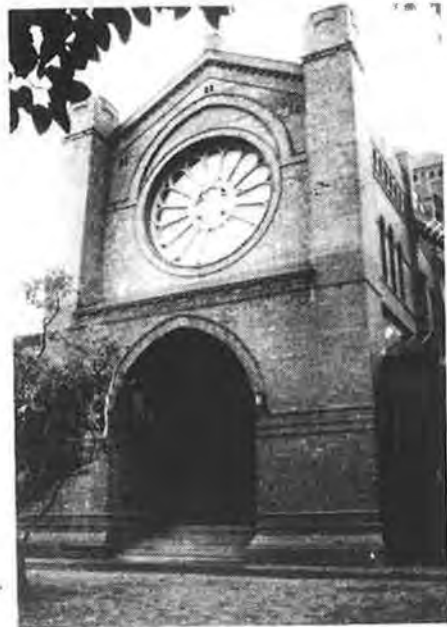
**Figure 2 - West wall**

1. **General view of East Newcastle** with the Cathedral in the upper central position. The recent slides highlight the east west motion of the 1989 earthquake.
2. **West wall.** The masonry foundations were placed between 1883 and 1885. They are in the order of 2m width and 2m depth. Prior to recent investigation, it was thought that they were founded upon the prevalent sandstone of the area. However, it has now been determined that the site consists of dense sands of 10 to 30m depth. The lower half of the massive solid masonry wall was erected in the 1890's.

During 1906 and 1907, significant site movement occurred, probably related to mine subsidence, with the additional possibility that stress relief in the structure was occurring due to consolidation of the site founding material. This part of the structure moved forward 100mm and separated by 25mm. The reported crack can be seen in the middle of the arch.

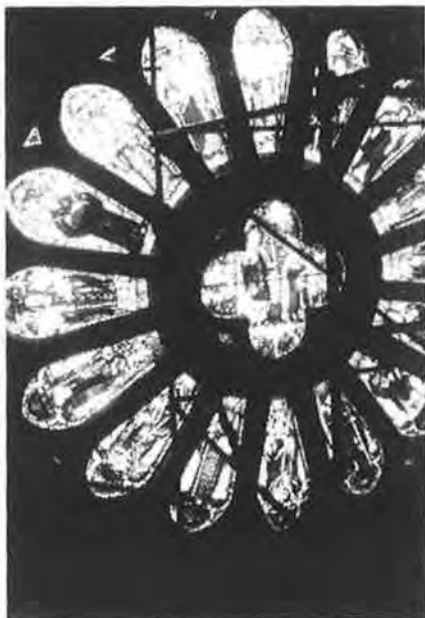
**Figure 3 - West Rose window**

3. **West Rose window.** The sandstone frames window was repointed in 1988 and did not suffer any significant damage during the earthquake despite it being face loaded.

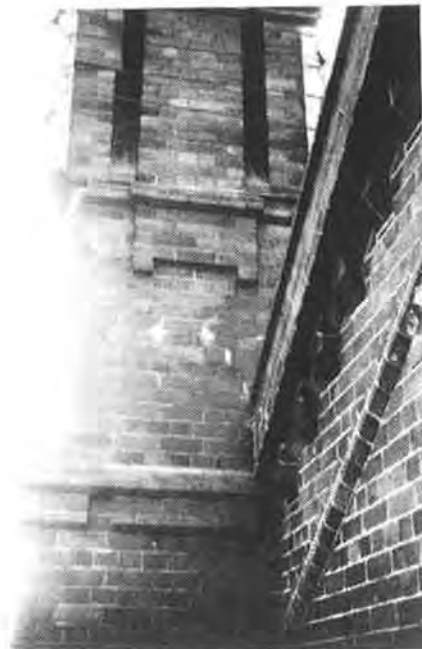
**Figure 4 - West wall turret**

4. **West wall turret.** The soil masonry turret of 1.5m x .5m slid on a flashing position during the earthquake. Some corner masonry spalled as a result of this movement.

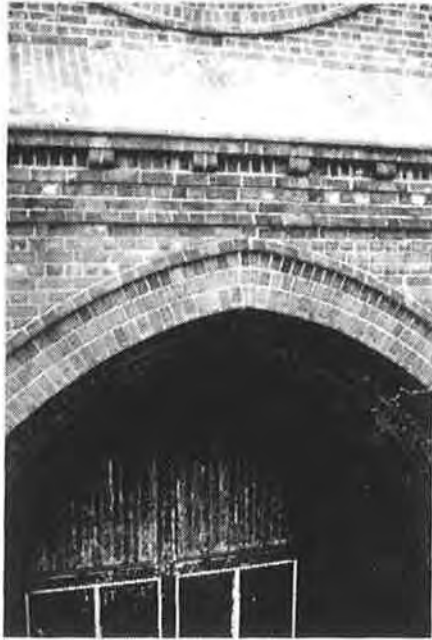
**Figure 5 - West wall damage**

5. **West wall damage.**
6. **West wall flashing.** The upper section of the western wall contained two flashings. The wall displaced at both of these positions. Much of the cracking had previously occurred due to further minor site movements with slight exacerbation during the earthquake.

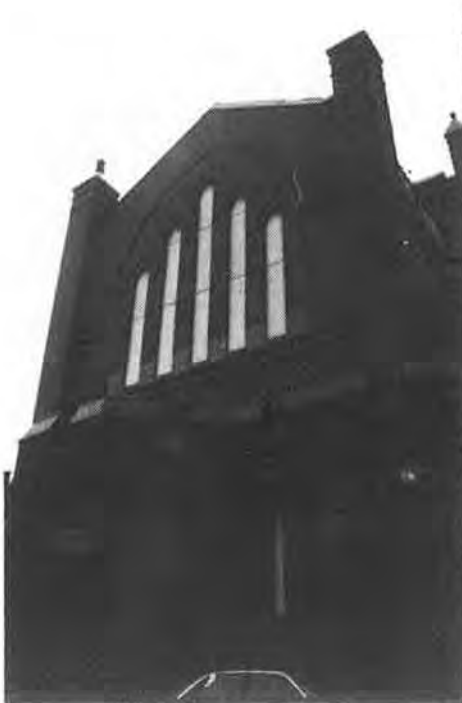
**Figure 7 - East wall**

7. **East wall.** Like the west, subject to face loading during the earthquake. The main wall is of 1m thick solid masonry. Displacement and cracking of the wall has occurred above the roof flashing position. The upper section of the wall was built in the 1910's and had previously been subject to earthquake and cyclonic forces.

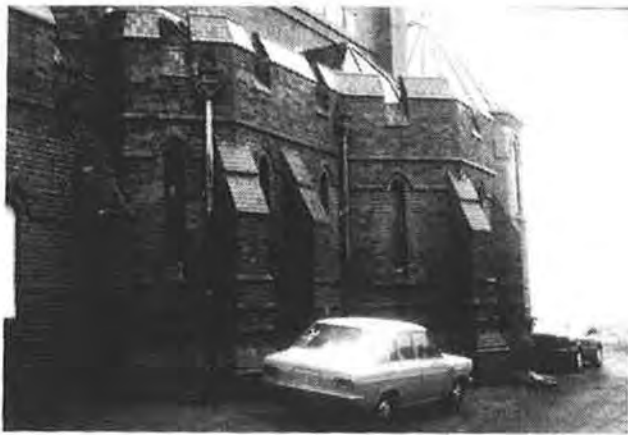
**Figure 9 - Low east**

9. **Low east.** These lower areas were added in the 1920's. The parapets are short and stocky and were not affected by the earthquake, despite the presence of pre-existing cracking.

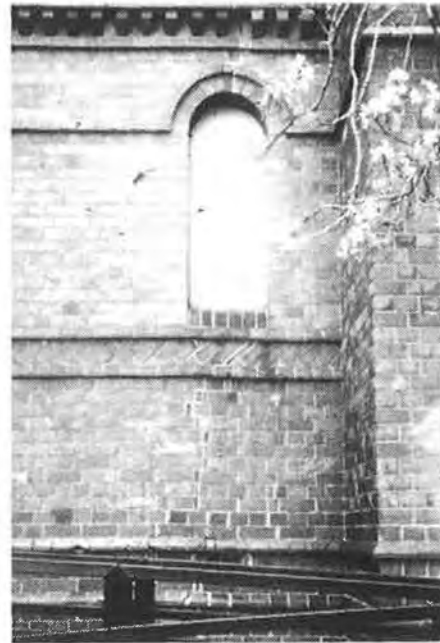
**Figure 10 - North wall "creep"**

10. **North wall "creep".** Cracking and repair due to the 1906/1907 site movements. This was not reactivated by the earthquake.
11. **South arch repairs.** Two tee sections added to stabilise the southern arch and the west end of the Cathedral following the 1906/1907 movements.

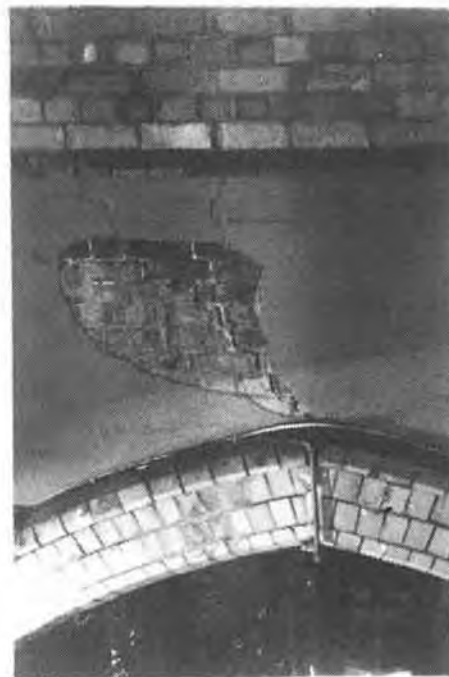
**Figure 12 - North arch repair/exacerbation**

12. **North arch repair/exacerbation.** The arch and a segment of walling over had been constructed by 1906. Repair work can be seen. Exacerbation of the original damage has occurred during the earthquake.

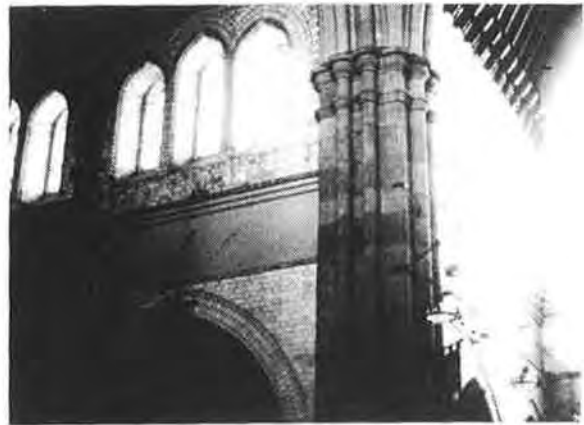
**Figure 14 - Northern arch**

13. **General interior.** With transept in the middle and the arches of the main northern and southern walls.
14. **Northern arch.** Cracking of the masonry over the arches occurred due to differential settlement of the structure caused by consolidation of the founding material after the erection of the tower in the 1970's. It appears that sway of the tower during the earthquake has exacerbated the existing cracking in the first bay from the transept arches in each direction.

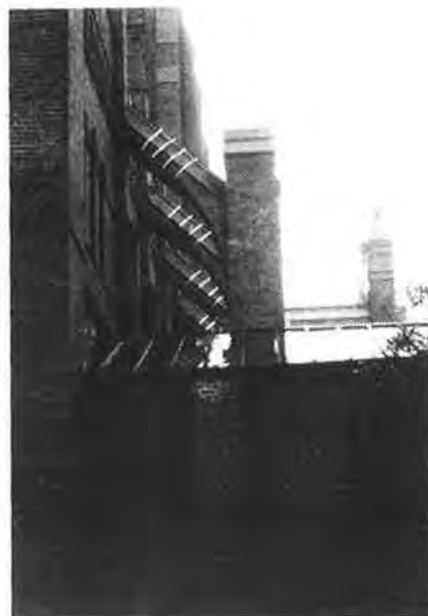
**Figure 16 - Flying buttress**

15. **Previous repairs to archway.**
16. **Flying buttress.** These were built for stability of the walls in the north south direction. Their own stability in the east west direction was not high, partly because of the existence of flashings in their height. The vertical part of the buttresses displaced up to 20mm due to the earthquake, affecting the arching over. As a result, the arches have suffered extensive damage, requiring remedial bracing

prior to general restoration of the structure. Some of the flying buttress-arches had been previously repaired due to damage caused by differential movements related to consolidation of the founding material.

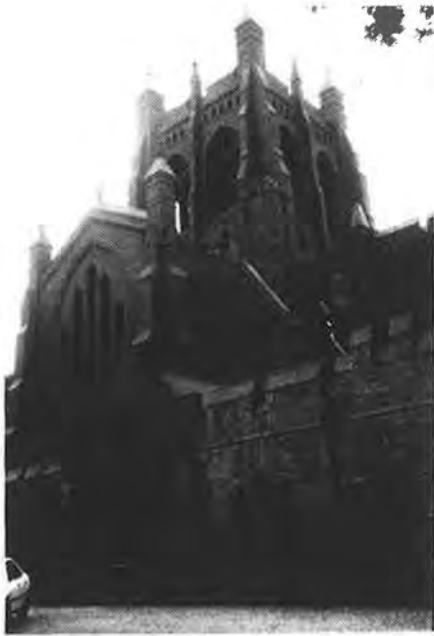
**Figure 17 - Southern transept and tower**

17. **Southern transept and tower.** The southern face appears to be totally undamaged by the 1989 earthquake.
18. **North transept wall.** Vertical cracks have occurred in the return walls of the transept, probably due to the earthquake. As will be discussed, these indicated the necessity to establish some ductility at the intersections. The north east tower turret had displaced 1mm over its 1400mm width. This was the only tower turret to display any damage.
19. **Parapets.** This is the parapet of the north western wall. Despite not being subjected to significant face loading, there has been some slight lateral displacement. The finals can be seen to have rotated on their central rod.

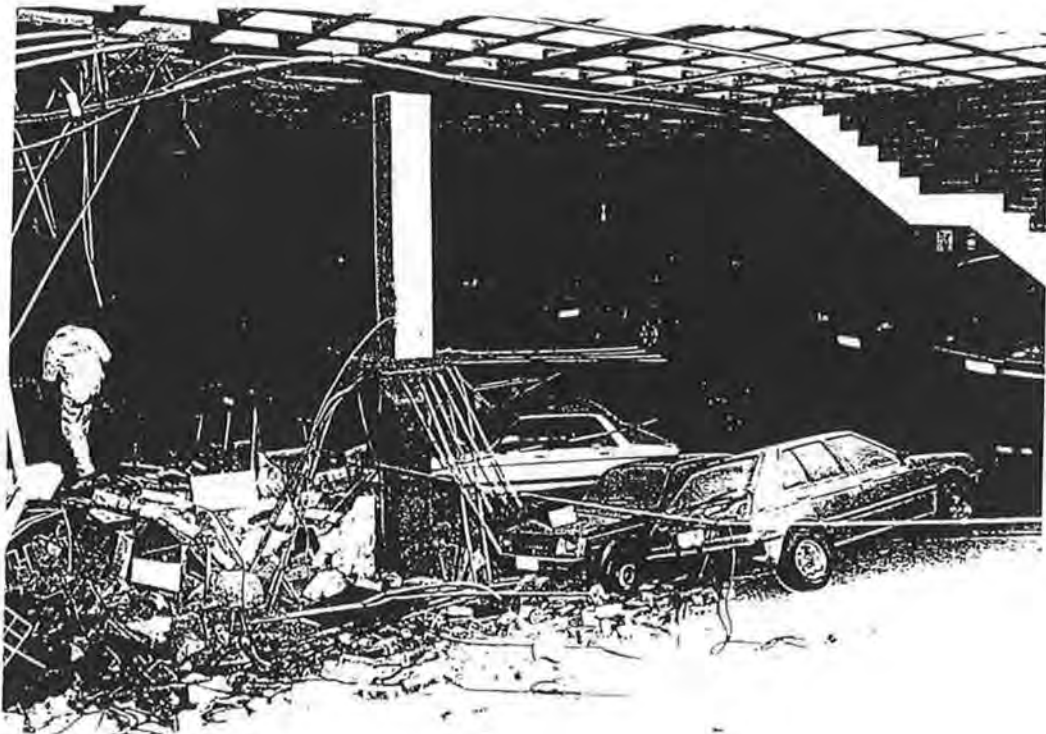
1. The punching shear failure at ground floor at the first line of columns adjacent to the west wall (figure 6).
2. Shear failure at first floor level close to the western edge of the drop panel adjacent to the western wall was the area of major collapse and the area where most fatal injuries occurred (figure 7).
3. The attachment of the steel hangers to the bottom chord of the structural steel trusses.
4. The lack of any of the typical signs of damage to the structural steel columns normally associated with the failure of such members (figure 8).
5. The collapsed brick wall for almost the full extent of the western wall.

The remaining slabs were then successively loaded from the floor above with the brittle punching shear failure occurring at the first line of columns in from the west wall. Again our calculations confirm this mode of failure.

Figure 6 - Punching shear failure

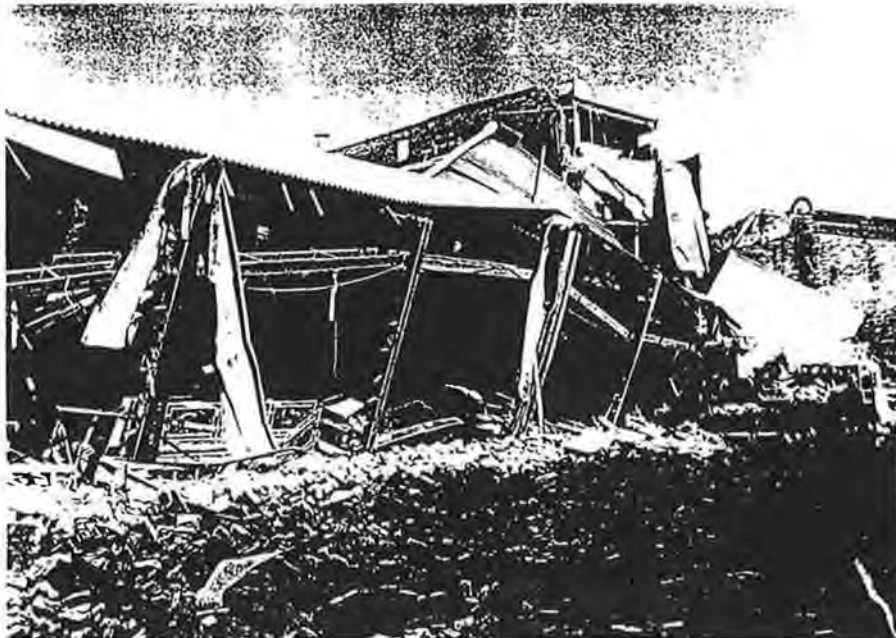
Figure 8 - Western wall steel columns

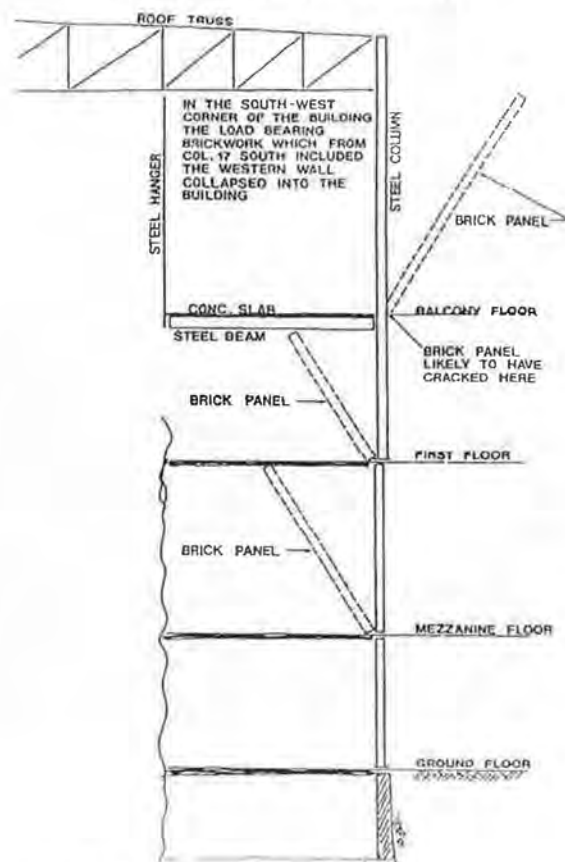
From calculations we found that the dynamic factor for a wall of the heights used falling onto the slabs of the stiffness detailed, is in the order of 20, which is greatly in excess of the dynamic factor of 2.5 (figure 10).

Figure 10 - Western wall failure

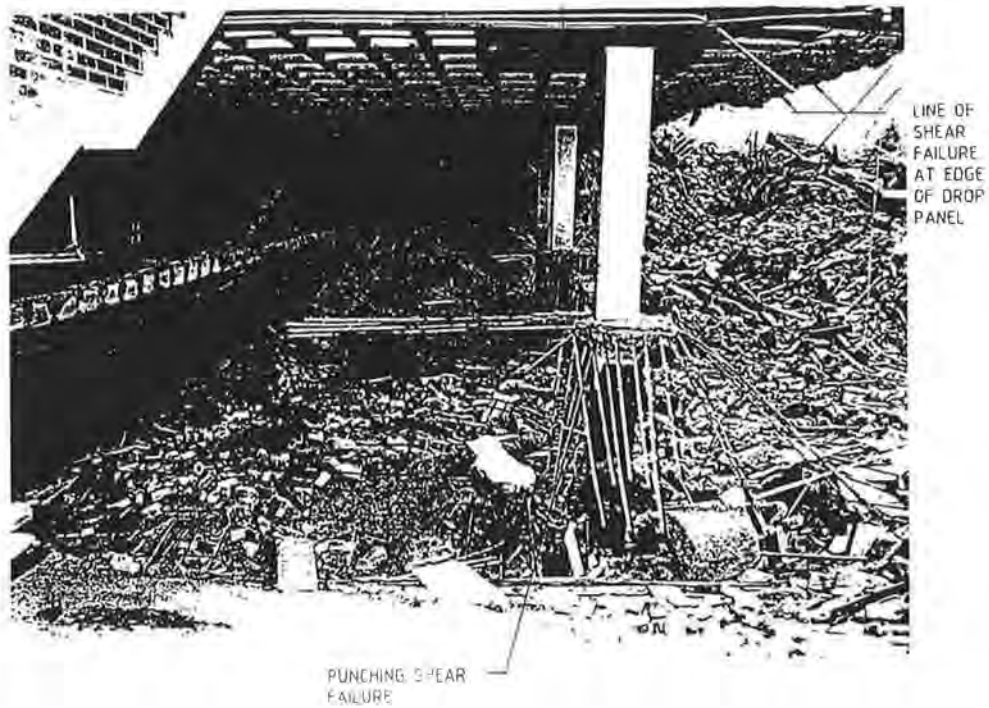
With the western wall failed the main auditorium (first) floor was then subject to the dynamic effects of these elements and our calculations show that shear failure would occur in the joist elements of the waffle slab in a line parallel to the west wall at approximately the junction of where the waffle slab meets the drop panel. Observations of the collapsed building confirm that this is where failure occurred in this slab (figure 11). We would add that our calculations indicate an even greater dynamic factor with the balcony and wall falling through a clear height of three metres.

**Figure 11 - First floor failure**
