BUILDING VULNERABILITY ASSESSMENT, PADANG EARTHQUAKE

BUILDING VULNERABILITY ASSESSMENT, PADANG EARTHQUAKE RECOMMENDATIONS

EXECUTIVE SUMMARY

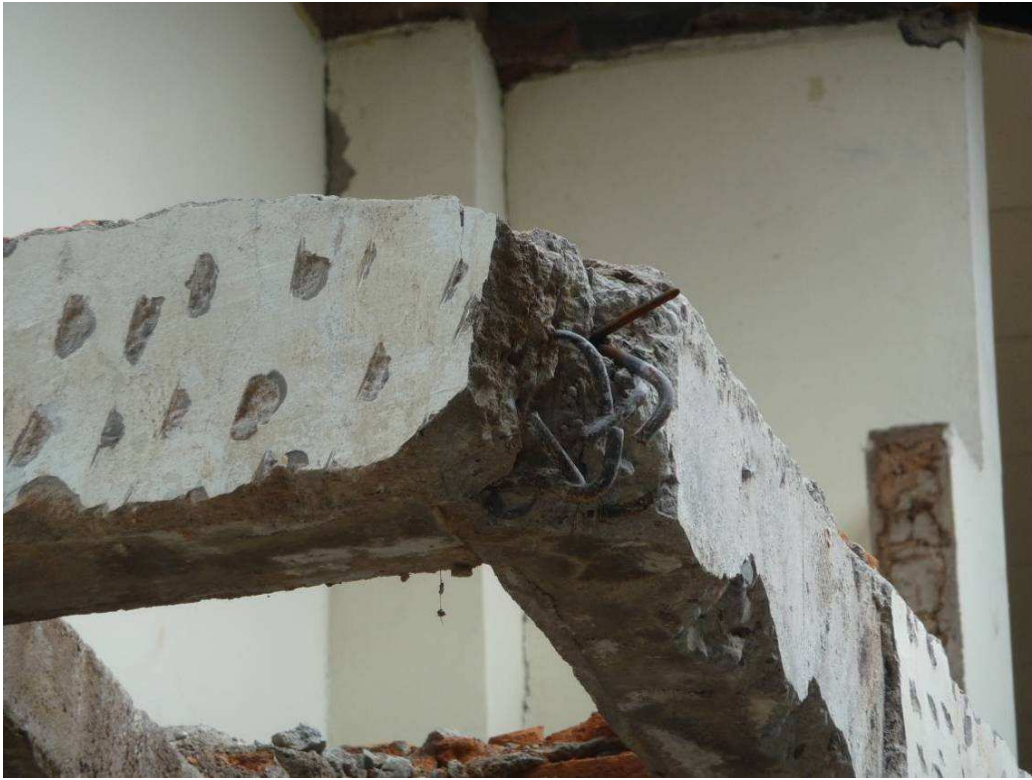
Figure 4 Poor reinforcement detailing

Reinforcement must be adequately detailed, particularly at joints. The appropriate Structural Concrete Design Standard should be followed. Where a Structural Engineer is not involved in the design (e.g. for the standard confined masonry type construction) guidelines should be provided on development lengths and lap lengths for the range of bar sizes and types (plain round and deformed) commonly used. These should take into account the steel strength and concrete strength.

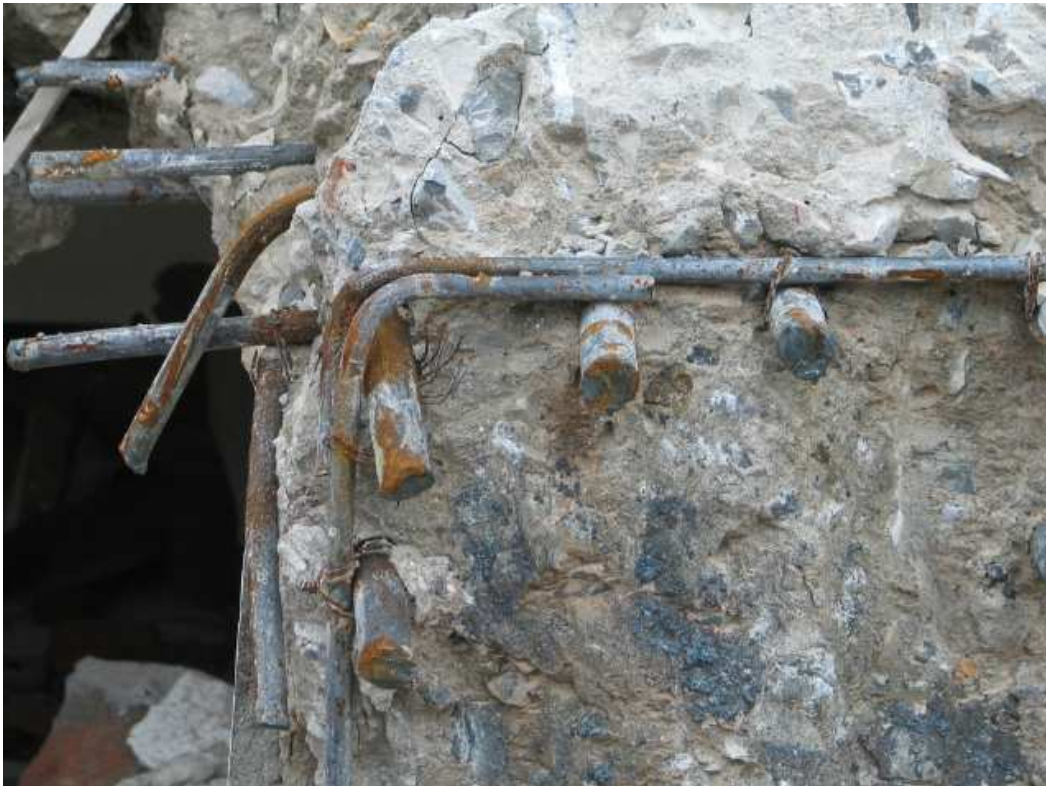
Figure 5 Poor reinforcement detailing

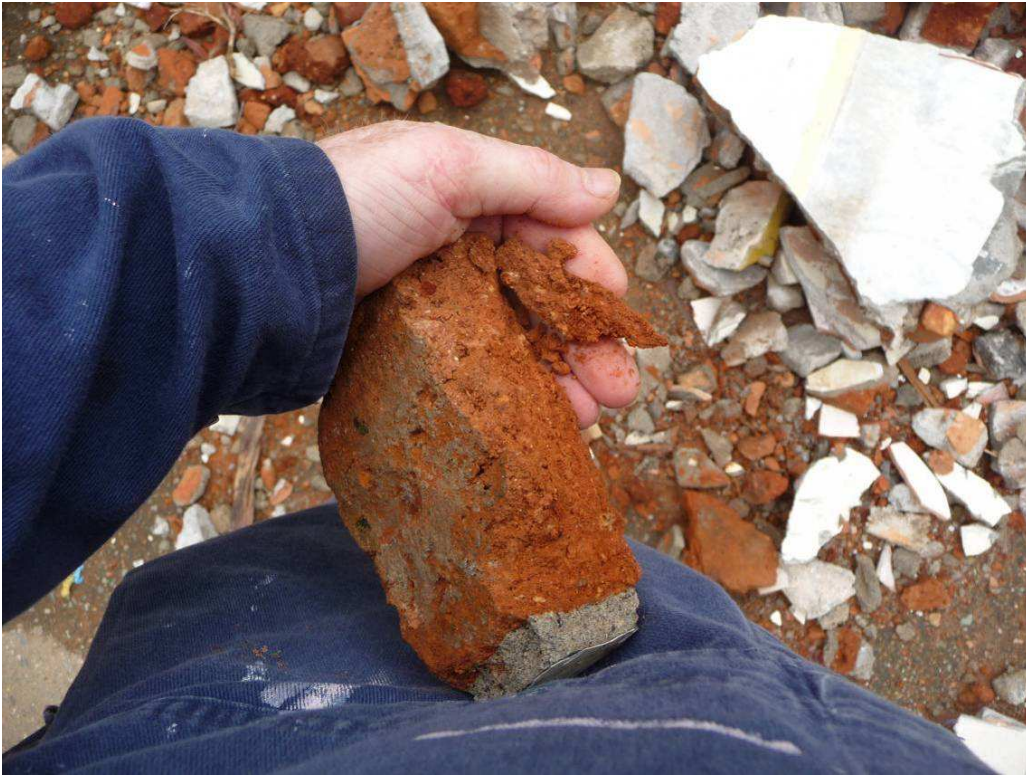
The bricks used throughout the building industry around Padang are of orange/red clay with the majority appearing to be incompletely fired. Bricks were commonly able to be broken easily by stamping on them with the foot. In only one case out of a number of manual tests carried out on numerous sites, the brick could not be broken with the foot. The fired clay was often able to be crumbled with the fingers, and in some cases the centre of the bricks appeared un-fired with the centre able to be hollowed with the thumbnail.

Figure 6 Soft bricks--Broken with fingers

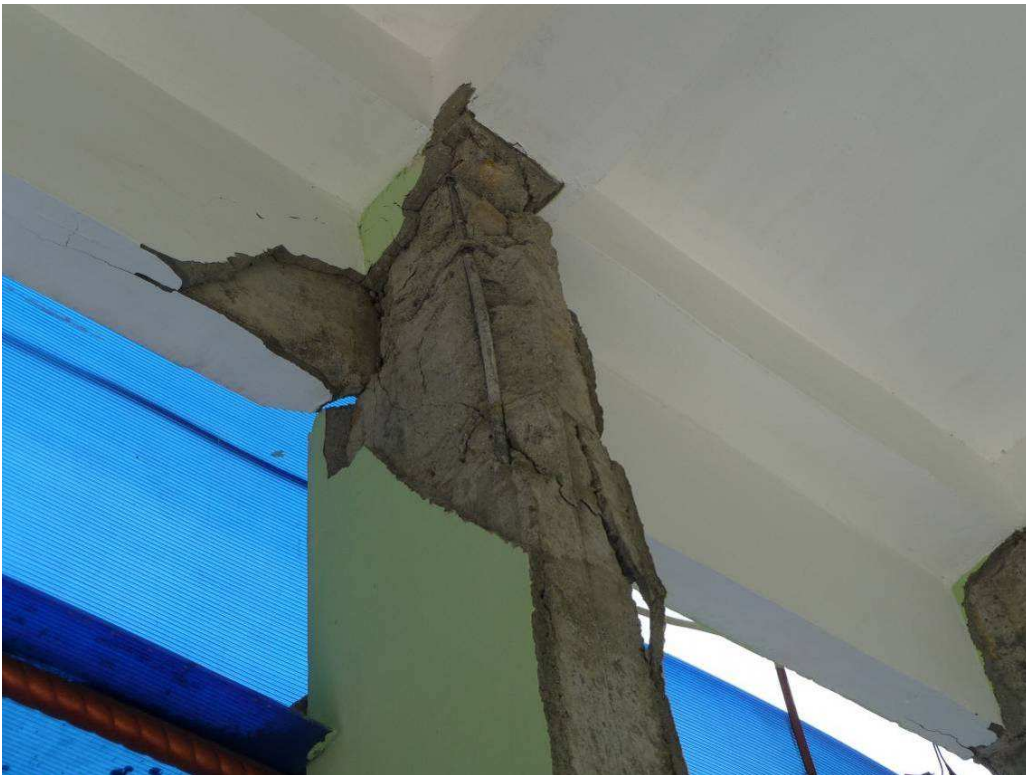
The stirrup reinforcement in columns was consistently observed to be too widely spaced and poorly detailed, which was particularly critical when column hinging occurred.

Figure 7 Missing ties in column/joint

Ties must be adequately anchored with hooks that turn 135 degrees (with appropriate leg length) and be spaced appropriately (e.g. max. 150mm centres).

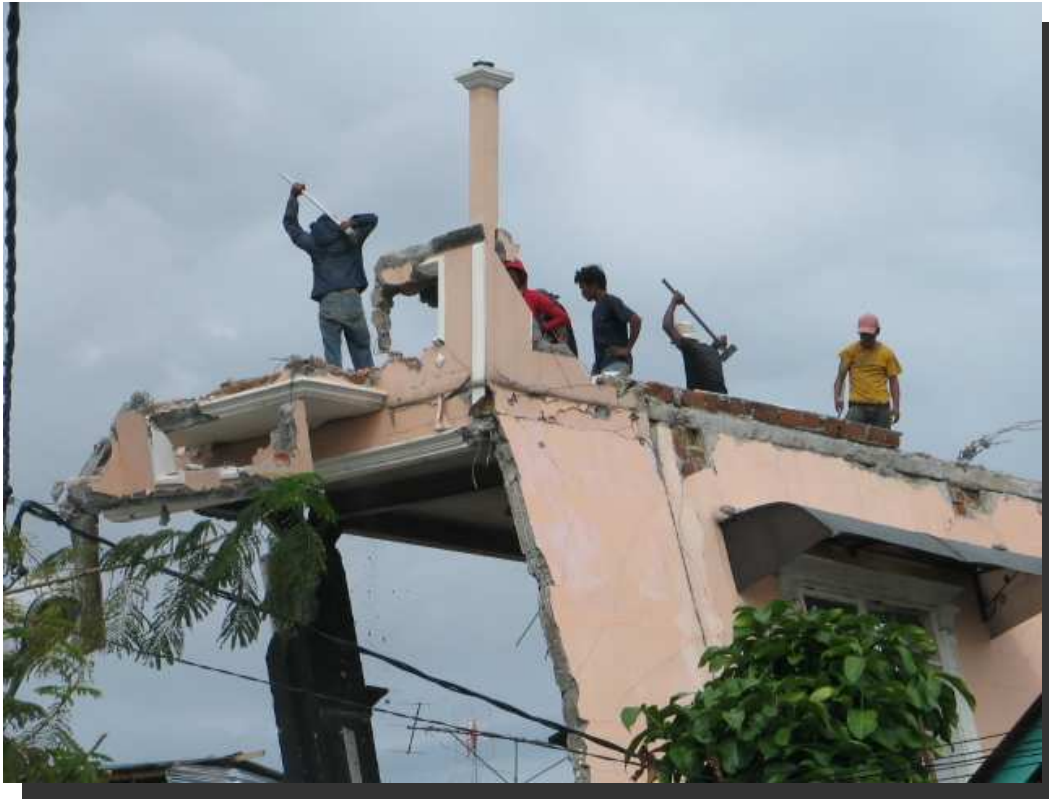
Figure 8 Demolition methods—recycling steel bars

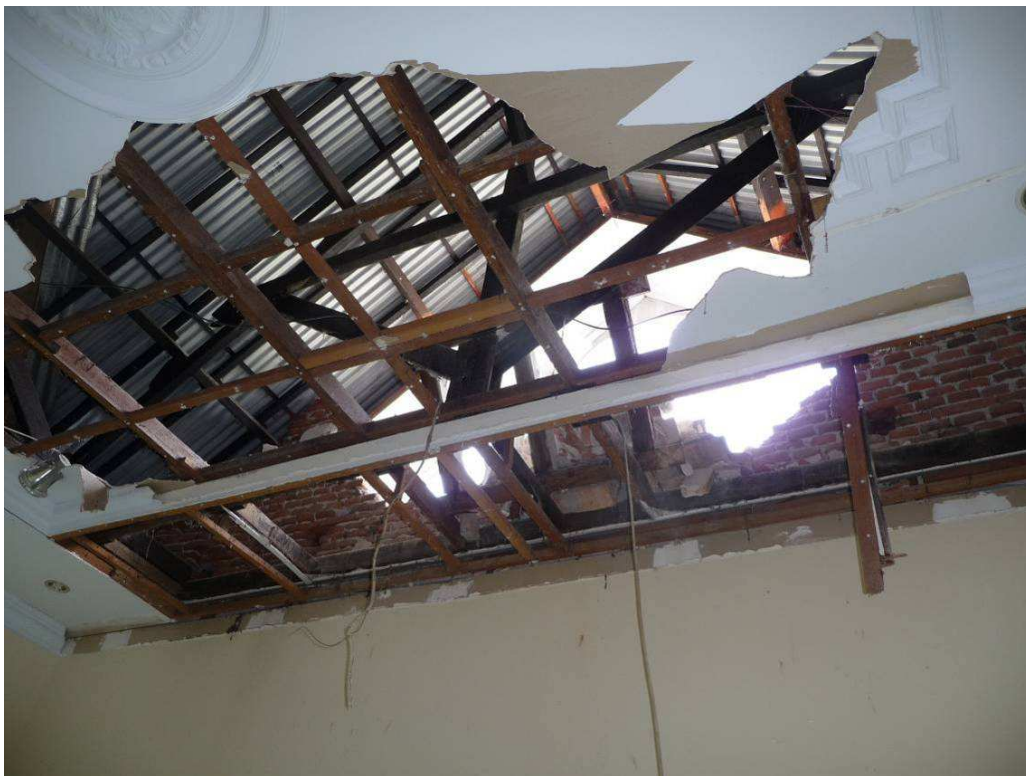
Figure 9 Failed Gable Wall

18. Gable walls, parapets and balcony barriers—Design of parapets and gable walls should be restricted to light framed materials (masonry should be banned for these elements) and provided with ties to the building structure of sufficient strength and durability to resist the lateral seismic forces.

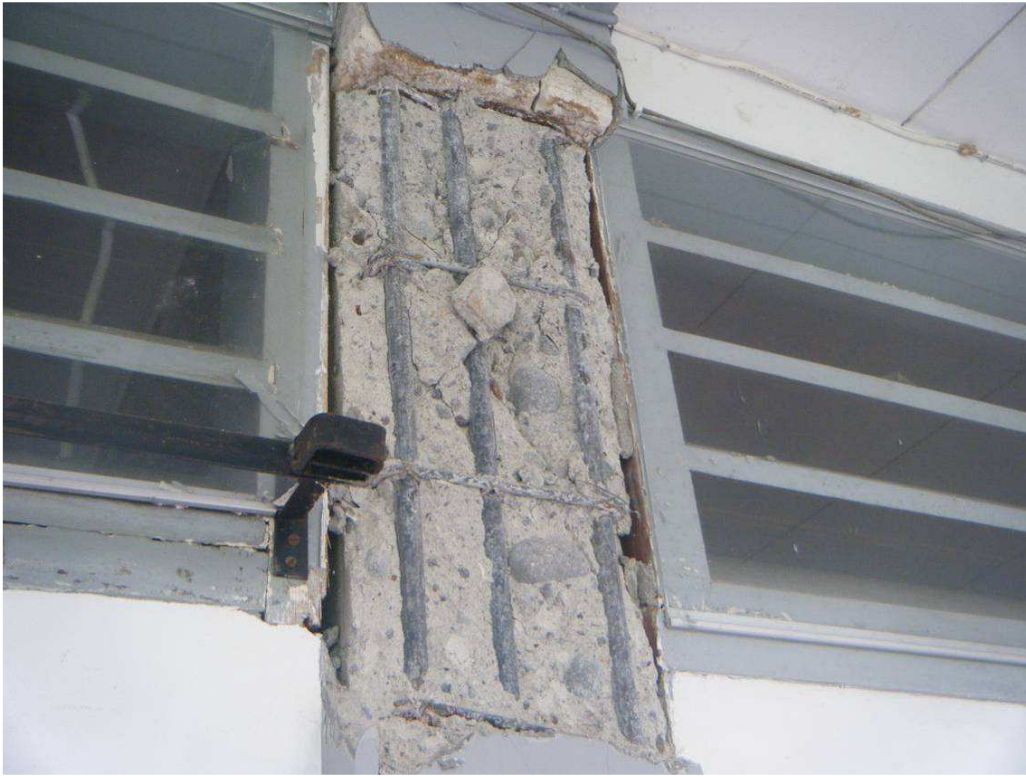
In many broken concrete members, the aggregate was observed to be of rounded river gravel of large size (ranging up to >40 mm). It was observed that reinforcing steel was being recovered from fallen structures by beating the concrete members with sledge hammers and hand hammers – further suggesting that the concrete strength is low. Honeycombing of concrete members was also observed on many buildings due to incomplete compaction of concrete during pouring.

Figure 10 Poor aggregates/concrete

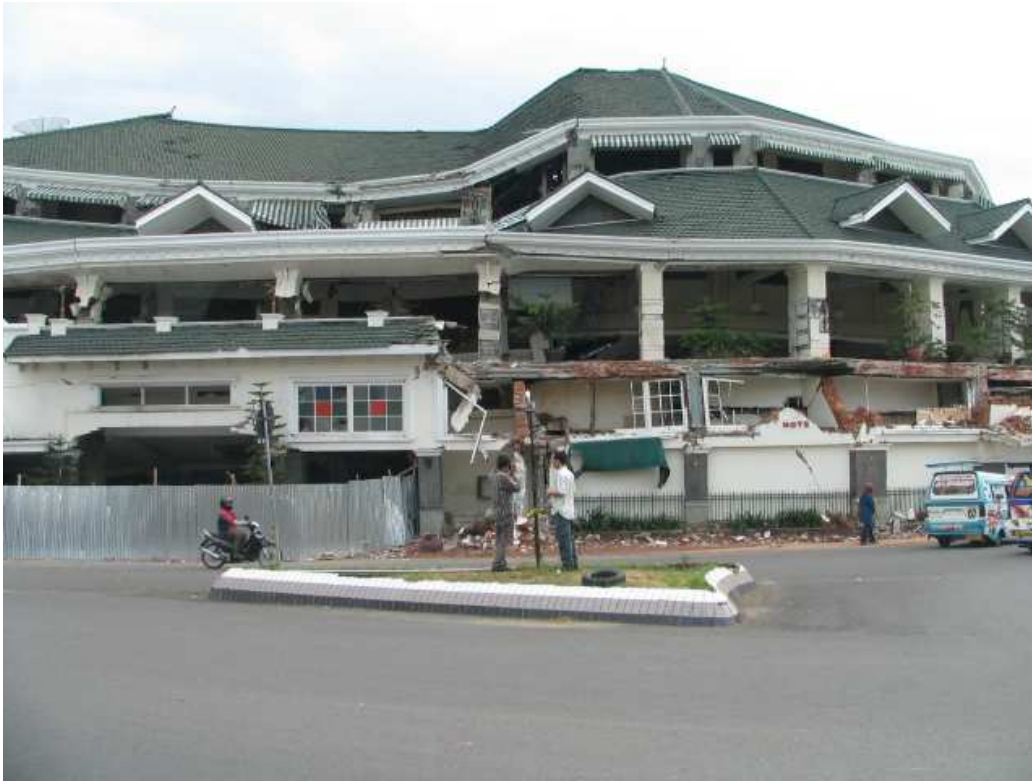
Figure 12 The 6 storey part of this hotel totally collapsed

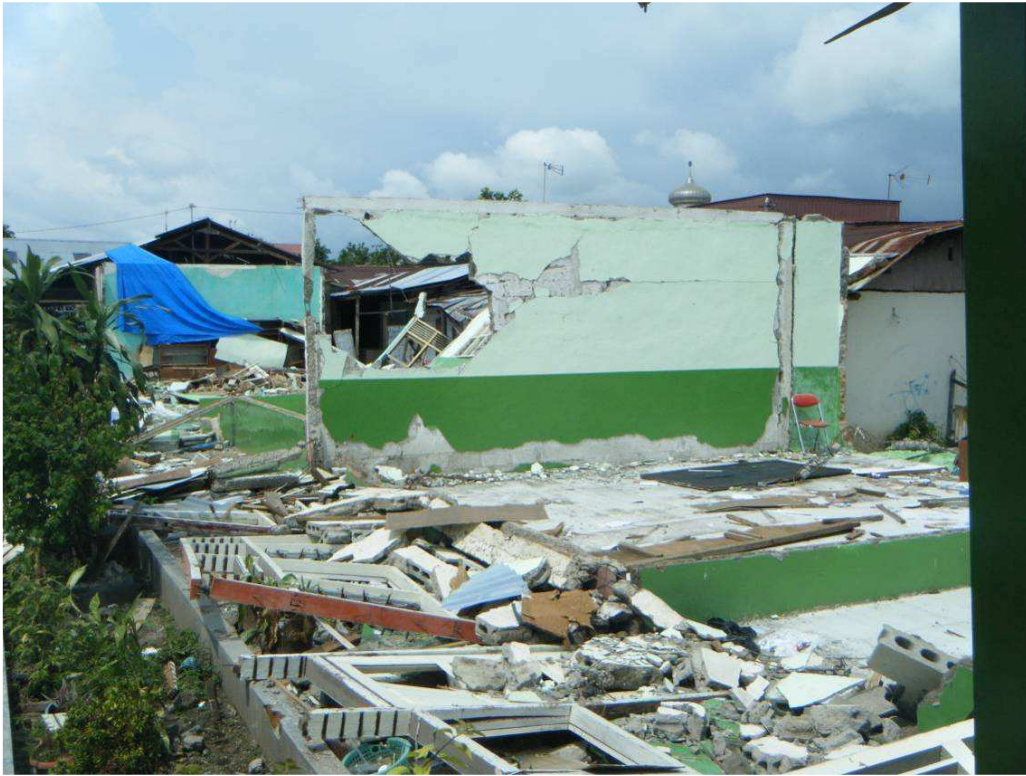
Figure 14 Collapsed school (single storey)

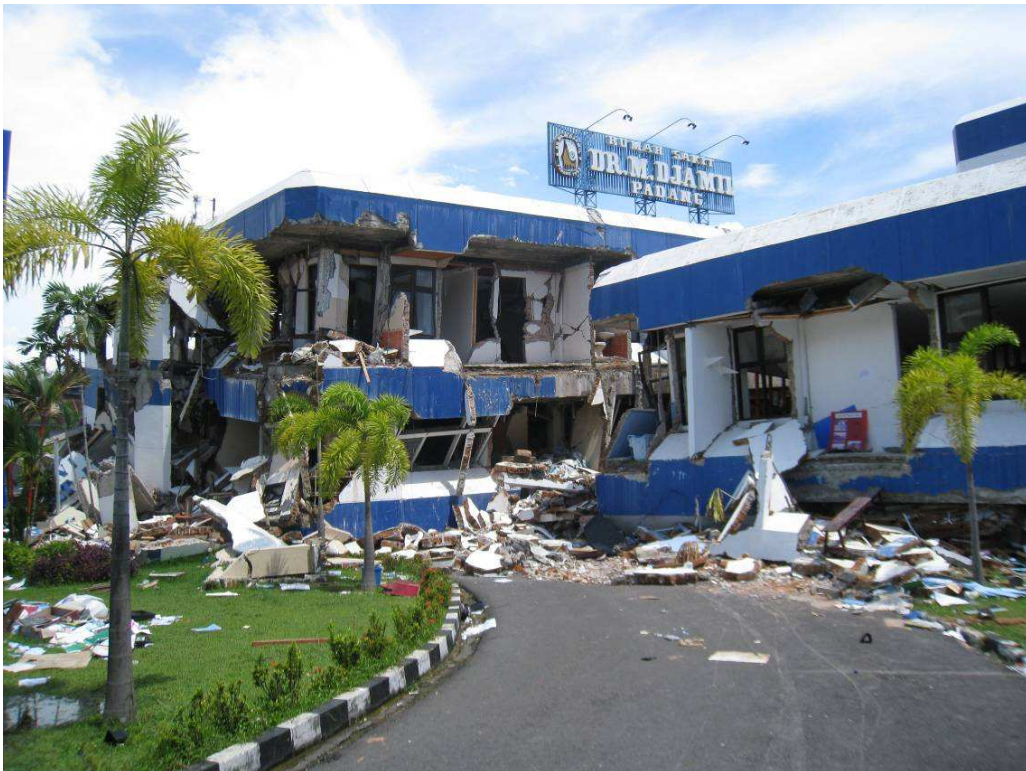
Figure 15 Collapsed Medical Facility

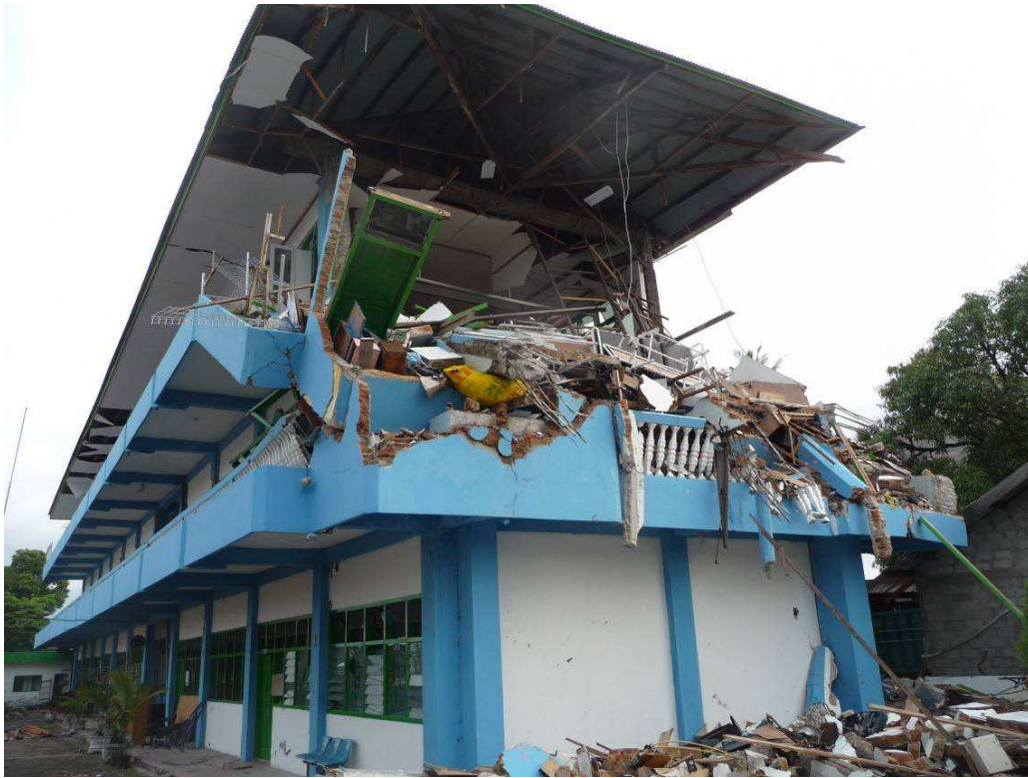
Figure 16 School abandoned

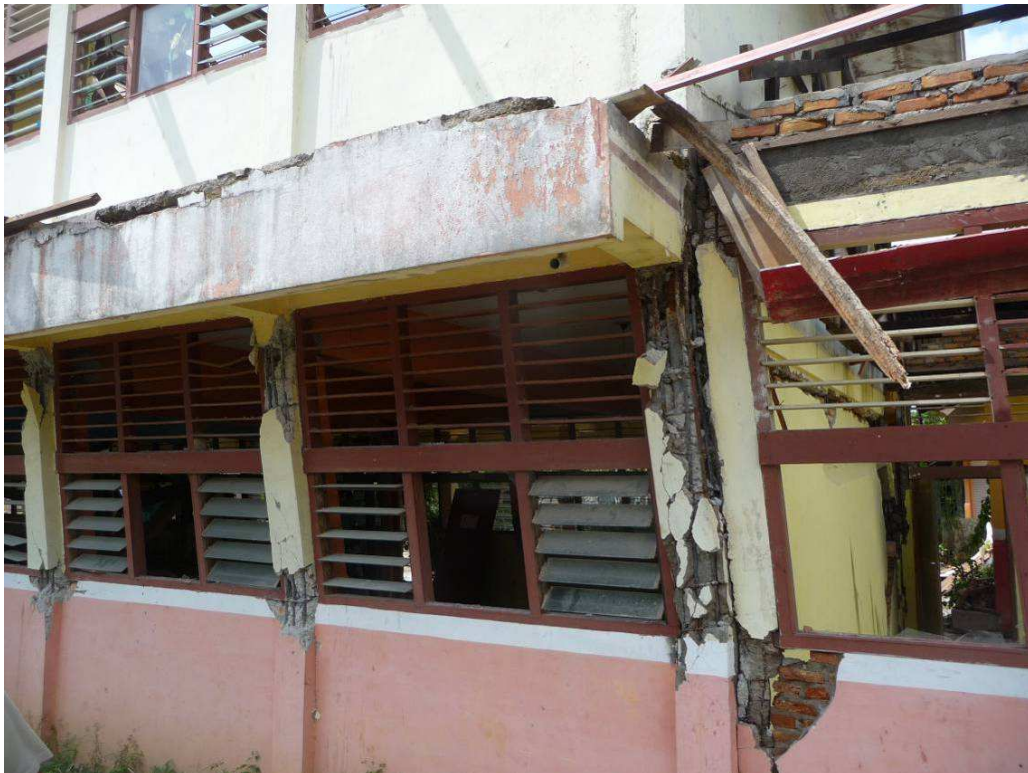
Figure 17 School very near collapse

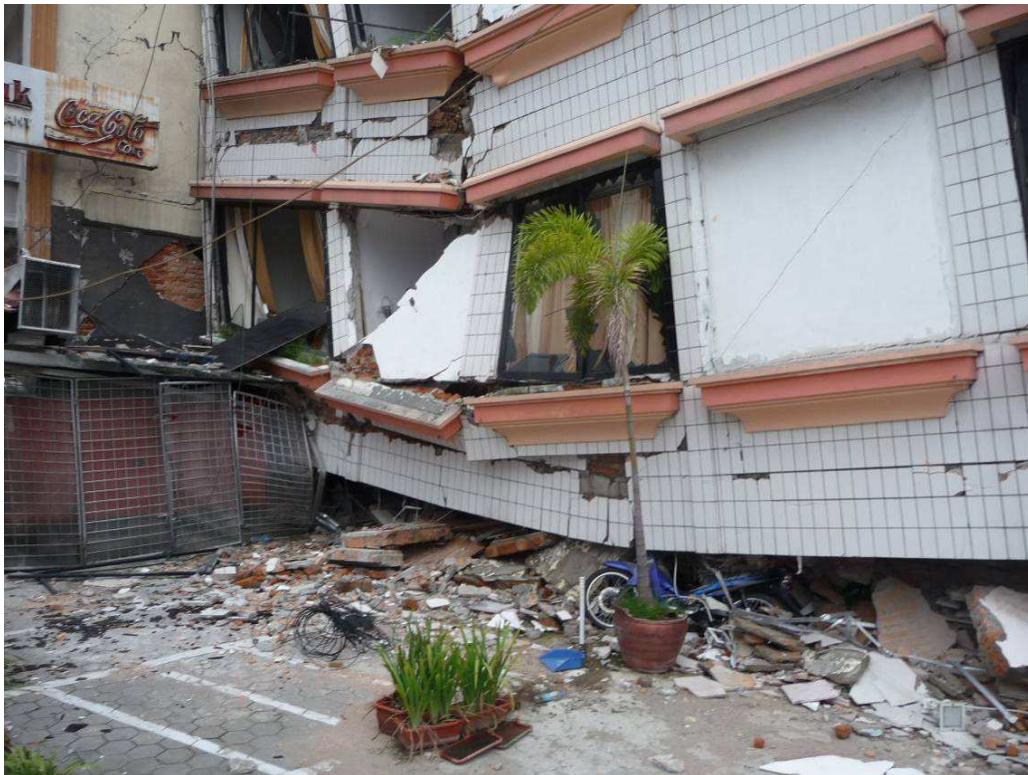
Figure 19 Soft Storey (commercial shop-front) Ground Floor Collapse

23. Shop Fronts—Many shop fronts have no shear resistance at the front of the building. This can cause a soft storey and/or torsional type failure. A number of such failures were seen. Some damaged buildings were still in use where the deformation was of a dangerous nature. Shop fronts should be provided with some form of lateral resistance (e.g. short shear walls).

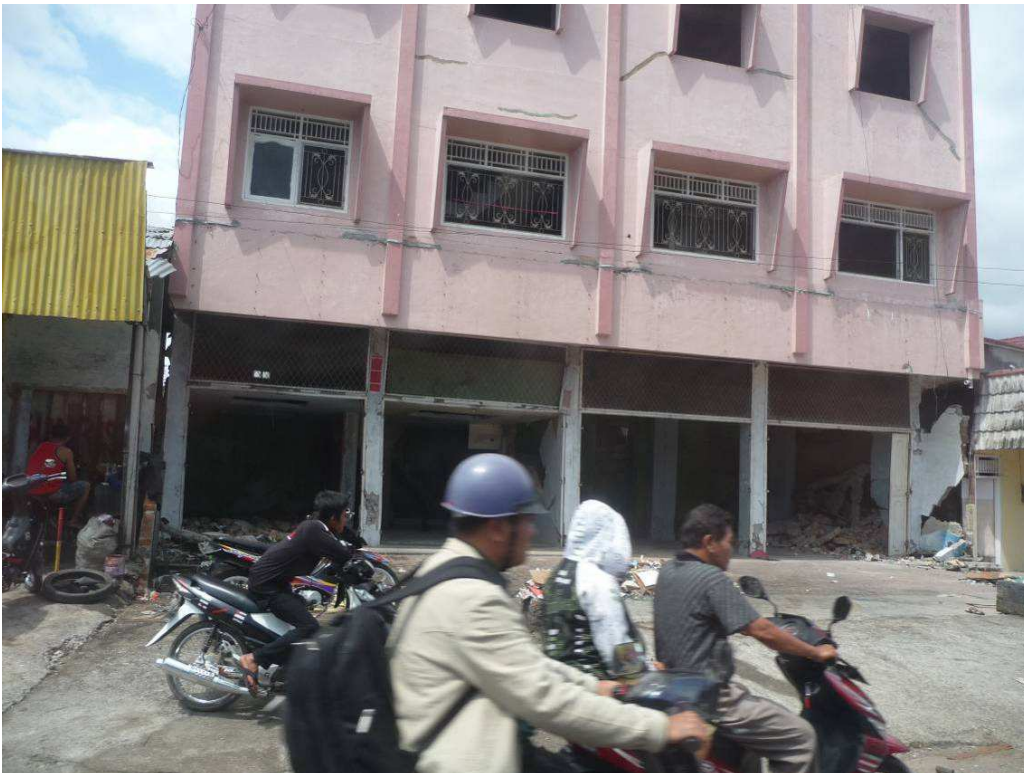
Figure 21 Another soft storey building near collapse

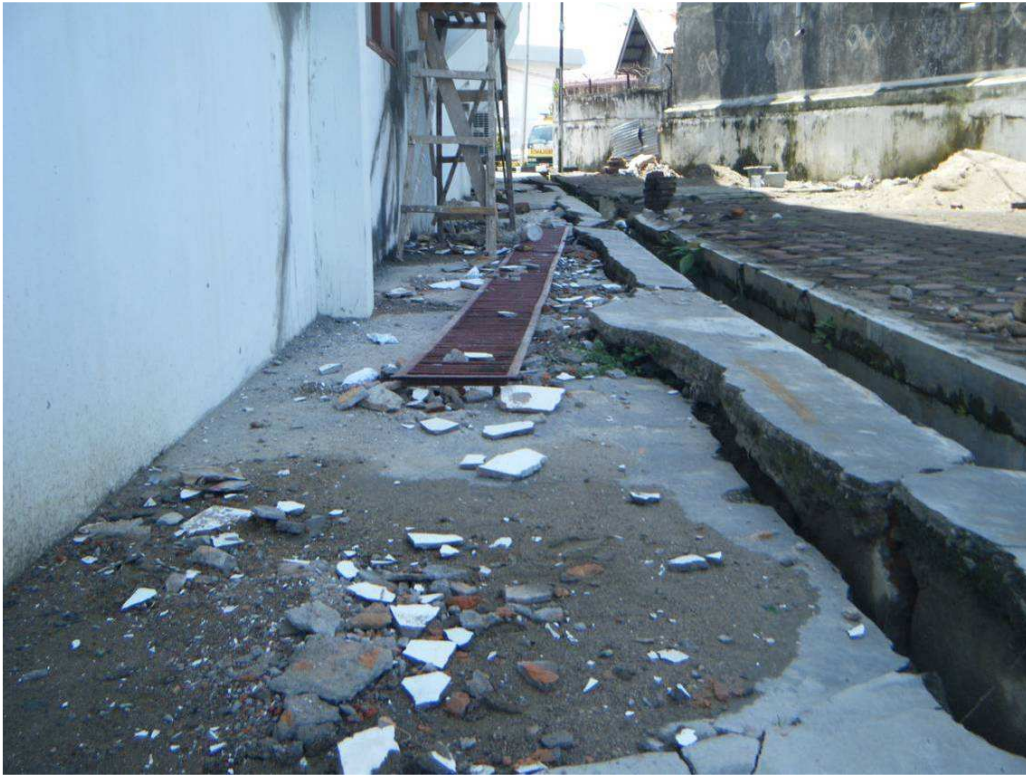
Evidence of liquefaction was noted at widely varying locations within the City of Padang. Liquefaction has caused ground settlement (300mm noted at one location). This type of settlement triggered serious damage to building structures. It affected the larger heavier structures more than single storey buildings and was more prevalent on the loose to medium sands near the coastline and along the edges of rivers. It is considered to have triggered the collapse of some large buildings due to the magnitude of displacements to building frames resulting from non-uniform levels of settlement throughout the structure.

Figure 22 Settlement due to liquefaction (note sand forced up through cracks in concrete)

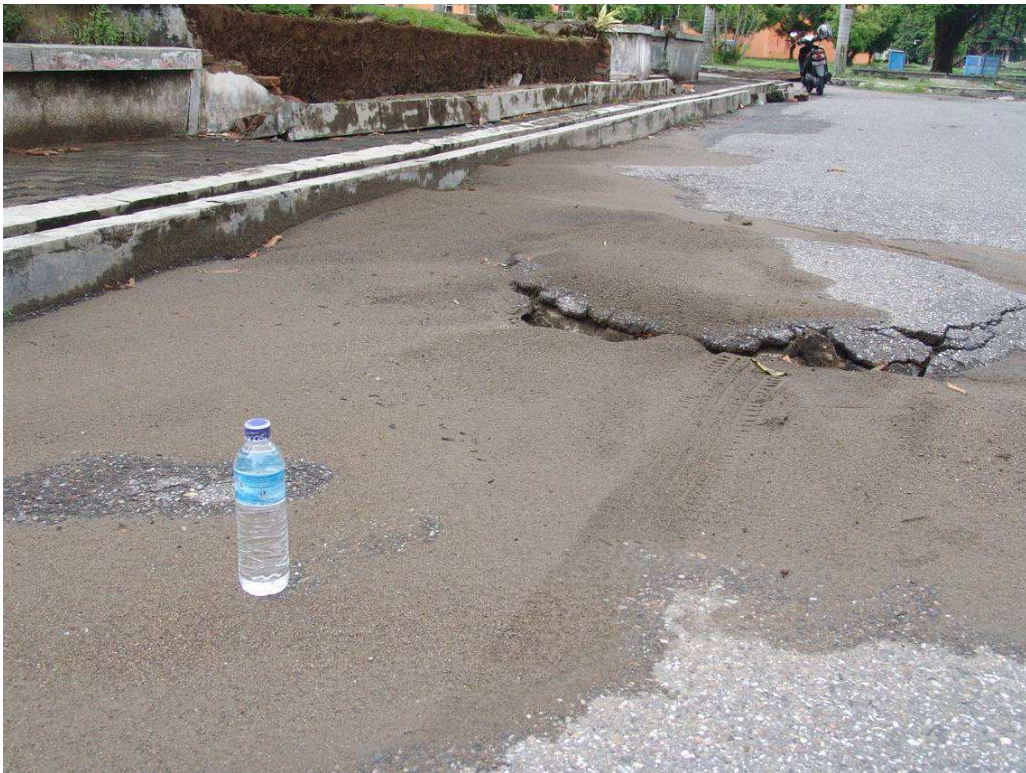
Figure 23 Sand brought to the surface due to liquefaction

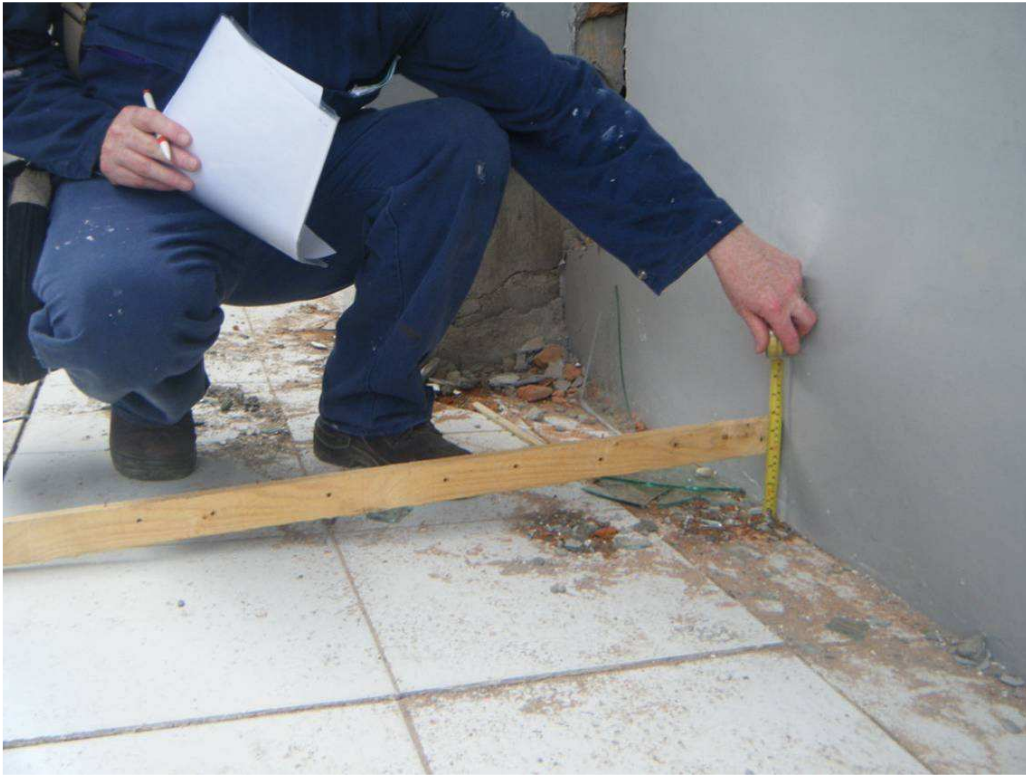
Figure 24 Liquefaction caused heavier buildings to sink
