Lessons Learned for Steel Seismic Design from the 2010/2011 Canterbury Earthquake Series

G. Charles Clifton¹

Abstract

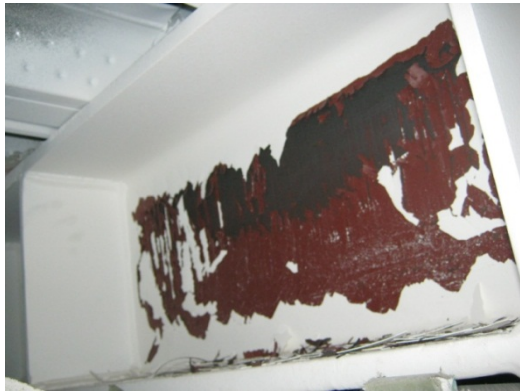
(c) Inelastic demand in EBF active link
[C Clifton]

The peak plastic strain in the EBF active links was approx. 7%, in the 5th level link in the East-West direction, shown in Figure 2 (c). This is less than 25% of the monotonic strain elongation capability of the steel.

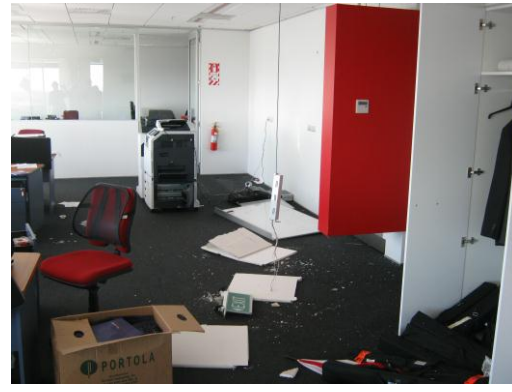
(d) Typical interior of office following 22 Feb 2011 earthquake [C Clifton]

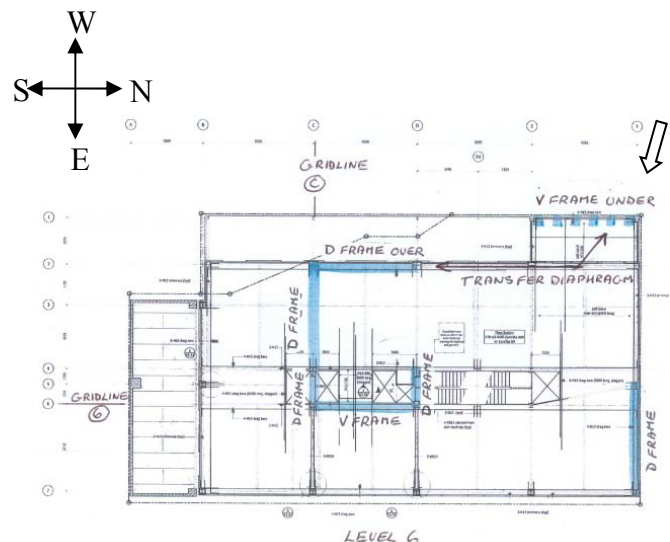
Figure 6 Pacific Tower [Photo by C Clifton, Floor Plans from S Gardiner] (the arrows in (b) show the direction of the view in (a))

However, one critical piece of evidence from Christchurch suggests that, at least in steel framed buildings with composite floors, this lack of redundancy is not critical. Figure 6 shows details of Pacific Tower. In the North-South direction, there are only two EBF systems up the full height of the building. On level 6, shown in Figure 6(b), the V frame under the NW corner stops and the EBF transfers to the D frame half way along the building for levels 7 to 22. The top link in the NW corner EBF fractured, either in the February 22nd 2011 earthquake or in the most intense earthquake of 13 June, partly due to use of steel with less than the specified Charpy Impact energy. In principle, this broke the continuity of the seismic-resisting system on the west side of the building and should have generated high torsional actions especially around the 6th level. Evidence from non-structural linings cracking showed a very slight increase in inelastic demand in the 6th and 7th storeys, however there was no evidence of enhanced torsional movement. The floor slab on level 6 functioned as an effective transfer diaphragm. This building was repaired and returned to service in May 2013.

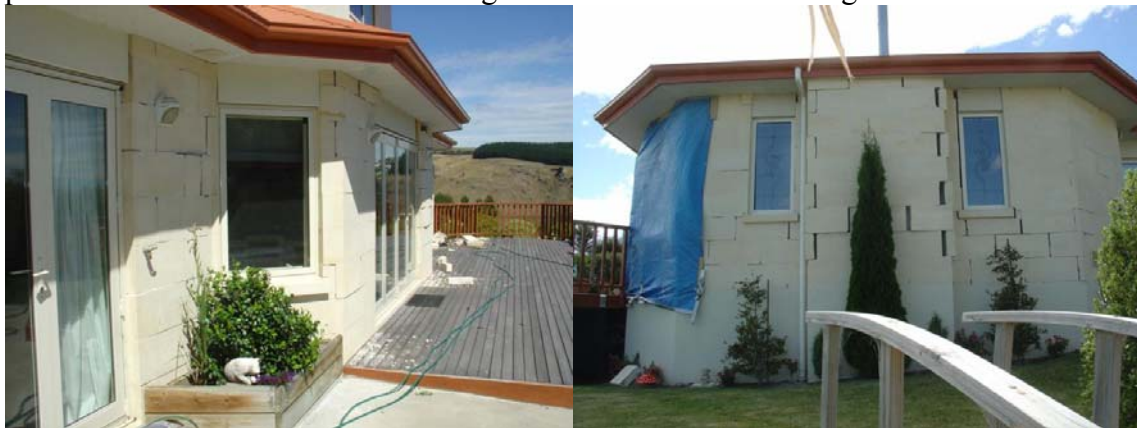
Performance in the Christchurch earthquake series was consistent with this; no damage to minimal hairline cracking of plasterboard linings for houses on good ground. The most outstanding example of LSF performance was a two storey light steel framed house with Oamaru stone cladding, situated very close to the epicenter of the 22 February 2011 earthquake and to a strong motion station that recorded PGA_H and $PGA_V = 1.8g$ in that event (a higher PGA_V was recorded at another station, but that figure is suspect to falling material in the vicinity of the recorder). Figure 7 shows two views of this house, showing the movement of the Oamaru stone on its bedding planes. There was also minor cracking to some internal wall linings. Both were

Figure 7 Two storey light steel frame house with Oamaru stone cladding [T Just]

readily repaired. With the Oamaru stone units being 4 times the weight of a standard clay brick and the acceleration demand being double that of the shaking table

experiments, this was a much more severe test of the light steel framed house system and the most demanding example studied from Christchurch.
