# Seismic Performance of Underground Pipes during the Canterbury Earthquake Sequence

A.K. Sherson

M. Nayyerloo & N.A. Horspool

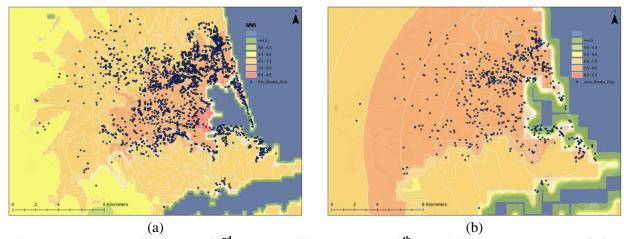
Figure 1. MMI maps from a) the 22<sup>nd</sup> February 2011 and b) the 13<sup>th</sup> June 2011 earthquakes. MMI5, for example, is the range between MM4.5 and 5.5 and so forth. The dots represent breaks to the water supply network.

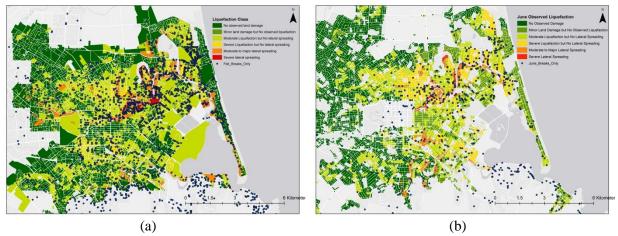
Figure 2. Observed liquefaction maps from Tonkin and Taylor for a) the February event, and b) the June event. The dots represent breaks to the water supply network.

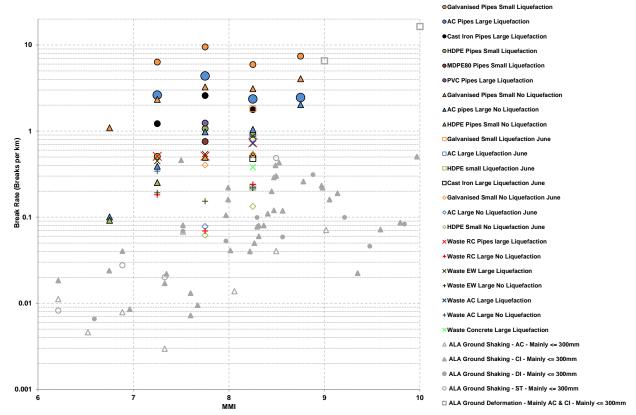
Figure 4 shows the break rate results in more detail for Christchurch water and waste water networks and both of the February and June events. Each point on the graph represents how a particular class of pipe (combination of material type and size) performed during the February or June event when subjected to a particular level of shaking and was in a particular ground condition (liquefied or non-liquefied). This way the effects of all contributing factors to damage are captured. Figure 4 confirms the previous conclusions drawn from the tabulated break rates. It also shows an increasing trend in the break rates with shaking intensity although for some pipe classes this may not be evident due to lack of data. As can be seen in the figure, there are no instances where different sizes of pipe, of the same material and in the same class of ground, were exposed to the same level of shaking, and so it was not possible for the effect of size on the seismic performance of pipes to be evaluated. However, larger pipes usually tend to be more robust to seismic loading compared to smaller pipes.

Figure 4. Christchurch water and waste water pipes break rates for different combinations of pipe material and size, calculated for different shaking intensity levels and ground liquefaction susceptibilities. Small wastewater pipes are smaller than 150mm and small water supply pipes are smaller than 100mm.
