The 2010 Chile Earthquake: a five-year reflection

J.C. de la Llera, J. Mitrani-Reiser, F. Rivera, C. Fortuño, R. Jünemann, A. Poulos, and J. Vásquez

ABSTRACT: At 3:34AM local time, on February 27th, 2010, a moment magnitude M_w 8.8 megathrust earthquake struck offshore the coast of Chile. The earthquake ruptured a 540 by 200 km mature seismic gap of the underlying subduction pacific plate interlocking mechanism. More than 75% of the 16 million Chileans spread over several large urban areas in the center-south of the country were affected by the earthquake, which caused 521 fatalities with 124 of them due to the tsunami, and an overall damage estimate of USD 30 billion. Because the earthquake struck the most densely populated area of the country, it represents a very unique opportunity to reflect on its ubiquitous impact over many different physical and social systems. The reflection contained in this article occurs five years later, once reconstruction and recovery are complete from this *longitudinal wound* of the country. Seismic codes have changed, research on the supposedly indestructible reinforced concrete shear walls has been done, new seismic protection technologies have

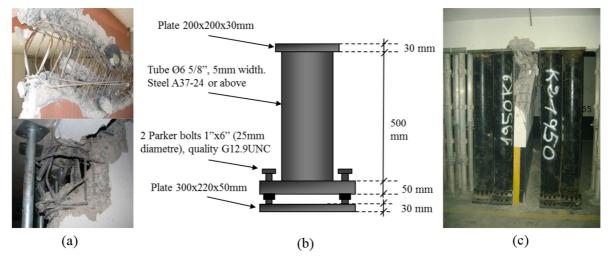
Figure 3. Damage and shoring system: (a) boundary damage and temporary shoring; (b) Yoder pipes and stabilization solution typically used for buildings; and (c) implementation of the stabilization solution at the basement level of a building in Santiago

If any building was severely damaged and at risk of collapse with the aftershocks, it was necessary to propose in a few days an emergency stabilization procedure, even before people could enter to inspect or do any work inside these structures. This was the case of several tall buildings, whose stabilization process provided very unique and useful information to other projects that followed a similar stabilization methodology (de la Llera et al. 2015). The emergency stabilization strategy was to install an important number of vertical struts readily available in the market; however, since these elements have low axial capacity, a more reliable solution was required due to high-intensity aftershocks. This solution consisted of 10" Yoder pipes with Parker bolts installed directly below the wall offset and continuously at all basement levels (see Fig. 3b and c). The bolts were used to preload the pipe and carry vertical load. These high strength pipes had Parker bolts that were calibrated to control the load on each element and avoid damage in slabs. This procedure was used in a large number of severely damaged buildings and was very successful.

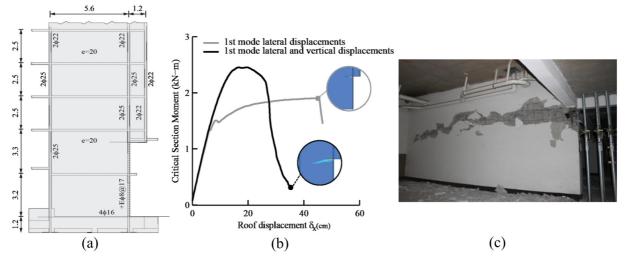
Thus, a pushover analysis was used to reproduce the observed damage in a few resting planes. These analyses considered different lateral loading configurations, and their goal was to reproduce the mechanism of collapse of selected resisting planes. This turned out to be an interesting problem and the results identify a specific loading pattern that generates the almost exact failure geometry. A key aspect to this pattern is to include the vertical deformations at the edges of the resisting plane. As it is shown in Figure 4, if such deformations are omitted, the geometry of the failure changes substantially. This failure of the resisting planes occurs, without any adjustment of parameters, in the exact location where it occurred during the earthquake. However, it is apparent that the different stress-strain relationships considered do have an influence on the rupture mechanism (Jünemann et al. 2015b).

Figure 4. Building analysed: (a) elevation of a resisting plane of building in Santiago (dimensions in meters); (b) pushover results for the moment-displacement curve with (black line) and without (grey line) vertical deformations; and (c) observed damage pattern reproduced analytically.
