Ground deformation and proposed mitigation during 2011 gigantic earthquake in Japan

Ikuo Towhata

President, Japanese Geotechnical Society, Tokyo, Japan.

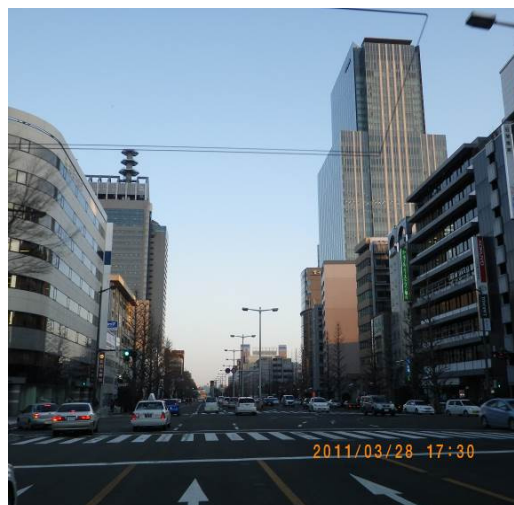
A good news is that very few buildings were damaged during the earthquake (Figure 1) because of the development of structural dynamics and

Figure 1 Intact buildings in the center of Sendai City

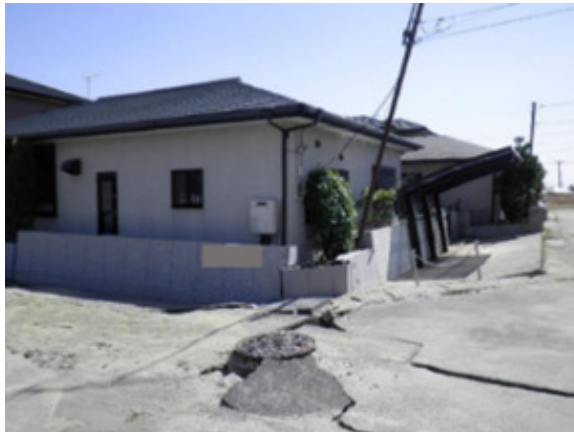
Many man-made islands have been constructed since 1970s along the shore of Tokyo Bay and some of them were designated as residential areas. Moreover, small lakes have been buried and converted to residential development in the recent decades. Liquefaction occurred in those young loose sandy water-saturated subsoil significantly in 2011. Figure 2 shows a typical liquefaction damage of a private house in which there is no structural damage but subsidence and tilting are substantial. Because of the subsidence, connection with lifelines were destroyed. Liquefied sand flowed into sewage pipelines from broken connections and stopped the sewage operation. Because of the tilting, daily life caused bad health problems; if tilting was more than 6/1000, residents felt dizziness and headache (Japan Structural Consultants Association, 2011). Heavy structures subsided while lighter underground structures floated. Figure 3 illustrates an underground parking that floated extensively due to liquefaction.

Figure 2 Liquefaction-induced subsidence

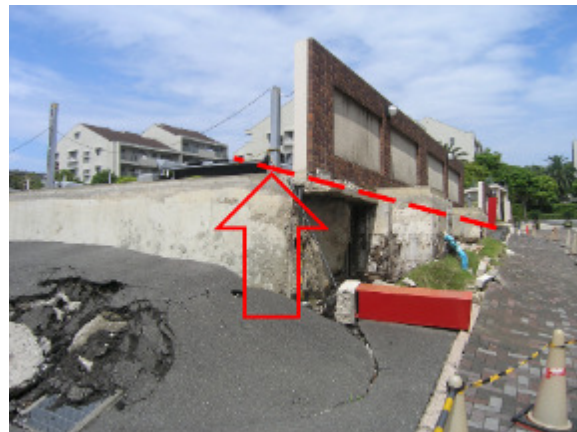
Figure 3 Floating of underground car parking

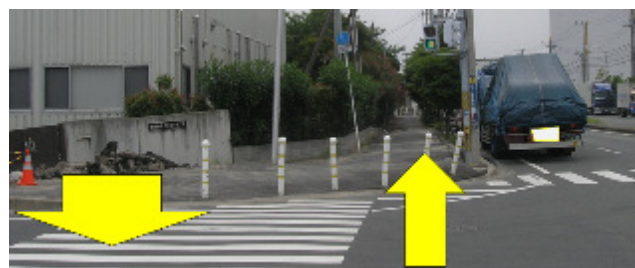
Figure 4 Subsidence of private building into liquefied subsoil induced distortion of public sidewalk

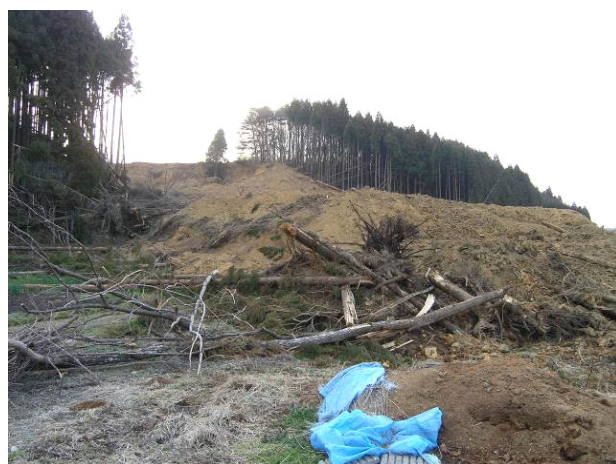
The 2011 earthquake triggered few slope failures. Figure 10 is one of the failures. In contrast, residential areas constructed in hilly areas revealed many instabilities. Figure 11 shows a case in Sendai City in which hilly areas had been developed by cutting and filling. Although the cut part was stable, the filled part suffered significant deformation during the earthquake.

Figure 10 Seismic failure of natural slope at Konoha-daira in Shirakawa City

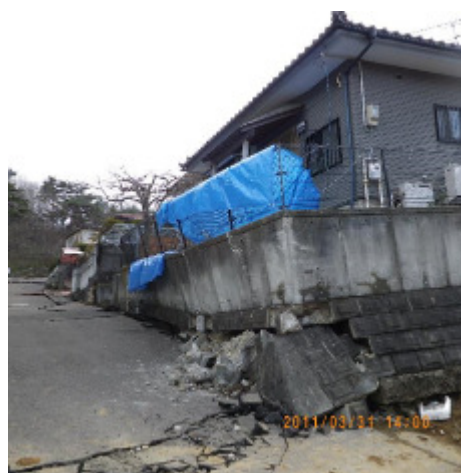
Figure 11 Earthquake damage in a filled part of residential development in hilly area (Oritate of Sendai City)

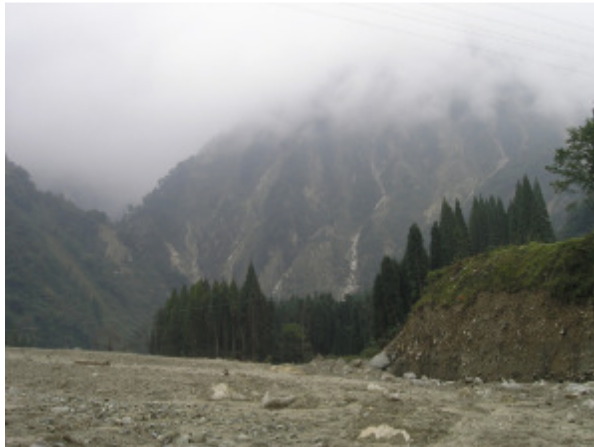
This section addresses experiences in different earthquakes. Figure 12 shows a situation in a mountain area of Sichuan Province of China where debris flow started to occur frequently after the 2008 Wenchuan earthquake. The valley bottom in this figure is filled with debris and the mountain slope in the back side is totally unstable. Figure 13 indicates a similar post-earthquake slope instability behind

Figure 12 Frequent debris flow in Sichuan Province of China

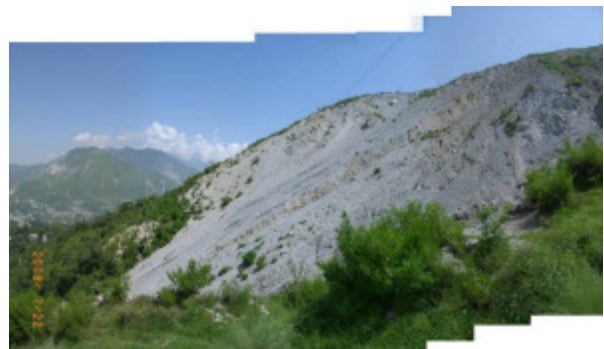
Muzaffarabad of north Pakistan which was severely damaged in 2005. Similar post-quake slope disasters occurred after the 1999 Chi Chi earthquake in Taiwan. All these sites are situated near big causative faults.

Figure 13 Post-earthquake slope instability behind Muzaffarabad, Pakistan
