Performance Study of Seismic Bracing Assemblies of Suspended Ceiling Systems

G.C. Yao & W.C. Chen

Department of Architecture, National Cheng Kung University, Taiwan.

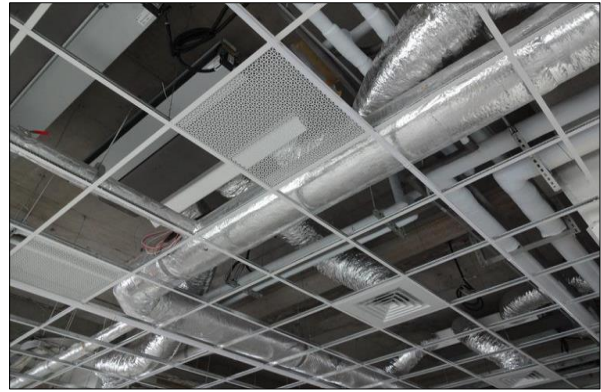
In 2011, an appendix referring to ASTM E580-06 was issued in the Taiwanese building seismic design code. The appendix explicitly provides guidance for the seismic installation of the suspended ceiling systems. The main construction details include the use of the fixtures at two fixed adjacent ends and the installation of the edge hanger wires which have proven advantageous in limiting the movement of the ceiling systems. In addition, the lateral bracing assemblies are required for all ceiling areas greater than 100m². However, the construction of the bracing assembly has always been a difficult problem leading to uneven qualities of the suspended ceilings. Figure 1 shows a bracing assembly consisting of four wires splayed 90° from each other also at an angle not exceeding 45° from the ceiling plane and a vertical strut performing as a compression post. To satisfy the demand of the angle not exceeding 45°, sufficient space in the horizontal direction is necessary. However, the installation of the suspended ceilings has always been arranged after the construction of other overhead non-structural elements such as mechanical equipment and piping systems. For this reason, the lateral bracing members especially the splayed wires are frequently obstructed by equipment and consequently installed in bad construction. Figure 2 demonstrates a common situation of ceiling construction in Taiwan, and it is obvious that there is almost not enough space to set up the bracing assembly.

Figure 2. Unfavorable installation condition

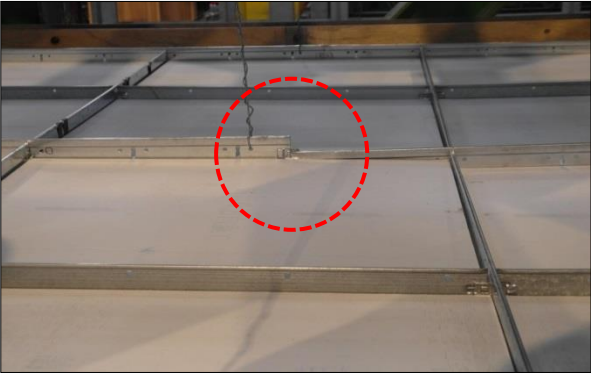
Figure 8. Detachment of the main runner joint Figure 9. Installation of the additional hanger wire

Table 1 summarizes the ceiling configurations. The ceiling specimens are divided into three groups in accordance with the installation of the bracing assemblies while all other details are identical. One thing is particularly worth mentioning, a certain connection joint of the main runner in the A type detached (Figure 8) every time when excited by vertical excitations, and this unexpected failure happened not only in one specimen. Therefore, an additional hanger wire shown in Figure 9 (denoted as “Connection joint reinforced” in Table 1) was installed when the specimen was reconstructed. The reason of this problem will be further discussed in the following section.

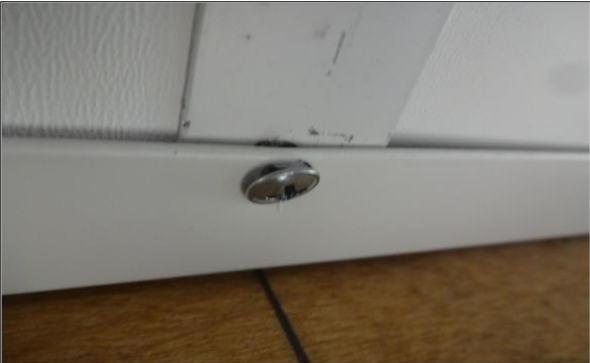
Almost no damage to the ceiling specimens was observed in response to unidirectional ground excitations while only a few tapping screws were dislodged as shown in Figure 10. The result revealed that the seismic ceiling systems used in Taiwan certainly had good resistance to horizontal forces. Concerning the experiments with vertical excitations, some of the perimeter connections and cross tee latches failed but the grid members especially the main runners always remained intact. Without losing the support of the tee grids, the tiles were not observed fallen over the course of the experiments. The largest damage was generated in C6 specimen that the ceiling was completely collapsed (Figure 11). Some of the failure patterns will be discussed in the following text.

The horizontal inertial force generated by the mass and the response acceleration of the ceiling induces axial force in the grid members. This force accumulates and becomes greater near the perimeter support than in the middle and is transferred to connection of tapping screws. However, as the tapping screws are installed regardless of the ceiling mass or the intensity of the input excitation, damage to tapping screws is always the first failure pattern observed during the experiments.

Figure 10. Dislodged tapping screw

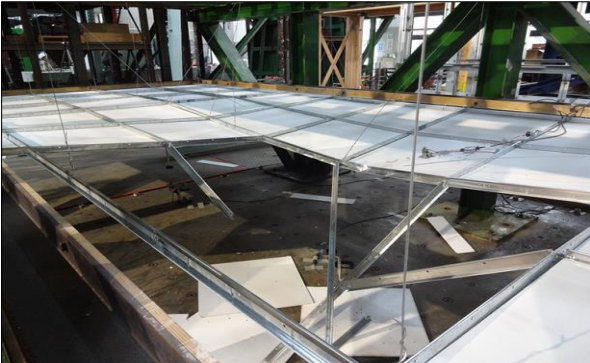
Figure 11. Collapse of the ceiling system

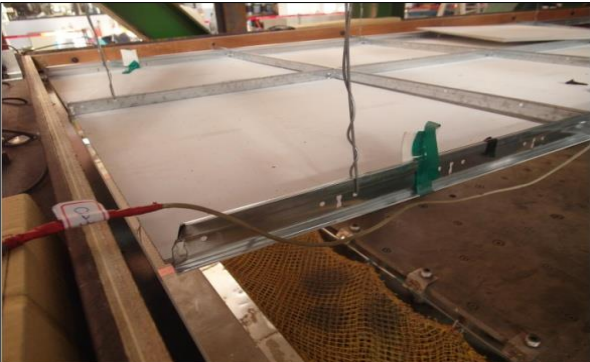
The primary damage in perimeter connections is the unseating of the ceiling grids from the wall molding as shown in Figure 12. Since 50mm wall molding is barely used in Taiwan therefore only 24mm wall molding was applied in the experiments. This failure can possibly due to the insufficient seat length of the wall molding at the unfixed sides or the failure of pop rivet at the fixed sides. As the unseating grid members move back toward the perimeter boundary, the grids hit the wall molding to cause the observed damage (Figure13). In some cases the failure of perimeter connection result in grid members and tiles falling from the ceiling, which particularly occurred around the connections of cross tees and wall moldings. In this paper, an additional test (B type configuration) without the wall moldings was conducted to evaluate the performance of the ceiling in a severe condition. The grid members of the ceiling were still intact in the shape of rectangle after the test and no falling tiles were observed (Figure 14). The result demonstrates the edge hanger wires can effectively prevent the grid members and tiles from falling.

Figure 12. Unseating of grid members

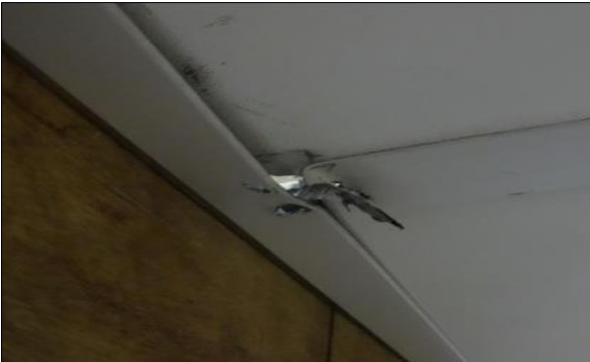
Figure 13. Failure of perimeter connection

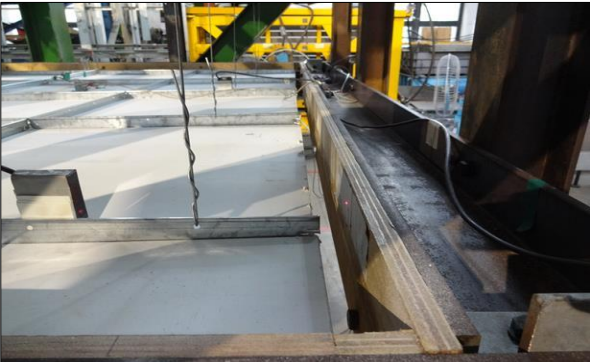
Figure 14. Specimen without wall moldings

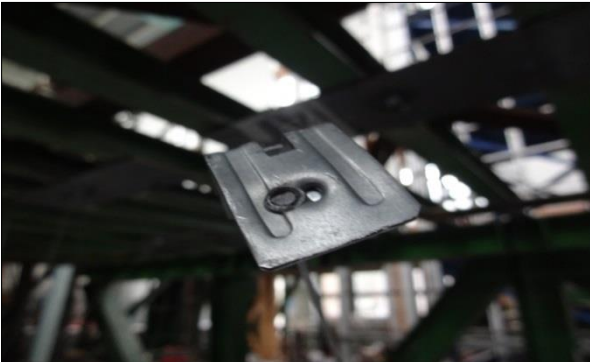
The attachment connecting the hanger wire and the frame structure failed during extreme vertical excitation (Figure 15). The failure of one hanger wire resulted in missing vertical supporting and uneven loading distribution of the ceiling grids, which led to a progressive failure of other hanger wires and caused a chaotic global collapse of the ceiling system. In all experiments, failure of hanger

wires only occurred in the braced ceiling specimen C6. In order to study whether the failure of hanger wire was caused by construction problem, the specimen C5 was reused with vertical ground motions after the unidirectional excitation test was finished. The result showed similar damage patterns including failure of hanger wires and serious collapse of the ceiling.

Figure 15. Failure of hanger wire

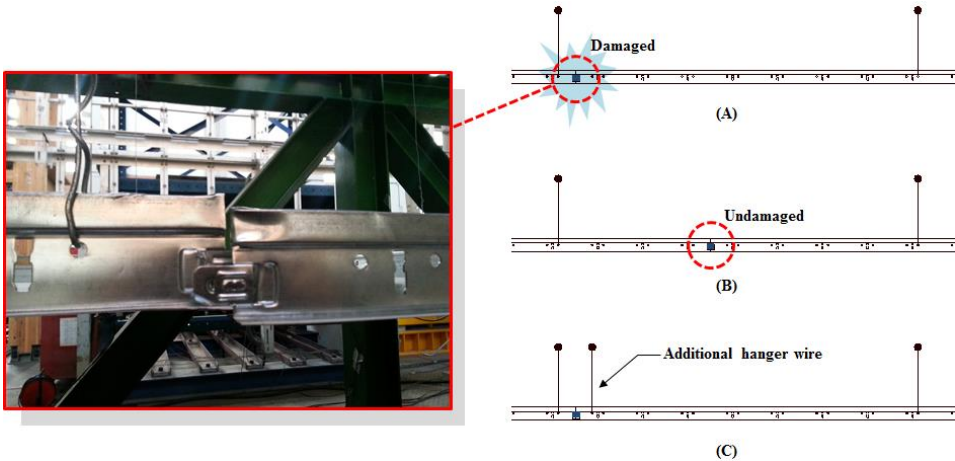
The damage to the connection joint of the main runner is an unexpected failure during experiments. The 7.3m main runner of the A type consisting of three pieces of grid members and has two connection joints along the grids, one of the joints shown in Figure 16-a failed frequently at low amplitude vertical excitation. Studying the locations of these two connection joints, the damaged joint is placed closely beside a hanger wire while the undamaged one is placed at the middle of two hanger wires (Figure 16-b). Displacement incompatibility on both sides of the connection joint is considered the most possible reason of the failure condition. When the grid members sustain downward loading inclusive of the excitation and the impact force from tiles, the grid on the left side of the joint is directly restrained by the hanger wire but the grid on the right side vibrates obviously. To prevent the displacement incompatibility between the connection joints, an additional hanger wire is installed

Figure 16. Damage to the connection joint of the main runner

beside the joint as shown in Figure 16-c, which has proven effective since no failure is observed after reinforcing.

From the previous discussion, some connections of the grid members show vulnerability to vertical excitation. Damage to the connection joint of the main runner is a special observation in this paper. A convenient retrofit construction is applied which efficiently prevent the failure from the strong vertical excitation.
