Seismic risk management of NSW Education's buildings including heritage buildings

Seismic risk management of NSW Education's buildings including heritage masonry buildings

Case study – Yass Public school

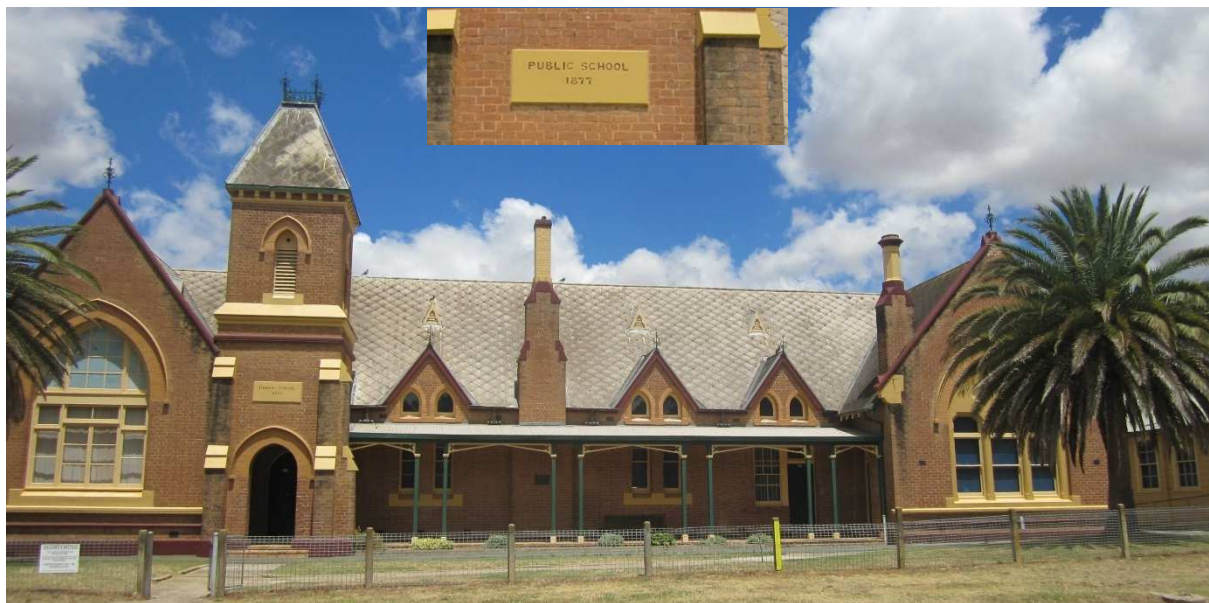
Yass Public Schools was chosen for this case study, as it is listed on the DoE & local LEP heritage register and has all the vulnerable parts, for example, Block “G” (Library/classroom block) has 7 chimneys, eight gable walls, 11 gablet walls and one parapet. Chimneys extend 5.5m above the building’s eaves level.

Figure 1 – Yass Public School – North-east elevation. Library and Classrooms Block “G”. Inset photo shows year of construction 1877.

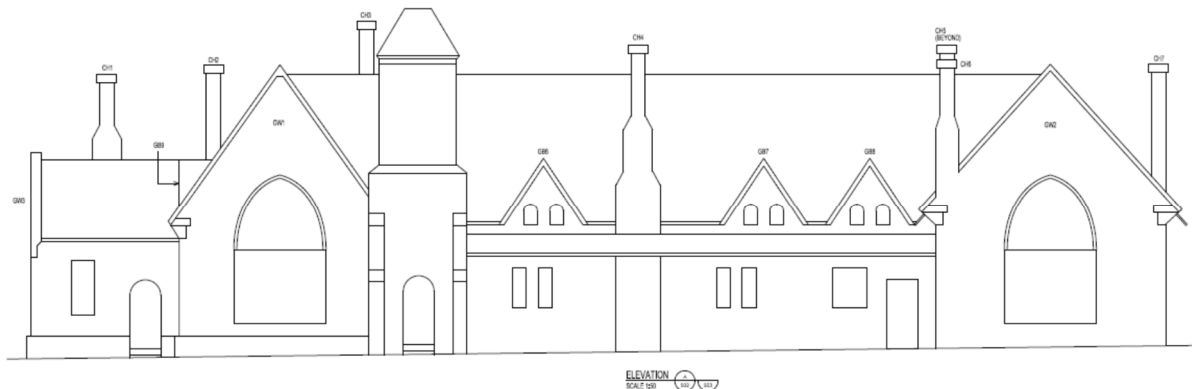
Figure 2 – Yass Public School – drawing of north-east elevation

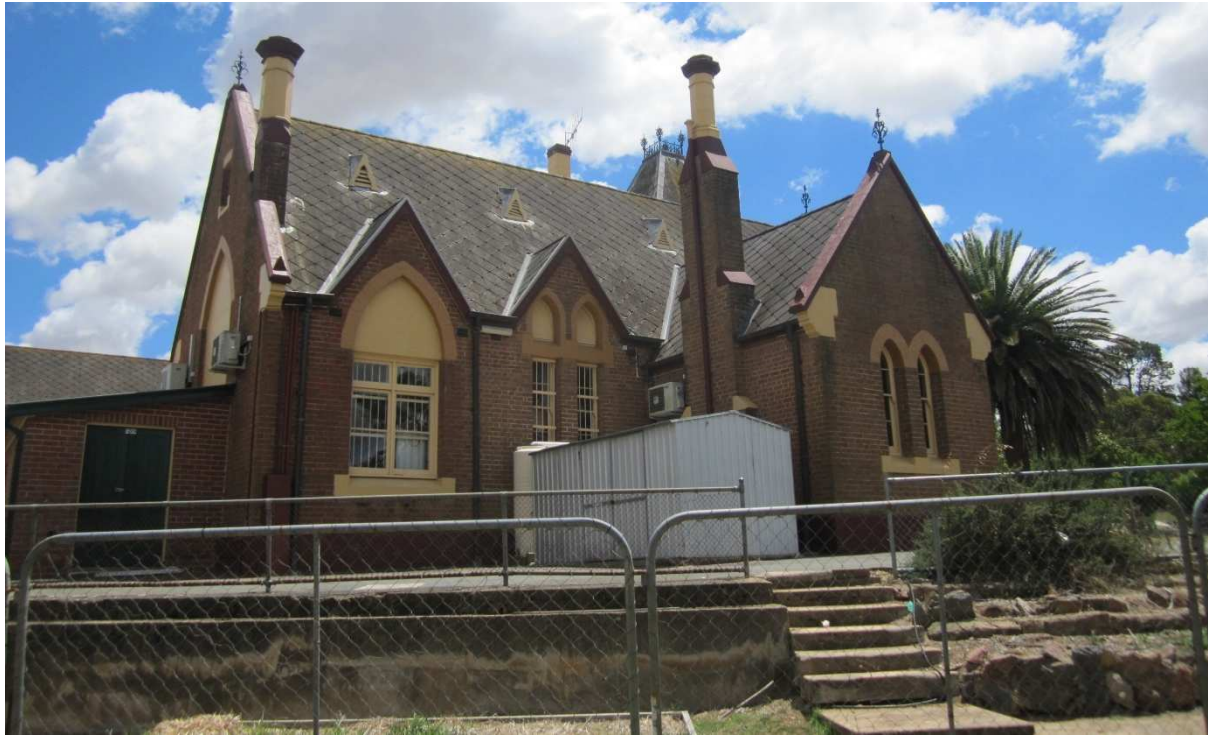
Figure 3 – South-East Elevation – showing two tall chimneys, two gable walls and two gables

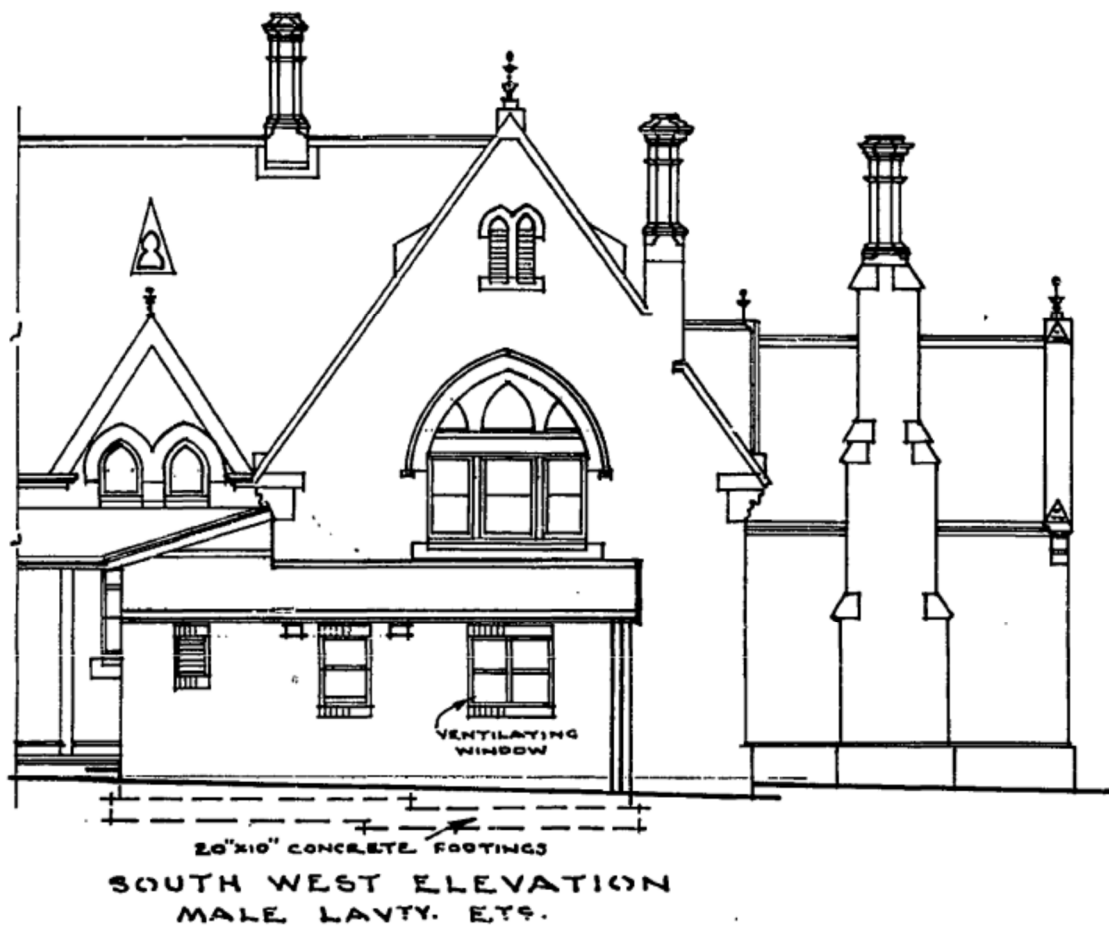
Figure 4 – South-West elevation from 1940 drawings for amenities extension.
