LOW DAMAGE SEISMIC RETROFIT OF A HERITAGE URM BUILDING WELLINGTON, NZ

Ioannis Prionas¹, Sheri Javadian², Arend Groen³

Abstract

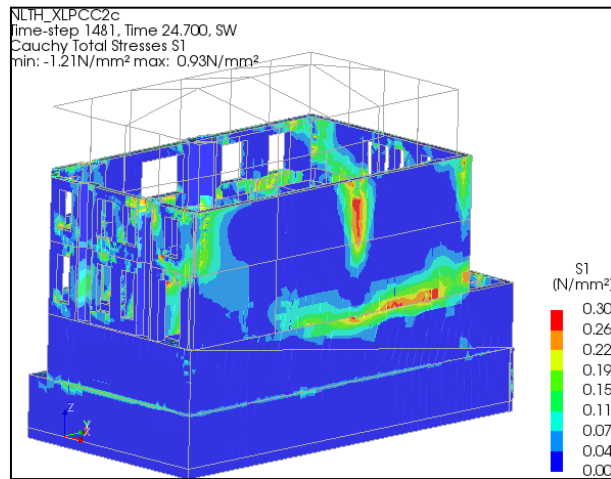
Figure 6: View of maximum tensile stresses in the building due to worst time history analysis case (Darfield scaled to 45%NBS, with primary component in the N-S direction)

The main areas showing signs of crack initiation under seismic shaking were the eastern and western end walls at the second floor and some minor crack initiation in the northern and southern walls. Figure 6 below shows the distribution of the maximum tensile stresses in the building. Our Engineering interpretation indicates out of plane failure of the URM walls as the main mode of failure with some localised areas of shear failure of slender/weak URM piers. Figure 6.1 at the next page shows the maximum deflected shape of the building at 45%NBS.

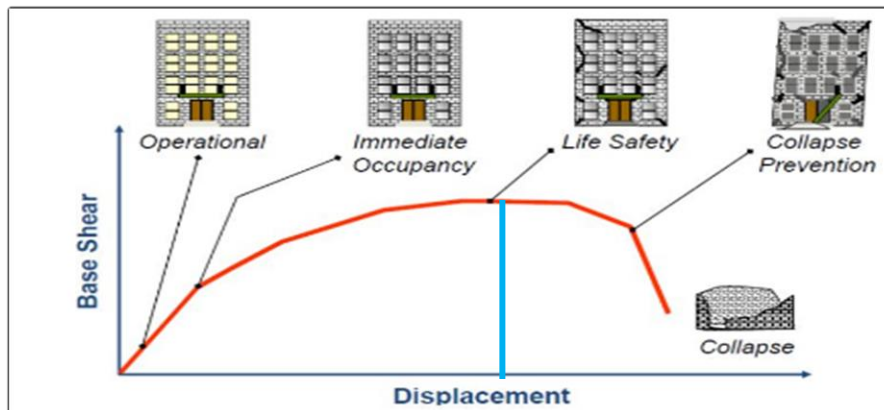
Figure 7: Force deformation diagram depicting different stages of building damage.

The performance of the 97 The Terrace Building, based on our calculations obtained from DIANA analysis at 45%NBS seismic loads, sits between the “*Immediate Occupancy*” state and the “*Life Safety*” state as shown in Figure 7. The blue line on the graph indicates the approximate location of the Building on this curve at 45%NBS loads. The global performance of the building was evaluated in accordance to the NZSEE Guidelines (2017) and the ASCE 41-17 (2017).
