The Newcastle Workers Club in retrospect - what can we still learn?

Robert E. Melchers

Centre for Infrastructure Performance and Reliability
The University of Newcastle, Australia

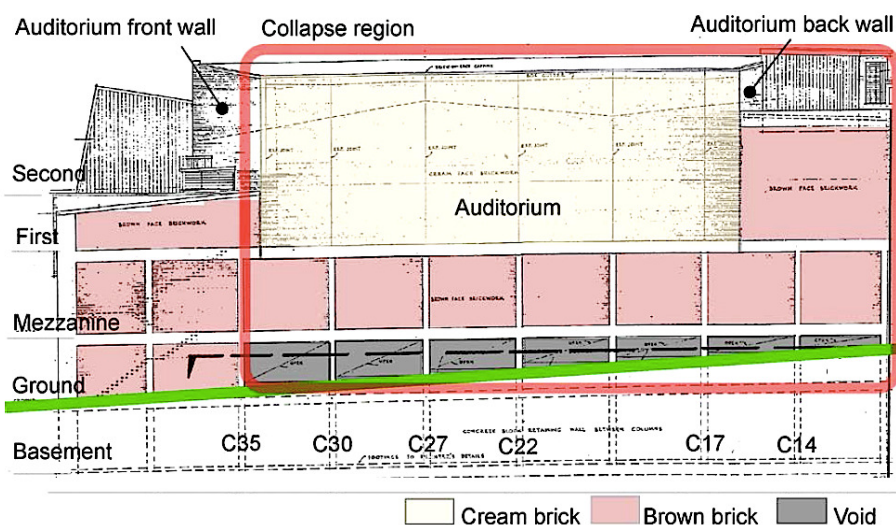
The first action on receiving the drawings and the photographs was simply one of immersing oneself in them. There were several hundred photographs, many showing very similar things, from slightly different angles and the 'trick' was to try to understand what it was one was actually looking at, and what that might mean. But if you do not know what to look for you will not see it, usually. So the photos were gone through many times as the investigation went on. Similarly, working through the drawings initially did not appear to show anything unusual, other than an early observation that the footings on the west side (the collapsed side) were different to those on the east side of the building, but were all very similar in size. The other (east) side of the building was complicated by the presence of the (older) neighbouring part of the club. That could have had an effect, but there was no visual evidence of any load transfer between the buildings. Also, it was noted that not the whole of the west side had collapsed, even though that facade appeared highly repetitive (Fig. 1).

Figure 1. Diagram of the west wall of the NWC based on design drawings, showing column and slab layout and the collapse region (redrawn from Melchers 2011).

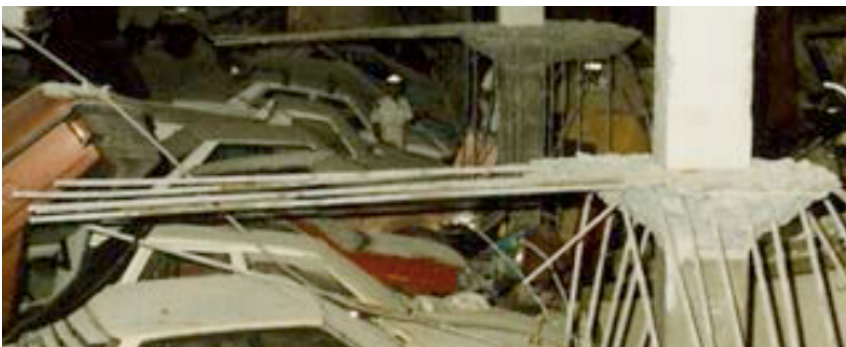
Figure 2. Reinforcement exposed at the drop panels (note column and drop panel at back).

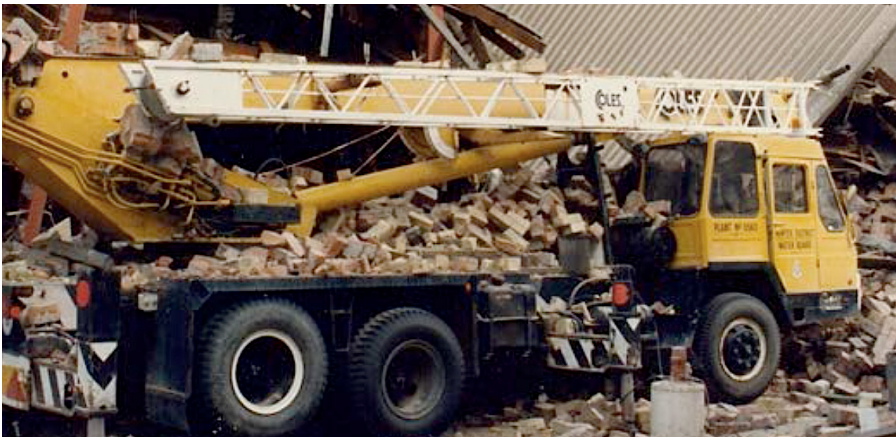
The photographs tendered in the coronial inquest showed clearly that very few bricks had fallen into the building onto the slabs from what were cavity brick infill panels. They did show many bricks in the laneway next to the west wall, with a considerable number scattered over the mobile crane that was parked there. Taken together, this is inconsistent with the notion of unsupported swaying brick walls collapsing under earthquake ground motion with the expectation that this would leave (roughly) equal numbers of bricks on each side. It also raised the question about the impact and damage that would be caused by even a single brick falling say 2-3 storeys from the upper, most swaying part of an unsupported skin of brickwork. It would be considerable. However, as noted in the report and subsequent paper (Melchers 2011), enquiries with the owners of the crane, Hunter Water Corporation (HWC), revealed that there was little damage to the crane and in particular its relatively thin steel (and therefore relatively weak) cabin roof and its windows. Their observations were supported by a close examination of the photographs of the crane (Fig. 3) The only possible conclusion was that the bricks had not fallen 2-3 storeys. That, together with the relatively large number of bricks on the crane and in the laneway indicated a different mode of failure altogether. But what?

Figure 3. Close-up view of crane showing lack of damage from bricks to cab and to cab windows (part of photo courtesy of NSW Police Service).

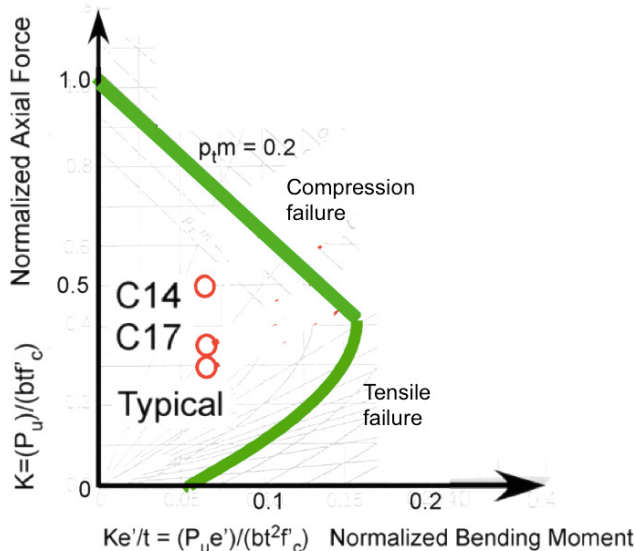
that structures should have a degree of ductility and deformation capacity as they approach ultimate capacity (Ferguson 1962). Explosive, brittle failure is not a subject uppermost in the minds of most structural engineers when they think about the structural behaviour of reinforced columns, but for the NWC, the question gradually became whether such a mode of failure was possible for the west wall columns? Could this be possible, given that the (M-P) combinations at ultimate load as estimated for these columns appeared to be well inside the capacity curve for the columns with their specified size and with the specified reinforcement (Fig. 4)?

Figure 4. Interaction diagram showing estimated M,P values for selected columns and capacity curve for typical west wall column size and reinforcement.

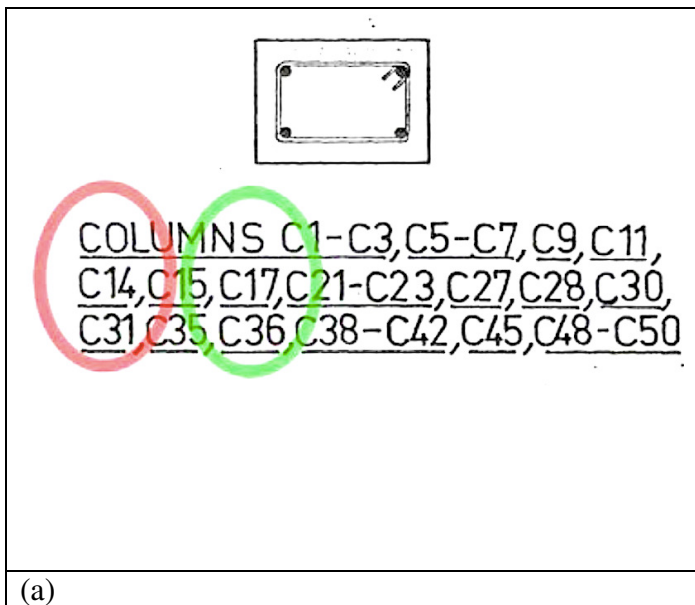
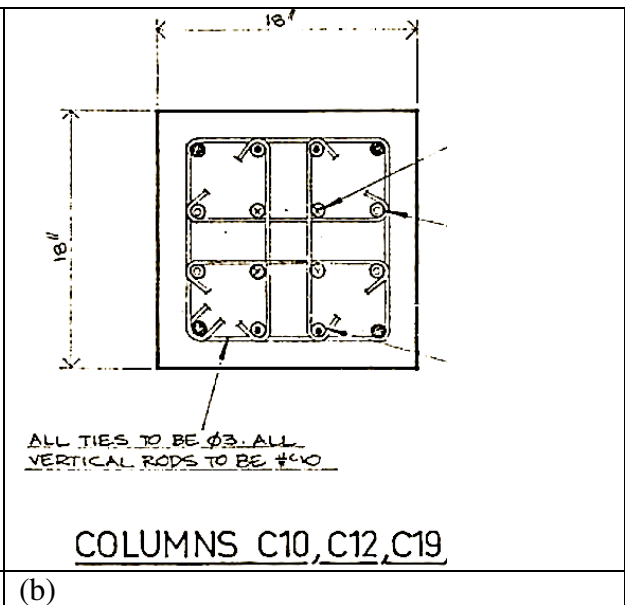
Figure 5. (a) Part of reinforcement schedule and cross-section from design drawings, (b) ditto from construction drawings, showing unclear notation (circled).

Figure 6. Cross-sections for columns on construction drawings (a) west wall columns including C14 and C17, (b) interior columns.

The column reinforcement schedule on the construction drawings for columns C14 and C17 are shown in Fig. 5b and might be compared with the details on the design drawings (Fig. 5a). On the construction drawing in question the notation for C14 is not particularly clear. Spacing of the text suggests it might have been meant to read 'C12', but it reads more like 'as C 2' - had the '1' simply been removed? Why? As noted, column C2 was one of the standard west wall columns with just 4

reinforcement bars, as also shown on the construction drawings (Fig. 5b). For column C17 it is clearly ‘as for C2’ in both cases.
