RAPID EVALUATION OF BUILDING SAFETY: LEARNINGS FROM THE DECEMBER 2007 GISBORNE EARTHQUAKE

D R Brunson¹

SUMMARY

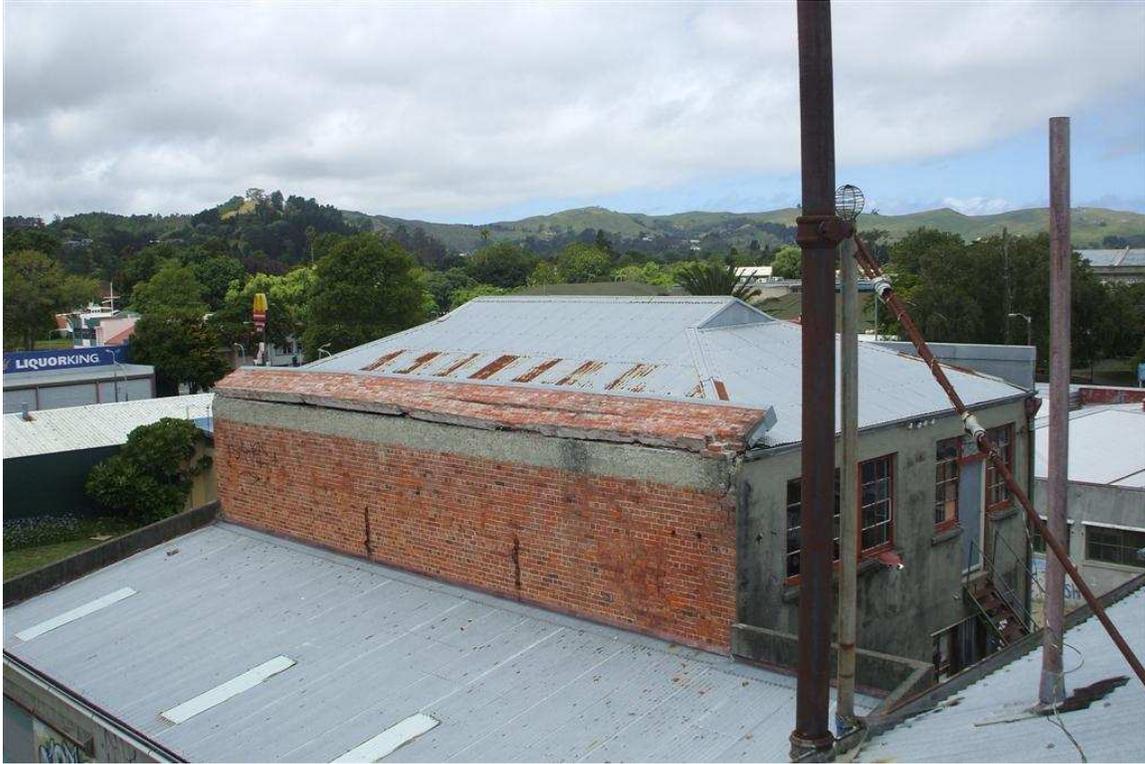
The earthquake was highly directional, being almost exactly parallel to the main street of Gisborne. This meant that unrestrained parapets and walls perpendicular to the main street experienced the greatest out-of-plane accelerations (Figure 3). A common form of damage was therefore from masonry falling from a two storey building onto (and in many cases through) the sheet metal roofing of an adjacent single storey building (Figure 4). Most of the damage in the CBD was directly attributable to damaged or failing parapets.

Figure 3: Indication of common mode of parapet failure parallel to the main street (noting unaffected roof below)

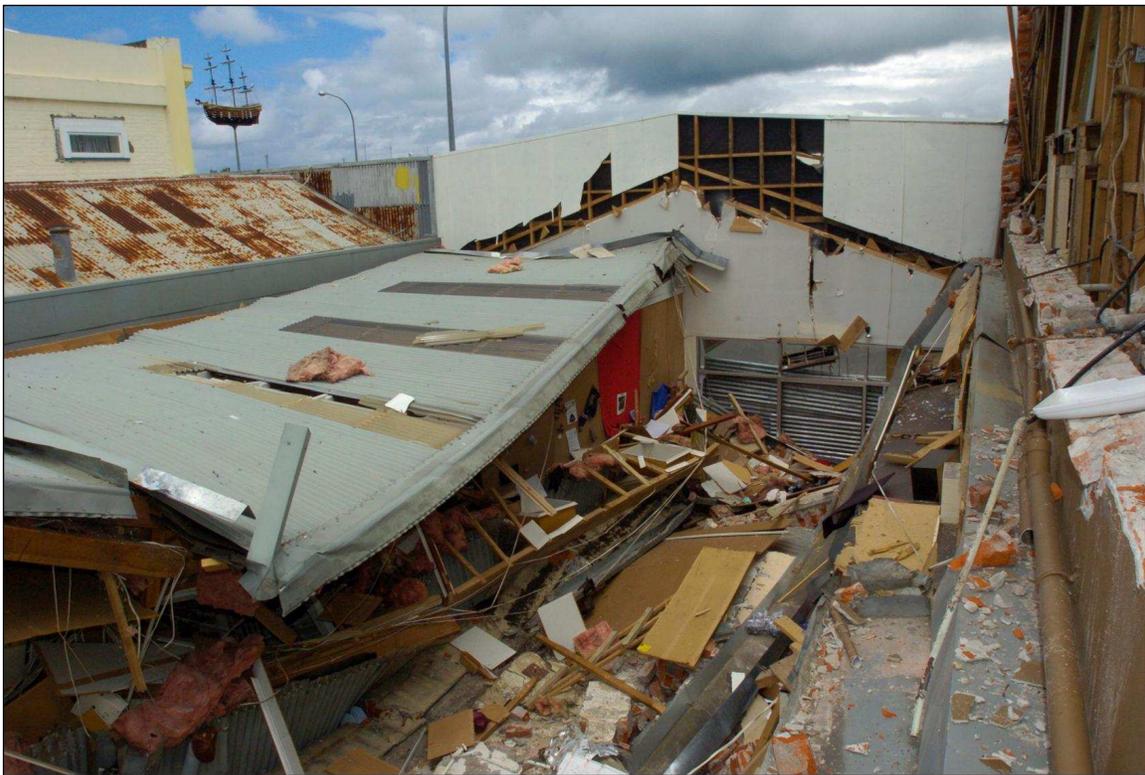
Figure 4: Damage to single-storey building from failure of upper level wall and parapet from neighbouring building at right (Photo from Gisborne Herald)
