Bridge performance during the 2010/2011 Canterbury Earthquakes

Rolando P. Orense¹⁾, Tam J. Larkin²⁾ and Nawawi Chouw³⁾

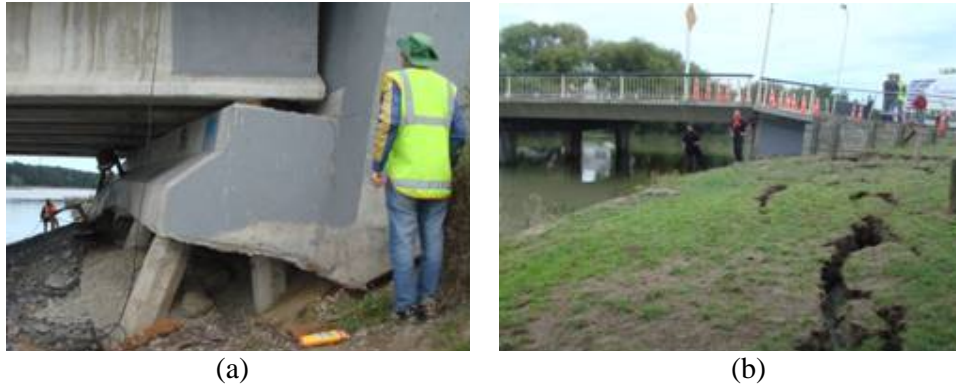
The Bridge Street bridge, which was damaged during the 2010 earthquake, was damaged again in 2011 due to liquefaction. Cracks were observed on the bridge approach while the western pier tilted, again due to liquefaction-induced lateral spreading (Fig 6a). A similar phenomenon was noted in the vicinity of the Avondale Road bridge, with large ground cracks observed along the banks of the river, (Fig 6b).

Figure 6: Typical damage to road bridges outside the CBD during the 2010 Darfield Earthquake: (a) Bridge Street bridge; and (b) Avondale Road bridge

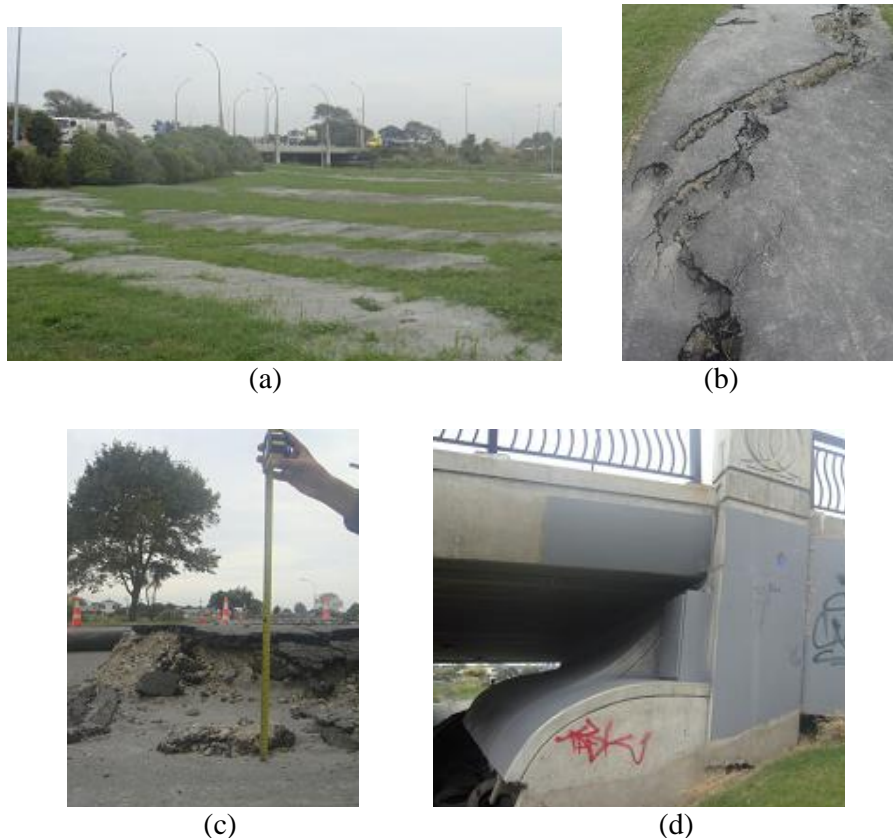
Figure 7 shows the consequence of soil liquefaction on the ANZAC bridge and its surroundings due to the 2011 Christchurch earthquake. The extensive sand boil in the surroundings (Figure 7a), the fissures along the walkway beneath the bridge (Figure 7b)

and the large relative permanent ground settlement, e.g. more than 20 cm (Figure 7c), clearly indicate the soil effect on the bridge site. The damage to the abutment is displayed in Figure 7(d). The rotation of the abutment due to the lateral movement of the ground surface caused pounding-induced damage between the abutment and the bridge superstructure.

Figure 7: Damage to the ANZAC bridge and surroundings due to the 2011 Christchurch Earthquake: (a) sand boils on local site; (b) damage to walkway beneath the bridge; (c) relative ground movement around a manhole next to the bridge; and (d) damage to bridge abutment.
