Pounding behaviour of adjacent structures in the 2011 Christchurch Earthquake

Nawawi Chow¹⁾ and Hong Hao²⁾

Abstract

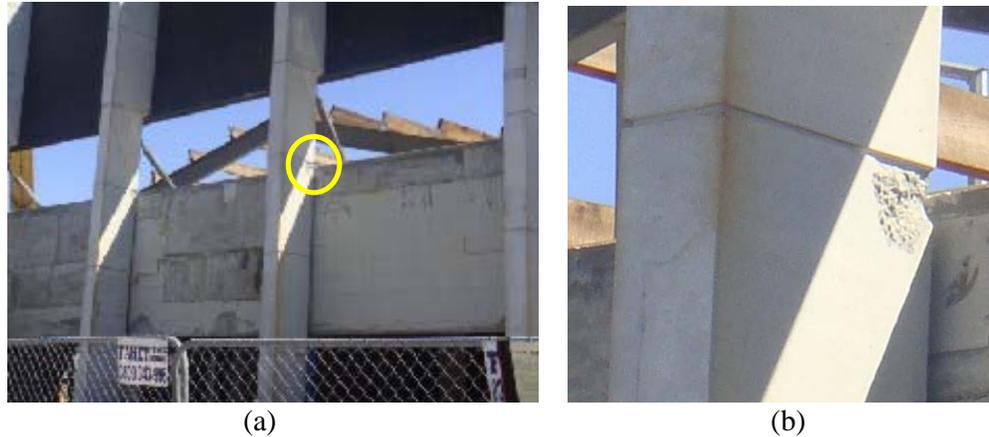
Damage due to relative movements between the structural components can be clearly seen from Figure 2. The building along Lichfield Street was under construction when the earthquake struck. All the columns pound with the floor and separate again. The pounding damage to the column indicated by a circle in Figure 2(a) can be seen in Figure 2(b).

Figure 2: Damage due to relative movement between columns and floor in the CBD.
(a) Overview and (b) pounding location.

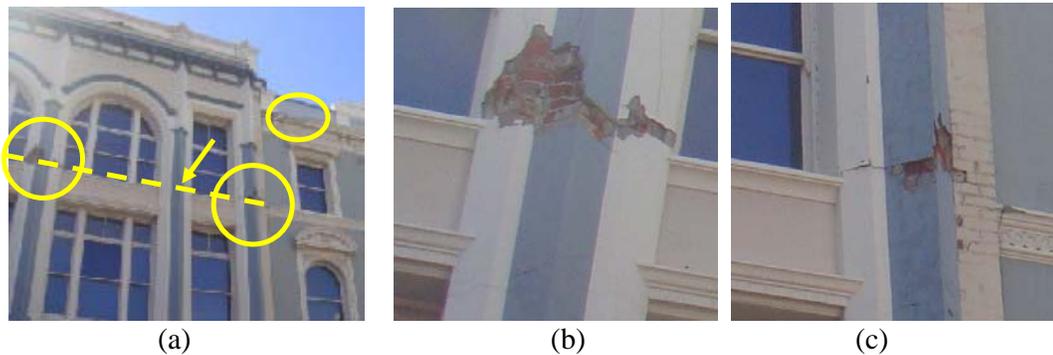
Figure 3 shows the pounding induced damage mainly to the left building. Because of the larger openings damage occurred to all lower sections between the openings, where not all windows are displayed in the figure. However, those close to the pounding walls can be seen in Figure 3(a). Apparently, the right and stiffer building experienced less damage. The visible damage above the top window of the right building is indicated by the top right circle. Figures 3(b) and 3(c) show the damage at the locations indicated by the left and middle circles. At the location indicated by the arrow in Figure 3(a) damage is also observed even though it is not so easy to see. These observations show that a number of large openings can cause a cut-off of the entire upper structure indicated by the dash line.

Figure 3: Pounding induced damage to locations between large openings in the CBD.
(a) Adjacent buildings, (b) detailed view of the left and (c) right damage locations.

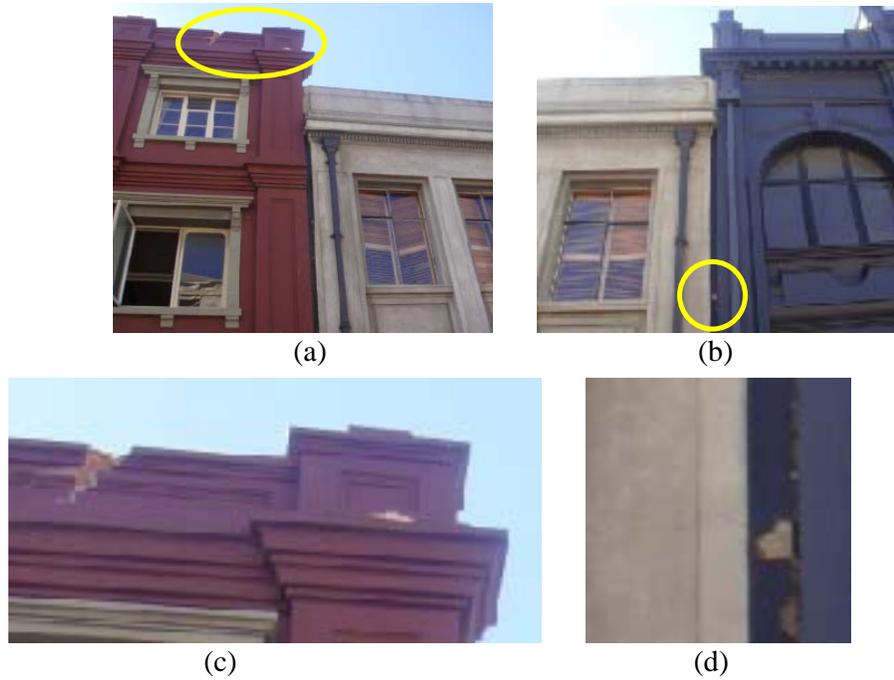
Figures 4(a) and 4(b) show pounding between three adjacent buildings in the CBD. The middle building is slightly shorter than both adjacent buildings. From the external inspection no damage to the middle building was observed. In contrast, the left building has a visible damage to the parapet and the top edge column (Figure 4(c)). The right adjacent building also suffered damage at the floor level (Figure 4(d)) as indicated by the circle in Figure 4(b).

Figure 4: Pounding induced damage to adjacent buildings in the CBD.
(a) and (b) Adjacent buildings, damage (c) to parapet and (d) at the adjacent walls.

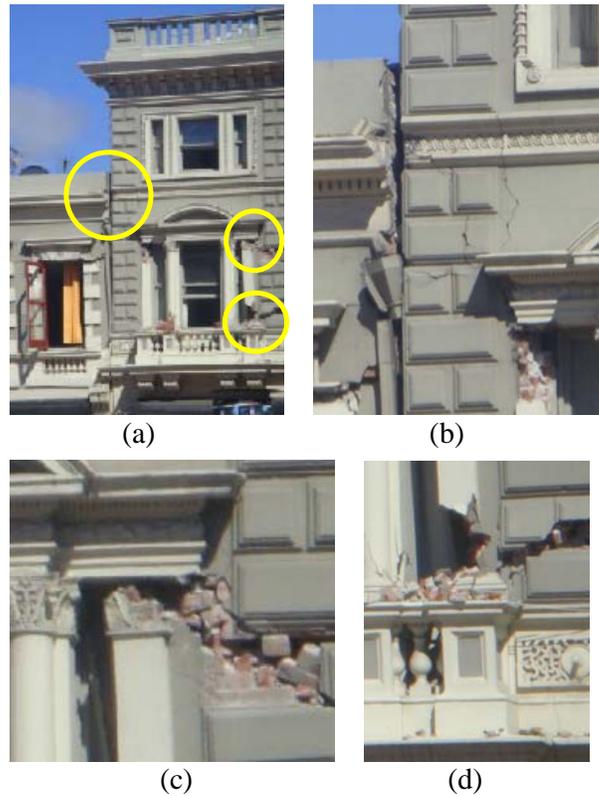
Similar observation has been made on the pounding behaviour between the adjacent buildings in Figure 5. There was practically no gap between them. Severe damage to the taller right building can be seen along the stress path about 45 degree from the pounding location toward the lower corner of the opening indicated respectively by the large circle and the lower small circle in Figure 5(a). Pounding caused a residual opening at the interface between the buildings. Damage to both buildings at the pounding location and the vicinity of the top corner of the right window can be seen in Figure 5(b). Figures 5(c) and 5(d) display the pounding induced damage to the top and lower right corners of the window of the right building. This observation shows that a consideration of wave propagation in the analysis of pounding-induced damage to the whole participating buildings might be significant.

Figure 5: Pounding induced damage to adjacent buildings in the CBD.
(a) Adjacent buildings, (b) damage at the pounding location, (c) induced damage at the top and (d) at the right corner of the right window.

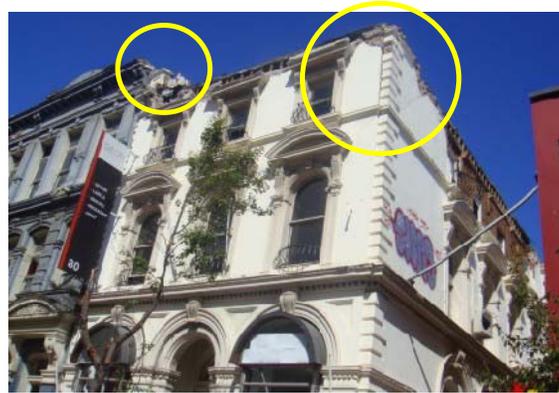
Figure 6: Pounding induced damage to end building.
(a) Adjacent buildings, (b) damage to parapet and (c) damage to end wall.

Figure 6 shows the damage to one of the many end buildings in the CBD. The severe impact caused the loss of the entire parapet of the right building. Figure 6(b) displays the damage at the pounding location as indicated by the small circle in Figure 6(a). The induced propagating waves must be so strong that the end wall was almost pushed away (see large circle in Figure 6(a) and the developed large crack at the interface between the perpendicular walls and in the end wall in Figure 6(c)).

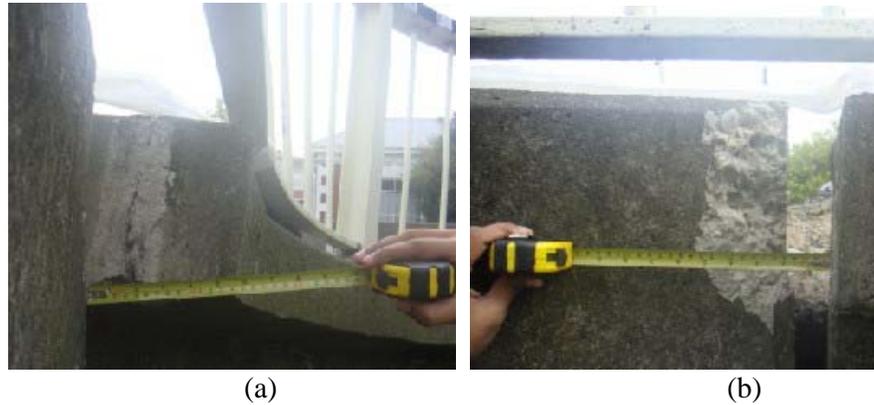
The February earthquake caused damage to many bridges in the Canterbury region. Most of the damage was related to the lateral spreading and settlements of the ground surface due to strong soil liquefaction. The unequal movements of the ground at abutments, bridge approach and intermediate supports induced significant relative movements between the adjacent bridge structures. Figures 7(a) and 7(b) show the damage due to lateral and longitudinal relative movements between the segments of the Fitzgerald Avenue Bridge over Avon River just outside of the Christchurch City centre. At both locations more than 5 cm residual relative movements were observed. Pounding damage due to the closing relative movement can be seen in Figure 7(b).

Figure 7: Relative movement induced damage to the Fitzgerald Avenue Bridge. (a) Lateral relative movement and (b) opening longitudinal relative movement.

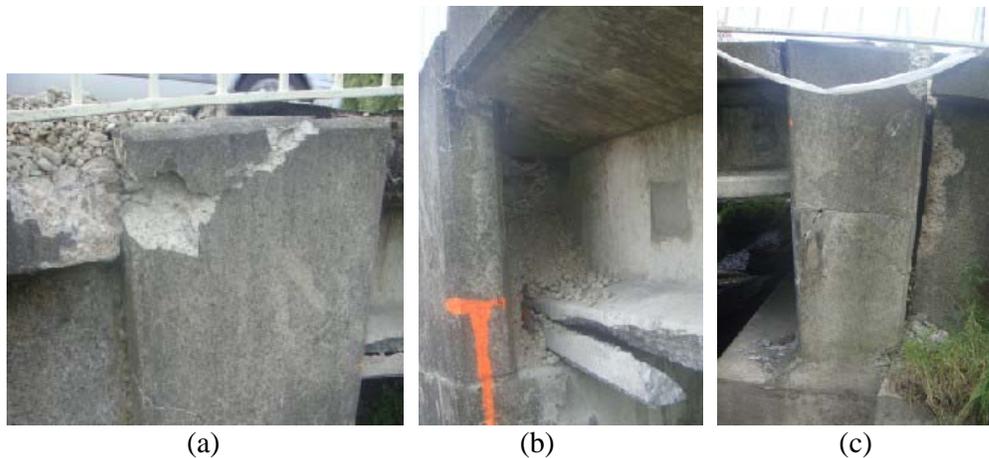
Figure 8: Pounding-induced damage to the Fitzgerald Avenue Bridge. Damage (a) at the abutment, (b) to the girder and (c) to the other abutment.

Damage due to pounding can also be observed at the abutments (Figures 8(a) and 8(c)) and at the bridge girder (Figure 8(b)). Especially, at the right abutment damage occurred along the entire height of the abutment wall. A few other pounding damage cases to bridges were also observed, which are not shown here owing to page limit. As one can notice in this event, pounding only caused minor to moderate damage to bridge structures, unlike in some other earthquakes such as the 1999 ChiChi earthquake in Taiwan and the 2010 Maule earthquake in Chile that pounding pushed the bridge deck off the pier and resulted in the bridge collapse.
