Retaining wall performance during the February 2011 Christchurch Earthquake

James N. Dismuke
Senior Geotechnical Engineer
Arup
Sydney, New South Wales
Email: james.dismuke@arup.com

ABSTRACT

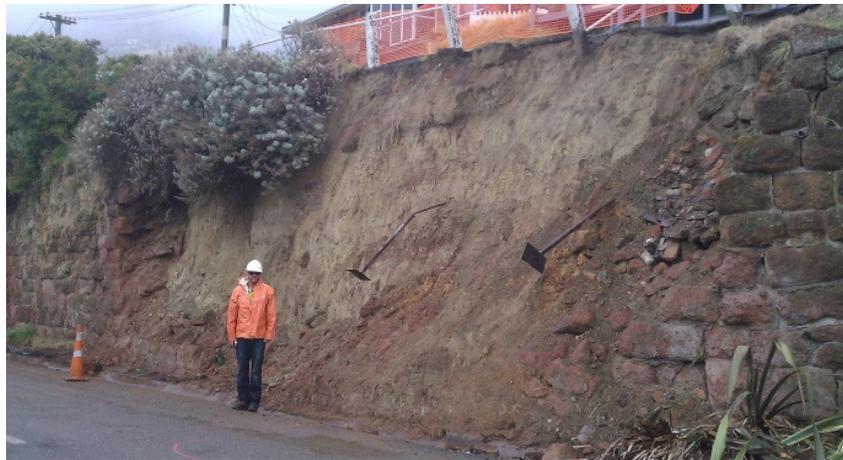
Interest in retaining walls was prompted by the observation of an anchored rock wall in Lyttelton. The wall was observed to be completely destroyed by the earthquake, but the supported native loess slope remained standing at a nearly vertical inclination (Figure 2). Additionally, an adjacent concrete crib wall was observed to be generally unharmed by the earthquake, which provided an interesting juxtaposition with the rock wall and loess slope. In response to the observation in Lyttelton, a performance survey of retaining walls was conducted, the results of which are discussed in this paper.

Figure 2: Collapsed Rock Wall and Free Standing Loess Slope in Lyttelton

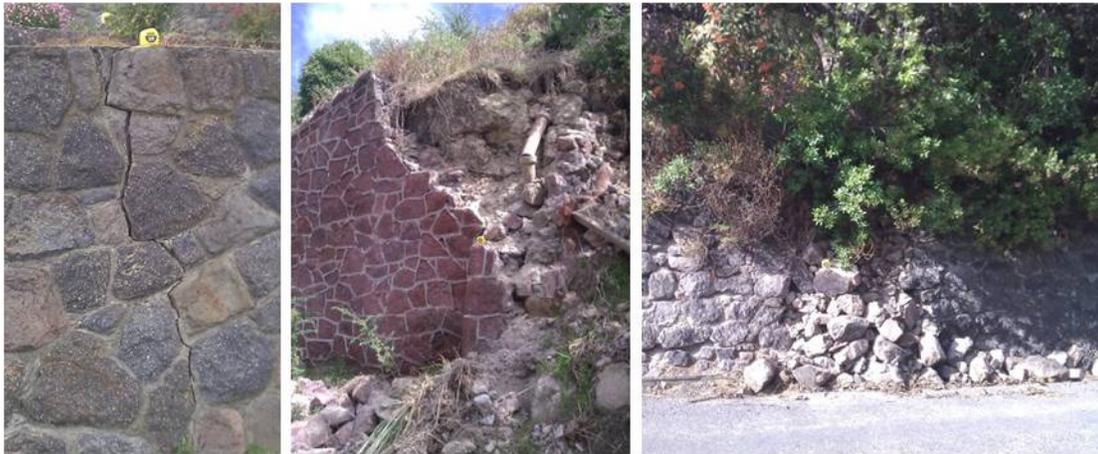
Rock walls were the most common type of wall observed. They were either dry or grouted and were used generally for gardens or as decoration. Dry stone walls were commonly 1m or less in height and nearly all were toppled by the earthquake. Grouted rock walls were observed to be greater height than dry rock walls, with the maximum height observed estimated to be about 6m; however, the majority of grouted rock walls were between 1 and 2m in height. Grouted rock walls were nearly all damaged; they were either cracked through the grout, experienced loss of stones, or completely collapsed. Figure 4 shows examples of rock wall performance.

Figure 4: Rock Walls (a) cracks along grout; (b) structural collapse; and (c) toppled dry rock wall

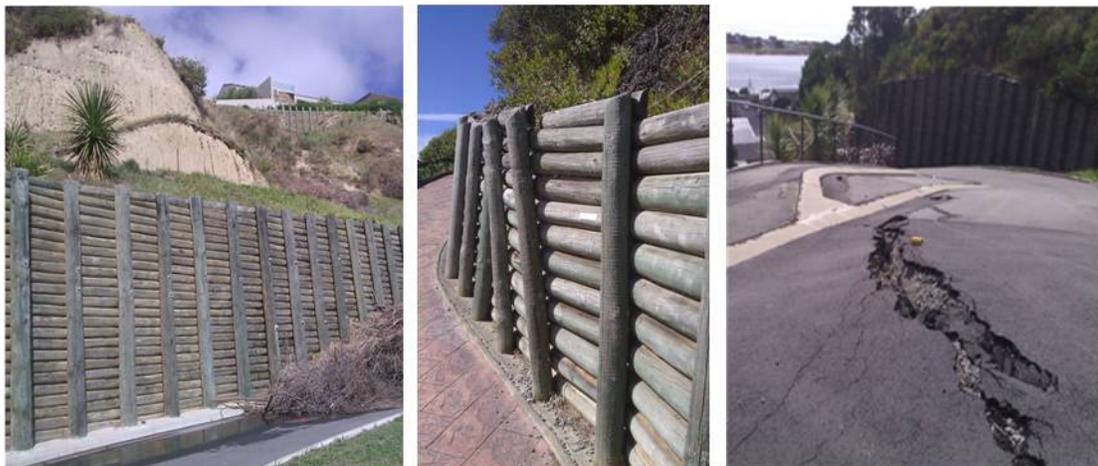
Timber pole walls were also commonly observed, though less frequently than rock walls. Timber pole walls provided a variety of uses, but were regularly observed protecting road reserve. Timber pole walls were frequently on the order of 2m or more in height comprising poles between 175 and 225 mm small end diameter with pole spacing of 0.9 to 1.2m. Taller walls were also anchored. Structurally, timber pole walls performed well. Most timber pole walls experienced rotation and settlement of drainage material, but were rarely observed to collapse. Figure 5 shows an example of timber pole wall performance.

Figure 5: Timber pole walls (a) good performing timber pole wall with unsupported loess slope; (b) rotated timber poles; and (c) settlement of fill behind timber pole wall

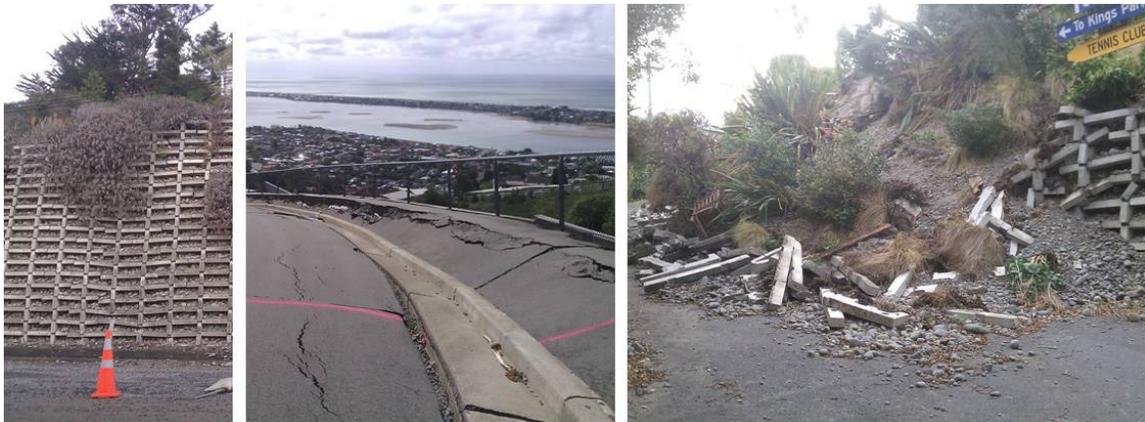
Crib walls were initially thought to be a common wall type in Christchurch because the March 2011 survey was conducted from the roadway, where most crib walls are located. After further observations, crib walls, both timber and concrete, were found to be uncommon compared to other wall types because they were not typically used within the properties. The crib walls observed were generally tall, on the order of 2 to 4m. Nearly all crib walls were broken and contained displaced cribs. Many had collapsed. Settlement of fill behind crib walls was also a common feature. Figure 6 shows some examples of crib wall damage.

Figure 6: Crib walls with (a) displaced and settled concrete cribs; (b) settlement of fill behind timber crib wall; and (c) collapse of concrete crib wall
