Seismic Performance of Masonry Buildings in the Christchurch Earthquakes 2010-2011: A Progress Report

Lisa M. Moon¹, Dmytro Dizhur², Jason M. Ingham³ & Michael C. Griffith⁴

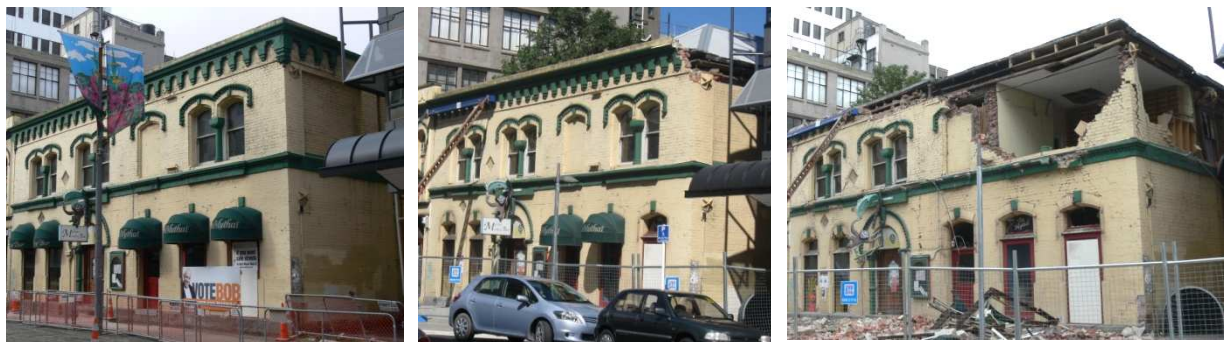
Figure 3 - Progression of damage from September 2010 until February 2011

Engineers from the Universities of Auckland and Adelaide spent time in Christchurch studying the damage to URM buildings following the 4 September 2010 earthquake, and this has been reported by Dizhur et al (2010), Griffith et al (2010) and Ingham & Griffith (2011a). This meant that not only were the team familiar with the Christchurch URM building stock but that they also had a record of damage to these buildings from before the 22 February earthquake and could therefore better understand what additional damage was caused by the February earthquake. Figure 3 shows an example of progressive damage to a URM building in Christchurch. Figure 3 (a) shows the building fenced off after the 2010 Darfield earthquake; Figure 3 (b) shows the same building five months later with part of the parapet fallen and the front wall braced on the left; and Figure 3 (c), taken four days after the 22 February earthquake and six days after Figure 3 (b), shows the loss of the front parapet and out-of-plane failures of upper walls.

a) 1 October 2010

b) 20 February 2011

c) 26 February 2011

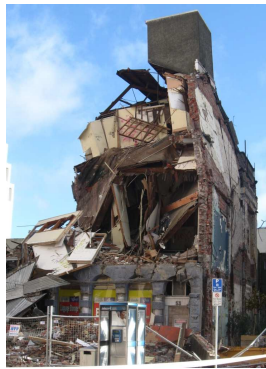
a) Unretrofitted URM building

Figure 4 - Typical URM building (a) and URM building retrofit (b) in Christchurch CBD following 22nd February 2011 earthquake

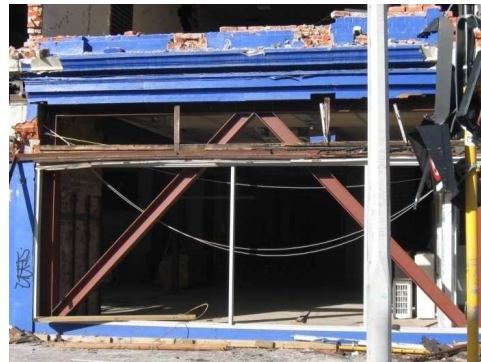
b) URM building with visible retrofit

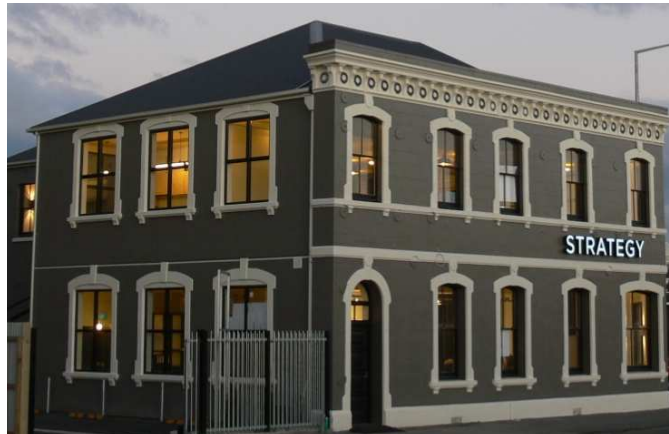
It is likely the team will have the opportunity to return to Christchurch to collect further information on retrofits previously made to URM buildings. This information, together with the database of damage and the data already collected on seismic retrofits, will enable further evaluation of the performance of all types of seismic retrofits. This will enable the team to assess the effectiveness of all URM building retrofits and where deficiencies are found suggest improvements. Figure 7 shows a successfully retrofitted Christchurch masonry building in May 2011.

Figure 7 - Successfully retrofitted Christchurch URM building (May 2011)
