Unsolved engineering problems after 2011 gigantic earthquake in Japan

ABSTRACT: The gigantic earthquake of magnitude=9 in 2011 in Japan caused many unexpected problems in the community. The significant number of problems over a vast area interacted with one another and made the situation much worse. Nuclear issues have developed to political problems and are difficult to solve in a short time. In addition, engineering is encountering such problems as mitigation of the risk caused by the next tsunami attack, protection of people's houses from subsoil liquefaction, and the preparedness for very rare seismic events in future. The balance between life safety and continuation of economic activities is the key issue but the decision is often affected by political and emotional issues. Because of the speakers majoring field, the talk will put emphasis on geotechnical issues. Note that this report is a minor modification of one of the author's recent papers that were published, first, during the Indian Geotechnical Conference (2011) and, second, in an electronic issue of the Indian Geotechnical Journal

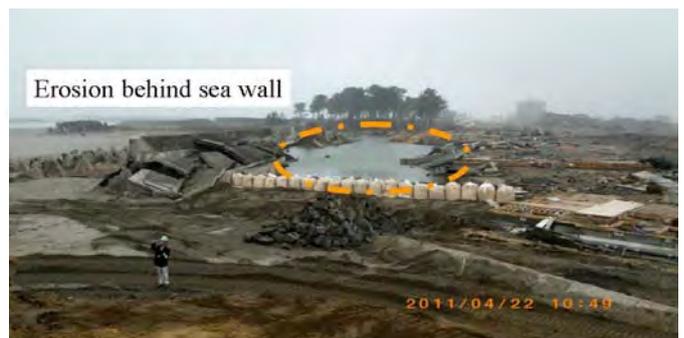
Figure 5 demonstrates a damaged shape of a sea wall. The overtopping of tsunami water significantly eroded the ground behind the wall and this loss of soil there probably reduced the lateral resistance of the sea wall (passive earth pressure). Consequently, walls were translated toward the land, and, when the second and the following tsunamis came, there was no protection any more. Note that tsunami came 4 times.

Fig. 5 Destroyed shape of sea wall (near the mouth of Abukuma River to the south of Sendai City)

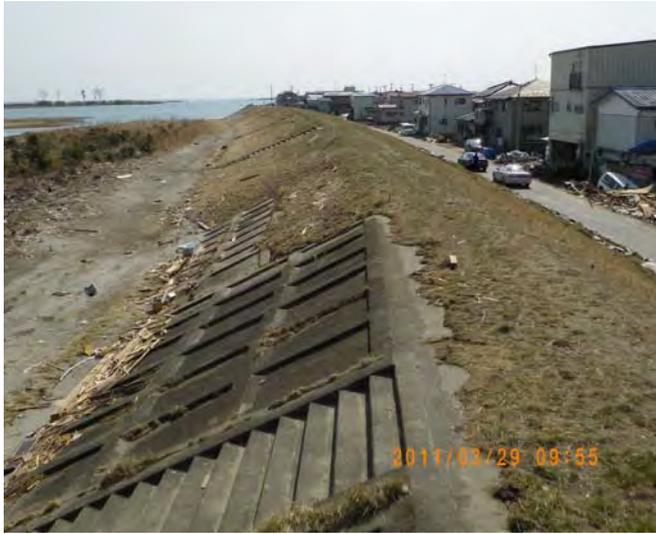
In contrast, many river levees survived the attack of tsunami that propagated upstream through river channels (Fig. 6). This good performance is interpreted either as the tsunami propagated not normal but parallel to the levees or as the ground behind the levees had already been inundated by tsunami water that directly invaded from the coast line and protected ground from eroding impact of overtopping water. Conversely, Fig. 7 illustrates a damaged levee of Kitakami River to the east of Sendai where the channel bent and allowed tsunami to directly hit the levee.

Fig. 6 River levee that survived tsunami in spite of overtopping (Natori River at Yuriage)

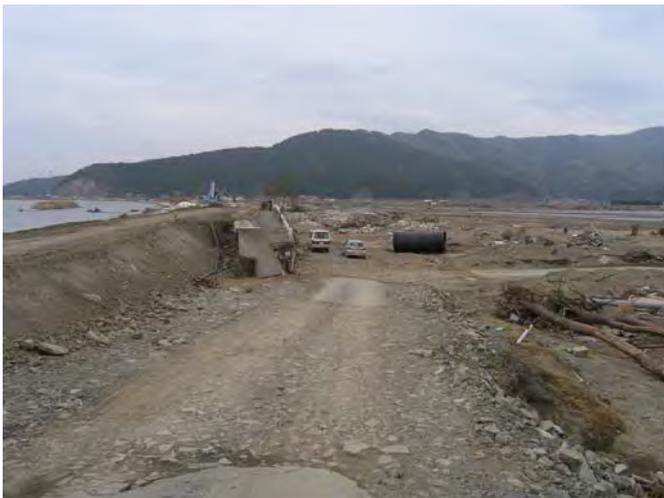
Fig. 7 Damage of Kitakami River levee that was directly hit by tsunami

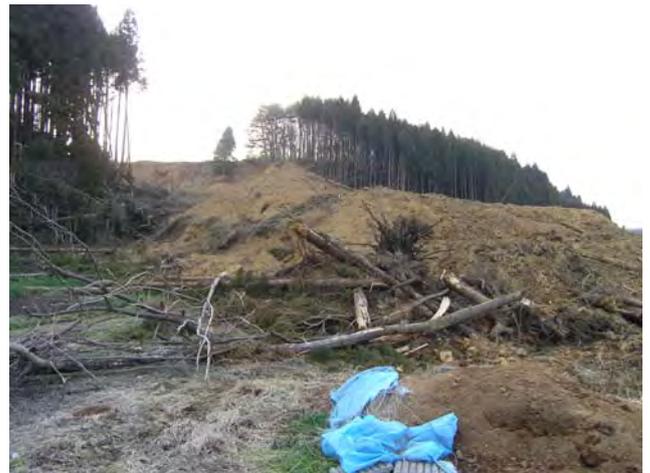
Fig. 8 Failure of natural slope in Shirakawa City

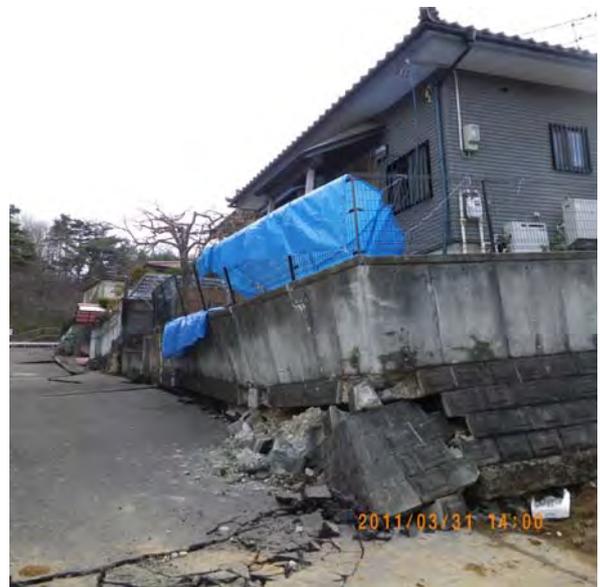
More damaging slope problems, although the size was smaller, occurred in artificial earth fills in hill areas. The residential development in Sendai City has traditionally been conducted in hilly areas where cut-and-fill construction has been the tradition. Fig. 9 reveals a damage example. This occurred in the fill part of the area, causing significant property loss to the residents. Furthermore, Fig. 10 shows the remaining sand at the surface. This sand was an ejecta from liquefaction, because this area was constructed by filling a small water stream. The fill was submerged in water and became vulnerable to liquefaction. In contrast, the cut part of the residential area was of minor damage (Fig. 11).

Fig. 9 Damaged residential fill in Sendai

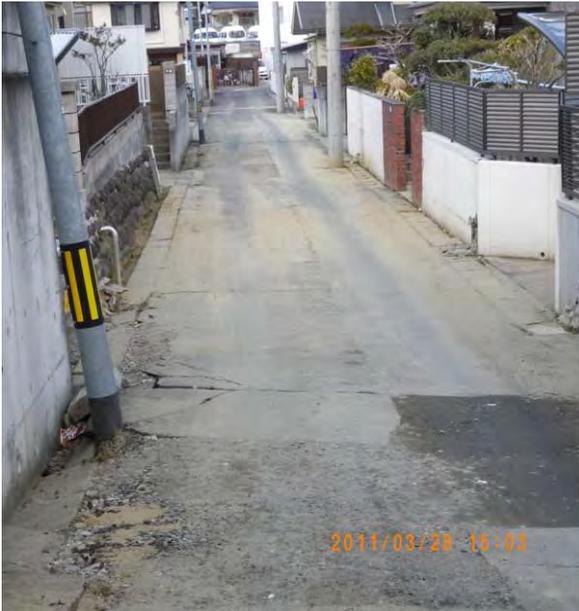
Fig. 10 Remains of liquefied sand at road surface in residential area where former water stream was filled with cut soil

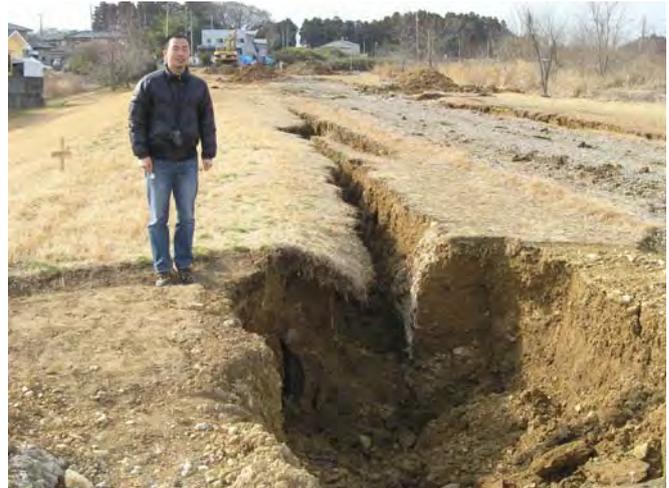
Fig. 12 Liquefaction-induced lateral spread and subsidence of Naka River levee

Many levees are situated on soft soil deposits. In particular, recent artificial change of river channels to a more straight shape resulted in new levees constructed on loose sandy deposits that are likely to liquefy. The number of damaged levees was nearly 2000, inclusive of major and minor damages. Fig. 12 illustrates a damaged shape of the Naka River levee in Mito City, about 100 km NE of Tokyo. The liquefiable sandy soil underlying this embankment caused lateral spreading and the consequent cracks in the longitudinal direction. At the same time, subsidence exceeded 1.5 m.

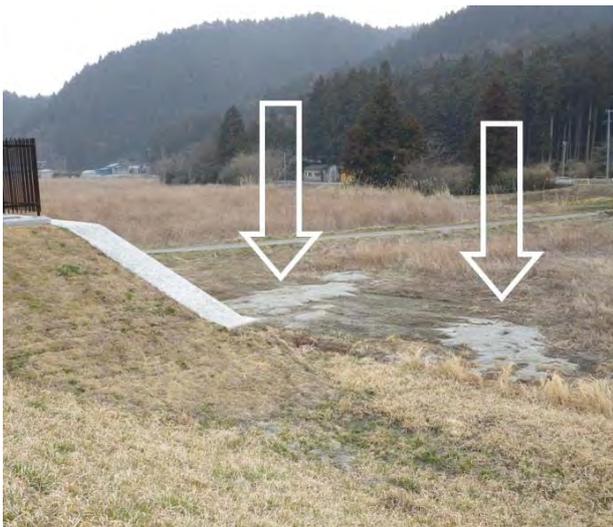
It is widely known that liquefied sand is consolidated afterwards and its density increases. Because the risk of liquefaction decreases with increase in density, people imagine that previously liquefied sites are less likely to liquefy again during future earthquakes. Unfortunately, this idea is too optimistic. The liquefaction-induced densification of sand is not sufficient; relative density increasing only 10% or less, which is far less than what soil compaction works achieve. Fig. 13 illustrates one of the examples of repeated liquefaction that took place for the 4th time since 1978. Note in this photograph that the river channel is situated to the left of the levee in the front and the area to the right is an abandoned river channel where sand is loose and water-saturated. Similarly, liquefactions were repeated in Christchurch, New Zealand, 3 times in September 2010, February, and June in 2011 [2]. Hence, initiation of the reconstruction delayed and was made very difficult.

Fig. 13 Repeated liquefaction at Kita-Wabuchi site of Eai River to the north of Sendai; sand ejecta shown by arrows

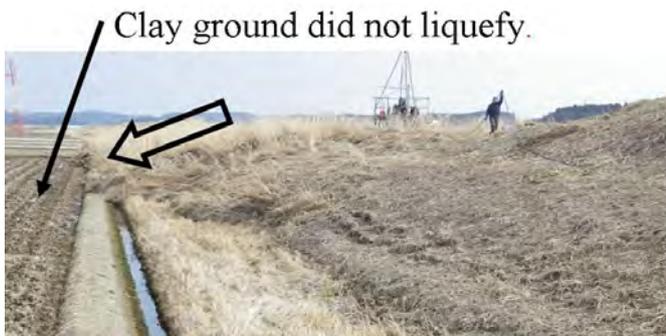
Fig. 14 Damaged levee resting on unliquefiable clayey subsoil (levee of Naruse River, north of Sendai)

A more significant and new problem is attracting a serious concern. Fig. 14 shows the distortion of a levee that rests on unliquefiable clayey deposit. The sliding of the slope surface and lateral bulging as well as the subsidence of the crest had been considered unlikely in the engineering practice when the foundation is composed of unliquefiable material. The reality is more complicated.

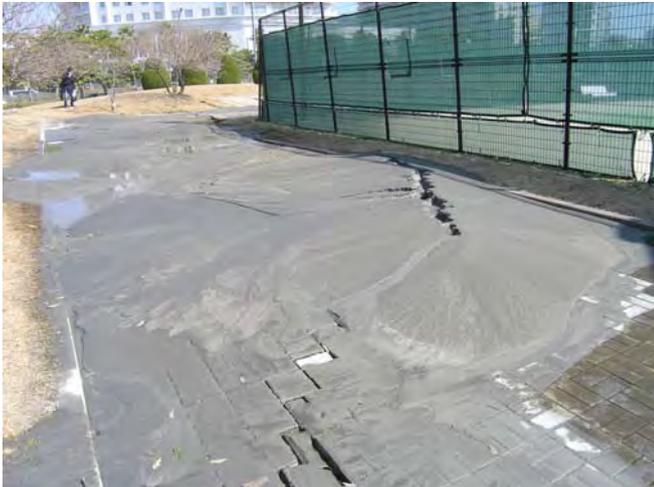
Figure 16 illustrates a site of typical liquefaction in Urayasu City (Fig. 1) to the east of Tokyo. The subsidence of ground after liquefaction is estimated to be 50 cm. The grain size distribution of sand ejecta is shown in Fig. 17. Note that the

Fig. 16 Liquefaction and sand ejection in Urayasu City

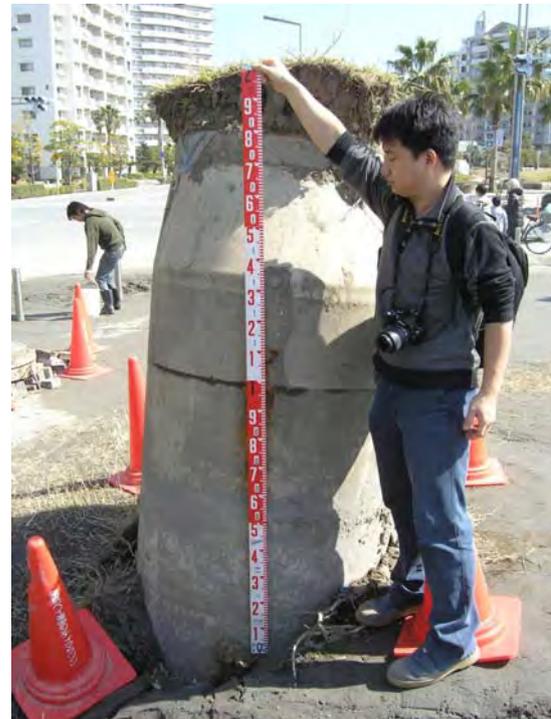
Fig. 19 2-meter floating of manhole

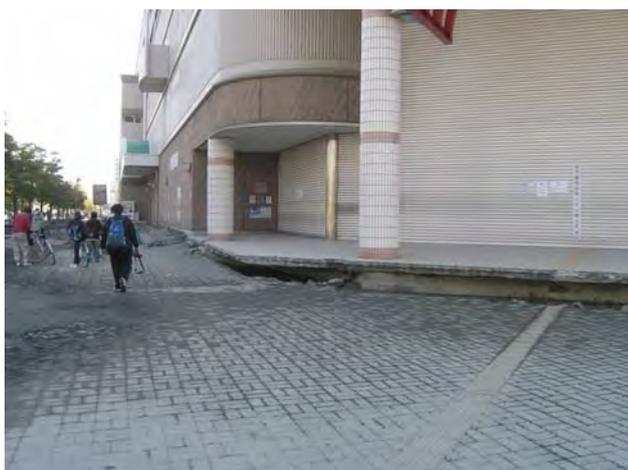
One of the countermeasures against liquefaction effects on buildings is the use of a pile foundation. Fig. 18 illustrates a successful example of pile foundation. However, note the differential settlement at the ground surface, which destroyed the connection of embedded lifelines with the building. Lifeline damage is typically shown by floating of manholes of sewage pipes (Figs. 19 and 20). Connections of sewage pipelines were destroyed by liquefaction of backfill sand.

Fig. 18 Differential settlement between surface of liquefied ground and pile-supported building

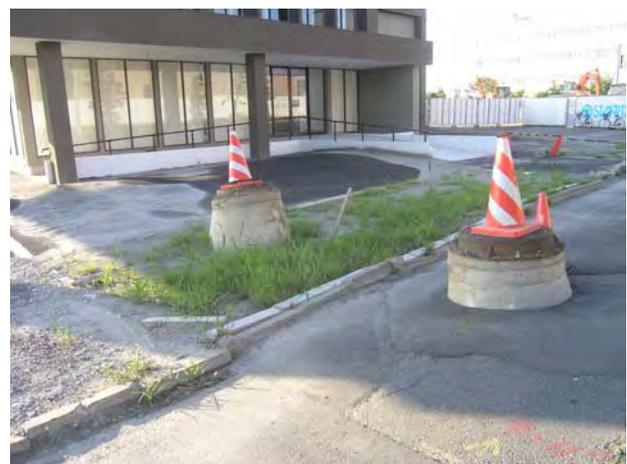
Fig. 20 Floating of a series of manholes

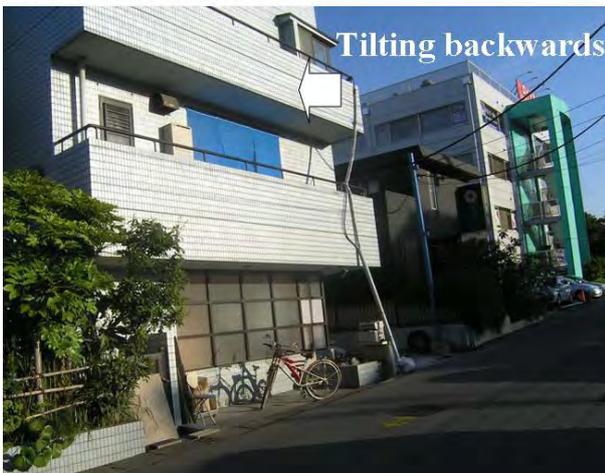
Figure 21 shows a tilted residential building. Due to lack of pile foundation in such a small structure, the subsurface liquefaction resulted in significant tilting and subsidence. Note, however, that there is no structural failure. Thus, the residual deformation and displacement are the essence of liquefaction-induced damage. Liability in such damage to

Fig. 21 Subsidence and floating of residential building

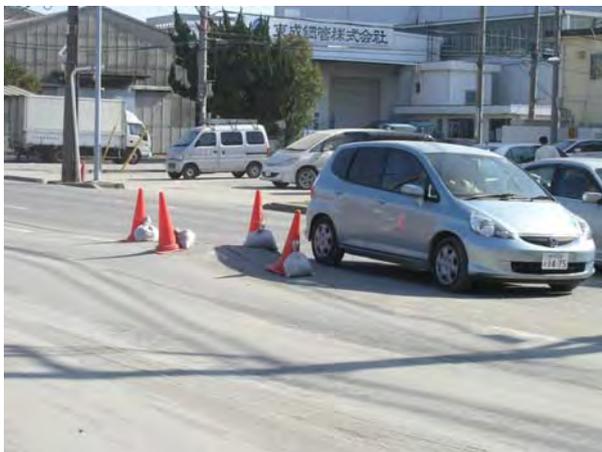
Fig. 22 Satisfactory performance of major road in Urayasu

The major roads in Urayasu City were able to maintain their function after the earthquake. Although some distortion occurred (Fig. 22), emergency vehicles were still able to travel at reasonable velocities. This good performance was achieved by special precautions during the road construction which decided to make pavement thicker than code requirements. It is noteworthy that subsurface liquefaction and the consequent volume contraction of sand under the pavement produced cavities underneath, and that the asphalt pavement started to collapse into the cavity at some places in summer when the temperature rose and the asphalt lost its mechanical strength.

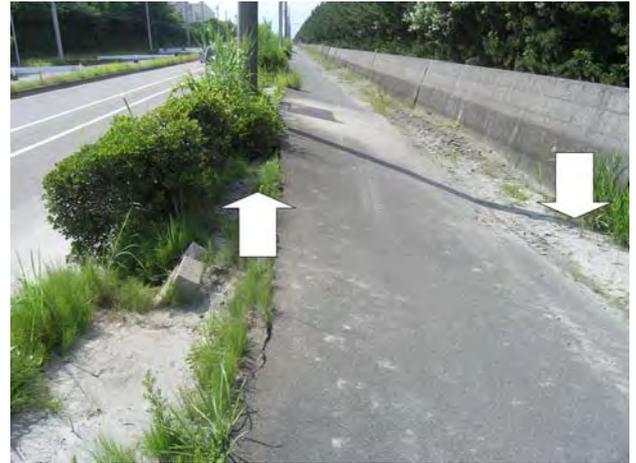
Fig. 23 Liquefaction-induced distortion of sidewalk

Another problem in the road is the heaving of sidewalk (Fig. 23). It is therefore likely that lifeline underneath, if any, is subjected to large distortion. The causative mechanism of this problem is yet to be known but the authors suppose that the subsidence of embankment and other heavy structures behind pushed the subsoil laterally and then upwards towards the sidewalk pavement that was not as rigid as that in the main road (Fig. 22). The contribution of elongated shaking together with a strong aftershock (30 min. after the main shock) requires further investigation.

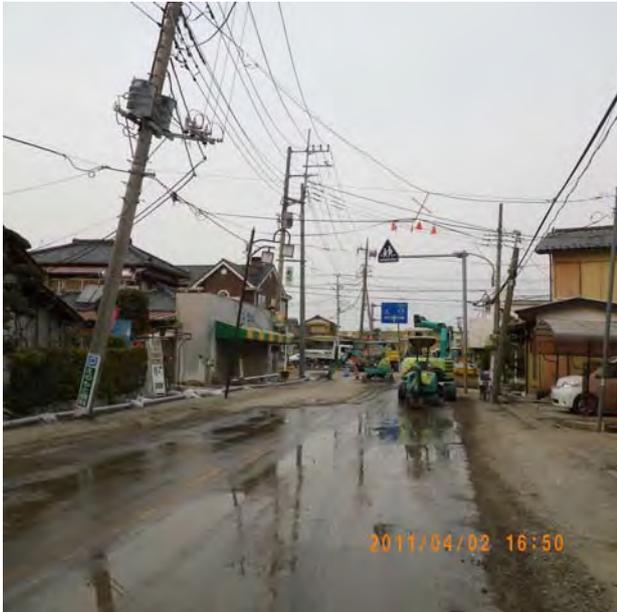
Tone River (Fig. 1) is one of the biggest rivers in Japan and there are many swamps and meandering channels along its main stream. Some of those water areas were filled with soil and formed liquefiable subsoil conditions. Fig. 27 is a liquefied site where flooding in 19th Century created a pond (Fig. 28) that was later filled with sand. The problem was that the liquefaction risk in this area was not indicated in a local hazard map probably because the lack of bore-hole investigation.

Fig. 27 Liquefaction in filled pond (Abiko City)

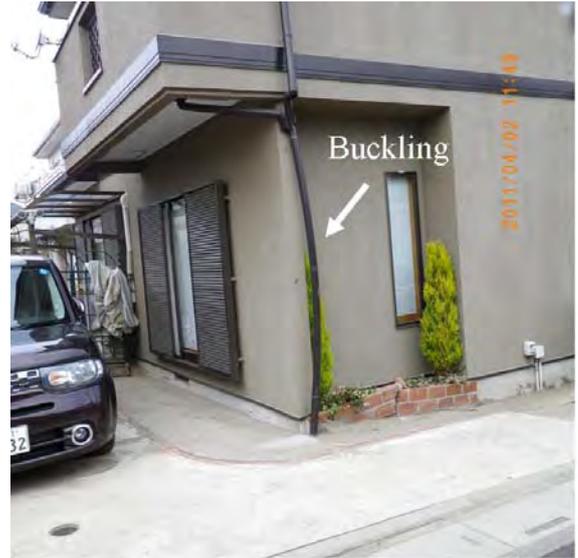
Liability problems occurred in the area of Fig. 29. This area used to be swampy with thick clayey deposit. In 1950s, the local government filled sandy soil above the surface, and this thin sandy layer was naturally saturated with water. Although the liquefaction layer was thus thin, minor tilting in houses (1% or less) has caused residents severe headache and dizziness. The point of argument is whether or not the risk of liquefaction was foreseen in 1950s prior to the 1964 Niigata earthquake and whether or not the recent caution by the local government about liquefaction risk has been sufficient.

Fig. 29 Liquefaction-induced tilting (Kazo City)
