The Behaviour of RC Frames with Masonry Infill in Wenchuan Earthquake

Alireza Mohyeddin-Kermani¹, Helen M Goldsworthy² and Emad F Gad³

Introduction

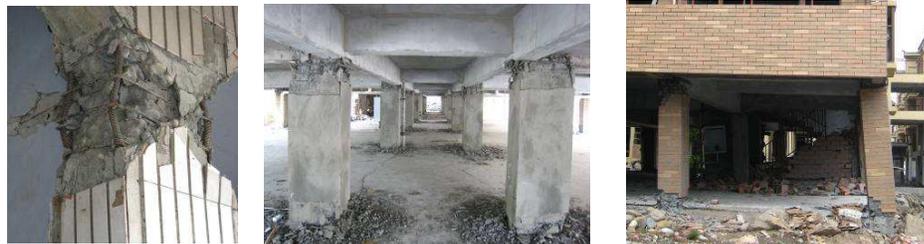
One of the most common types of damage to the mid-rise buildings was a “soft-storey” effect. Generally, soft-storey buildings experienced plastic hinges at the ends of the columns (at the soft-storey level) including buckling of the longitudinal reinforcing bars, crushing/spalling of the concrete core and cover and excessive yielding of stirrups. The masonry panels were mostly intact or lightly-damaged on other levels (Kafle et al. 2008). The soft-storey effect has been extensively studied in previous research (e.g. Rodsin et al. 2004 and Wilson et al. 2005). The damage in the buildings with a bare frame at one (first) storey and infill-frames at other (upper) storeys concentrates mainly at the storey where the frame is not filled (strengthened) with infill panels. This potential soft-storey mechanism needs to be recognised in the design to ensure that it cannot occur. Some examples of plastic hinges in soft-storey buildings are shown in Figure 2.

Figure 2: Examples of plastic hinges at the level of soft-storey in Dujiangyan

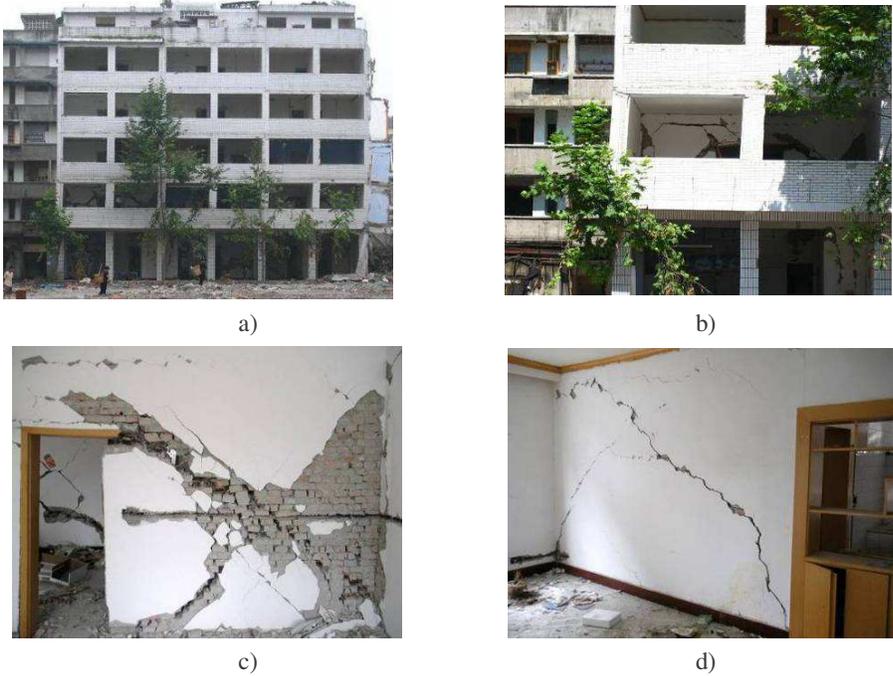
Figure 3 shows an example of a building with a soft storey at the second storey. This building is an example of an RC frame with infill panels at the first storey and RC ties with infill panels at upper storeys. Since the arrangement of the infill panels is similar at all storeys, the second storey (with RC ties) will be weaker than the first storey (with RC frame). Figure 3c shows the x-pattern crack in the masonry infill at the soft storey level which resulted in separation between the masonry units and mortar and crushing of the masonry material (the horizontal crack is not caused by the earthquake; electric cables, considered as valuable materials, were pulled out after the earthquake). Figure 3d shows diagonal cracks in the infill panel at the third storey (above the soft-storey) along the soft-storey direction. The damage at this level is substantially less than that of the soft-storey.

Figure 3: An example of a soft-story building in Dujiangyan.

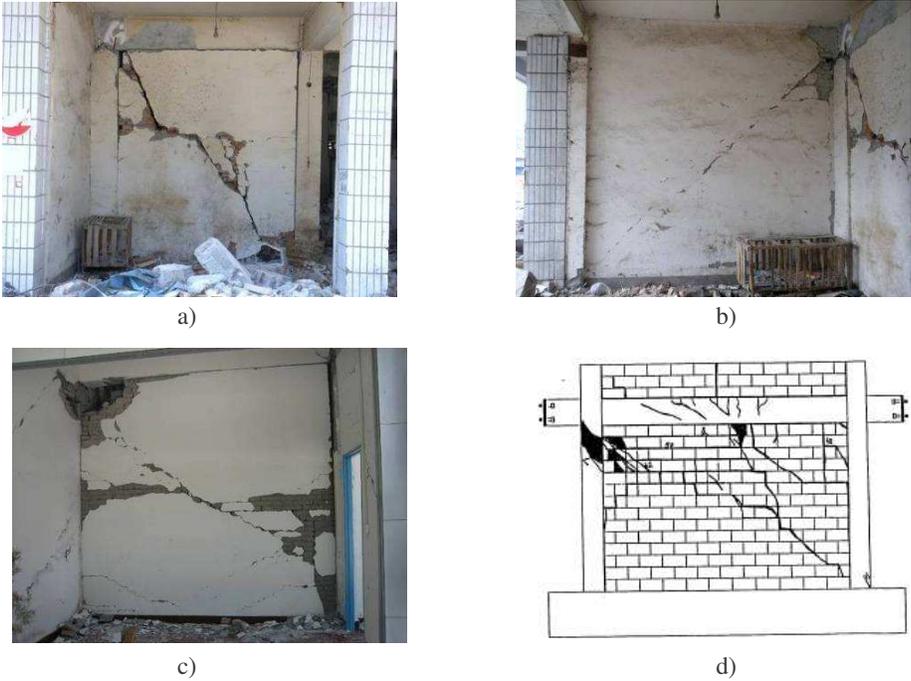
Figures 4a and 4b show two perpendicular infill panels at the ground level of a building with an RC frame. In both cases the infill experienced tension (diagonal) cracks and masonry crushing at upper corner. The column at the corner detached from the beam as

the result of insufficient reinforcement overlap. Figure 4c shows another infill panel with the same mode of failure where the masonry crushing at the corner is more severe. In Figures 4a and 4c the separation between the infill panel and frame can be observed indicating the relative residual displacements between the infill and frame.

Figure 4: Different failure patterns in masonry infill panels in Dujiangyan.

It is to be noted that in the case of Figure 4a, where the panel is in the direction of the strong component of the earthquake, the diagonal crack spread through both the mortar

and bricks accompanied by the bed-joint crack in the mid-height, whereas in Figure 4b the diagonal crack was mainly in the plaster. The patterns of failure shown in Figures 4a and 4c are similar to what was observed by Mehrabi (1994) when a non-ductile (weak) RC frame with solid masonry units was tested (Figure 4d). Figure 5 shows how the structural behaviour of a bare frame is different from an infill-frame. The corner crushing of the masonry shows that the strut action completely developed in the infill-frame and the compressive stress in the masonry exceeded the ultimate strength of the material. The strut action in the infill-frame has been extensively studied (e.g. Mehrabi 1994, Crisafulli et al. 2000 and FEMA 306).

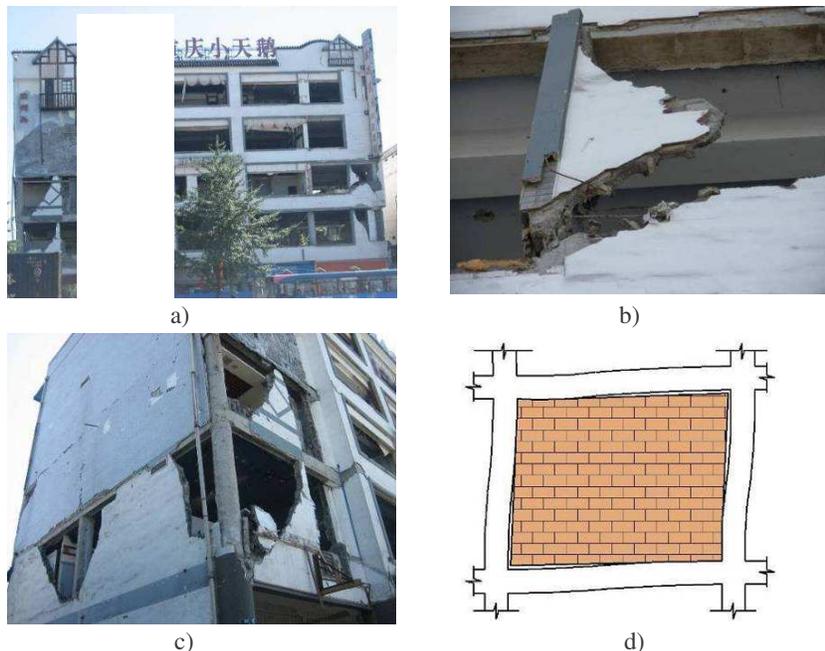
Another example of a damaged RC structure with masonry infill is shown in Figure 6. The x-pattern (tensile) cracking of the masonry resulted in shear cracks in the top and bottom of the column as can be seen in Figure 6b. The collapse of the masonry infill is due to a combination of out-of-plane instability and in-plane degradation. It can be seen in panels along two perpendicular directions. Some other cases of out-of-plane failure of infill panels were observed. In addition to the one shown in Figure 6c, two other examples of such failures are shown in Figures 7a and 8. In all these cases the beams have long spans and there is not sufficient contact between the frame and infill to develop the arching effect in the infill which is important in providing the out-of-plane stability of the infill panel (Angel 1994). Such separations between the frame and infill may be as the result of panel shrinkage, constructional issues or in-plane loads and deformations as shown in Figure 6d (Paulay et al. 1992).

Figure 6: An example of a damaged RC structure with masonry infill in Dujiangyan.

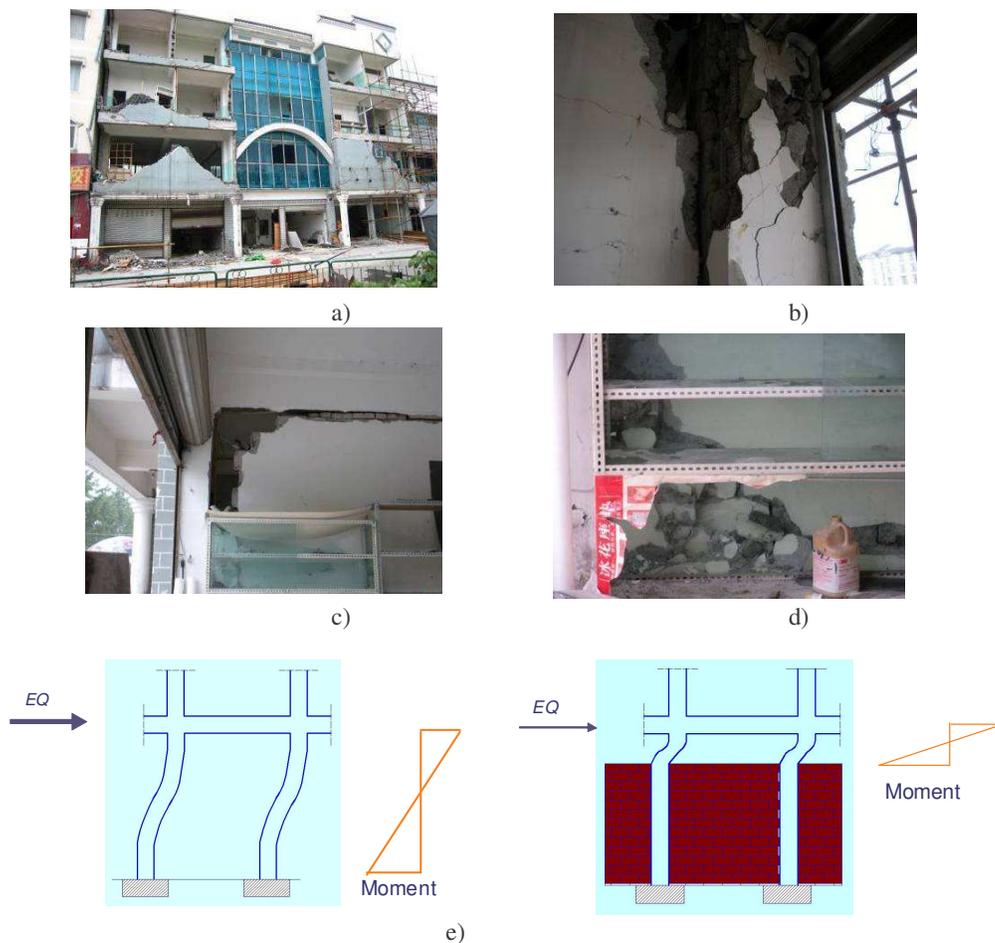
In Figures 7b, 7c and 7d, corner crushing of the masonry is shown which is an in-plane mode of failure and implies that a centric strut action developed well in the infill-frame. However, the damage to a limited length of the column on top which is in the form of concrete cover spalling and x-pattern cracks (shown in Figure 7b) indicates that the centric strut action changed into an eccentric strut action after crushing of the masonry at the corner of the panel. This resulted in a short column effect which is more common in the frames with partial infill panels in which the frame is not completely filled with the masonry. This effect is depicted in Figure 7e.

Figure 7: An example of different damage types in an RC frame with masonry infill in Dujiangyan.

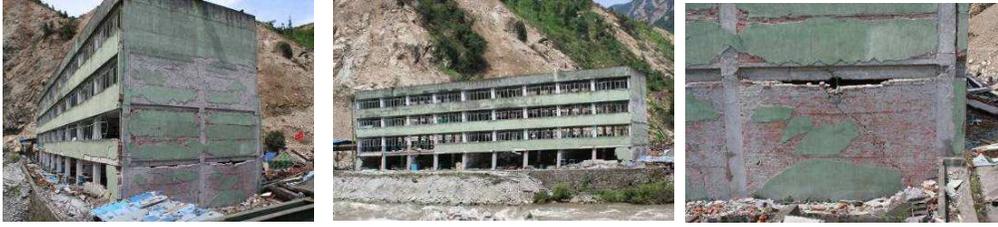
Figure 8: Soft-storey building in Yingxiu and the separation between the infill and frame.

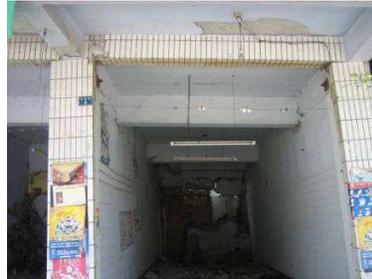
Figure 9: Out-of-plane stability of the infill-panel in a soft-storey building in Dujiangyan.

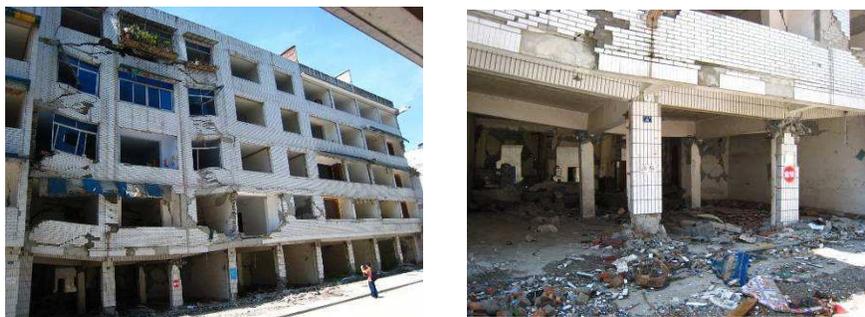
Figure 10 shows a good example of the difference between the behaviour of bare- and infill-frames under gravity and seismic loads. As shown, every other frame is filled with masonry except the two adjacent bare frames at one end of the building. All of the columns in the bare frames at the ground level experienced plastic hinges at top and bottom, whereas columns of the frames with infill were relatively undamaged. The formation of plastic hinges at the ends of the columns in the bare frames resulted in spalling and crushing of the concrete and hence the reduction in the axial capacity of the columns. Following on from this, there was a large vertical displacement that occurred at the top of the two adjacent bare frames.

Figure 10: The effect of infill panels on the structural behaviour under the combination of gravity and lateral loads in a 9-bay frame in Dujiangyan including 7 transverse infill-frames and 2 bare-frames.

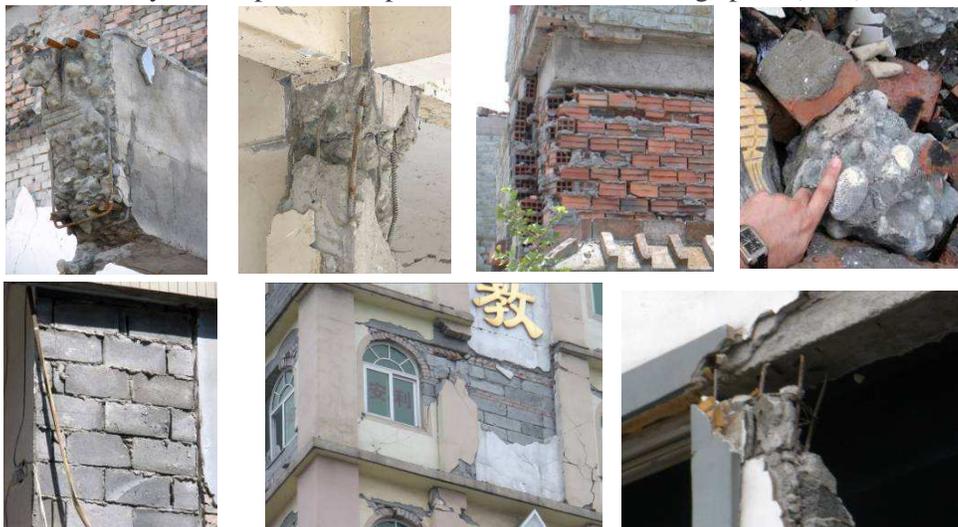
Figure 11: Examples of masonry units, masonry construction and concrete quality.
