# **Lessons Learned for Steel Seismic Design from the 2010/2011 Canterbury Earthquake Series**

**G. Charles Clifton<sup>1</sup>**

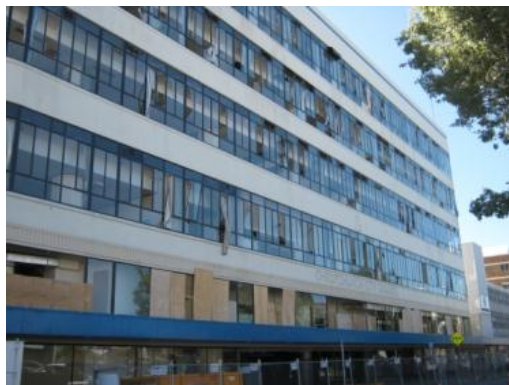
(a) Structural and claddings damage [J Ingham]

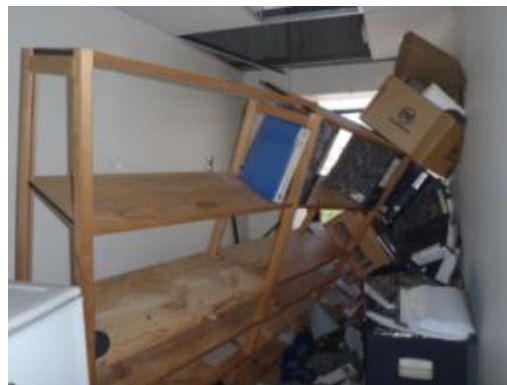
(b) Collapsed ceilings and contents [G Banks]

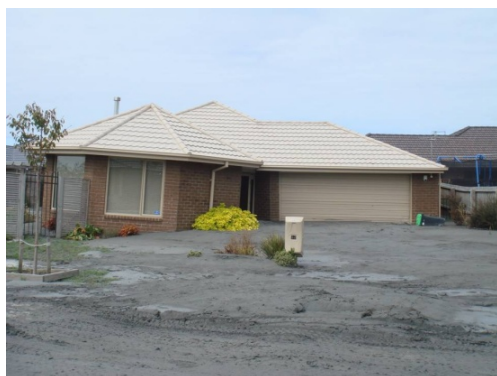
(c) Ground instability [M Pender]

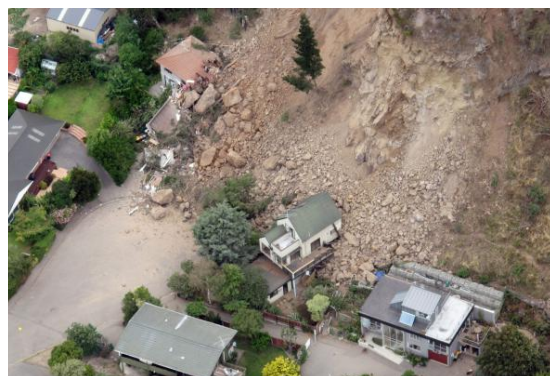
(d) Landslides /slope instability [M Pender]

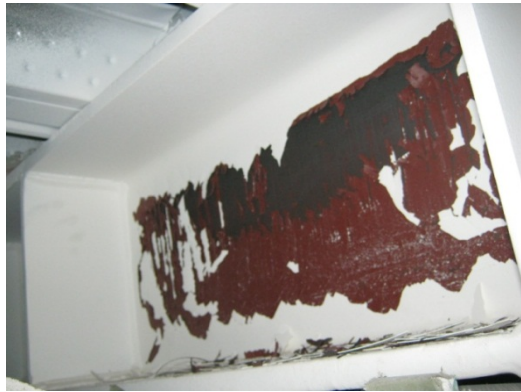
(c) Inelastic demand in EBF active link  
[C Clifton]

The peak plastic strain in the EBF active links was approx. 7%, in the 5<sup>th</sup> level link in the East-West direction, shown in Figure 2 (c). This is less than 25% of the monotonic strain elongation capability of the steel.

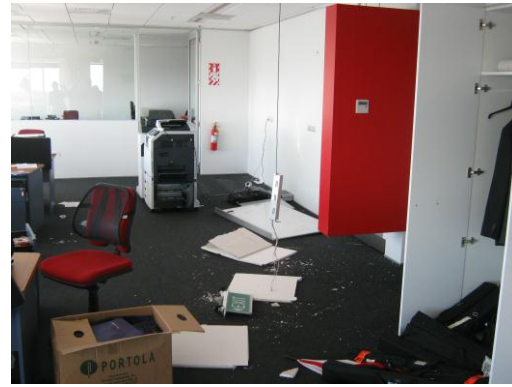
(d) Typical interior of office following 22 Feb 2011 earthquake [C Clifton]

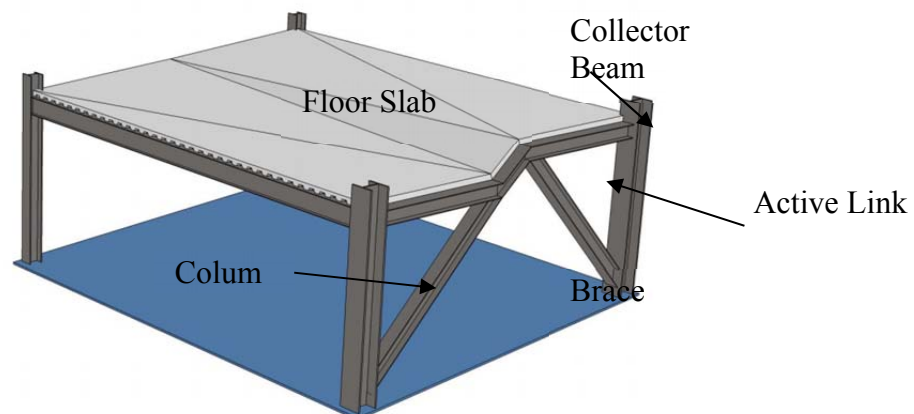
Figure 3 Floor slab contribution to EBF strength and stiffness

shown in Figure 3. A composite floor system comprising concrete slab on steel deck on composite steel beams has a high out of plane resistance to this movement. This has been quantified through research into this system's performance in fire (Clifton et al. 2010). Not only was the HSBC building stiffer than expected (see section 4.1) but it had a post-earthquake residual drift of only 0.14%. This led to consideration that the out of plane resistance of the floor slab might be a significant source of this stiffness and unexpected ability to self-centre. An undergraduate study in 2011 (Mathieson 2011; Volynkin 2011) provided an initial quantification of these effects, based on simple yieldline theory, and showed that the floor slab decreased the peak lateral deflection of a hypothetical, 10 storey V-braced EBF designed to current New Zealand design practice (Feeney and Clifton 2001; NZS3404 1997/2001/2007) under a range of 10 representative earthquake records scaled to the ULS level by between 10 and 50% and the peak residual drift to less than 33% of that without the slab effect.

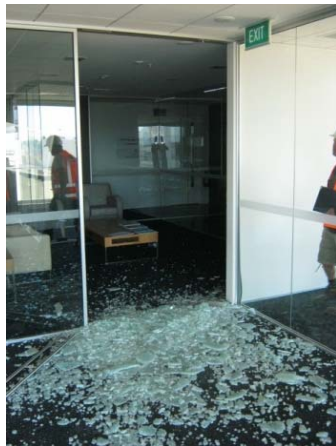
PGV levels in the February 22<sup>nd</sup> 2011 earthquake exceeded 1g within the CBD, which exceeded the PGH levels in that region. This very high level had only minor influence on steel framed buildings; in HSBC Tower, for example, it dislodged glass doors from their hinge supports (see Figure 4 (a)) and enhanced non-structural internal wall lining cracking in cantilevered window boxes out the building's north face (see Figure 2 (a))

(a) Dislodged glass door [C Clifton]

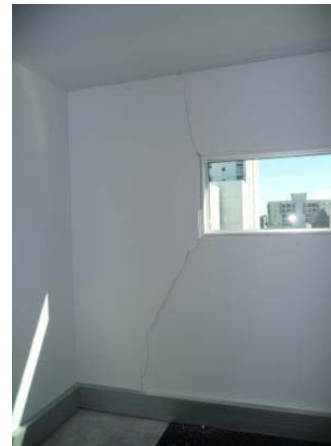
(b) Cracking to internal linings of window-box [C Clifton]

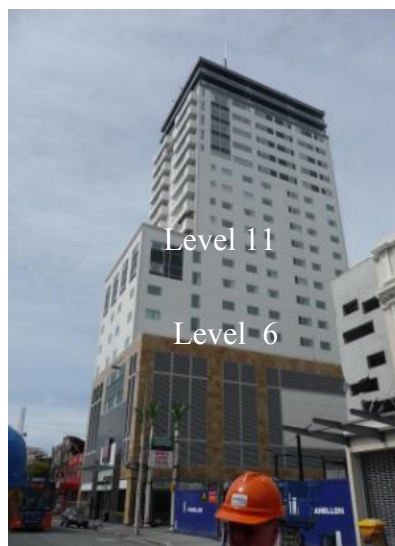
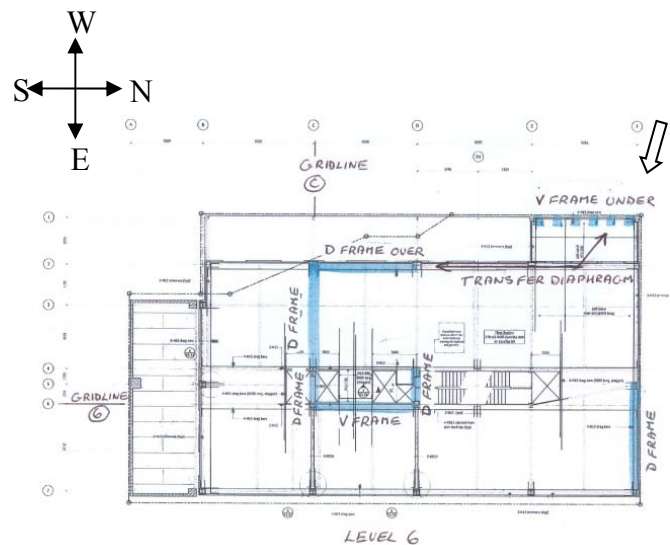
Figure 6 Pacific Tower [Photo by C Clifton, Floor Plans from S Gardiner] (the arrows in (b) show the direction of the view in (a))

However, one critical piece of evidence from Christchurch suggests that, at least in steel framed buildings with composite floors, this lack of redundancy is not critical. Figure 6 shows details of Pacific Tower. In the North-South direction, there are only two EBF systems up the full height of the building. On level 6, shown in Figure 6(b), the V frame under the NW corner stops and the EBF transfers to the D frame half way along the building for levels 7 to 22. The top link in the NW corner EBF fractured, either in the February 22<sup>nd</sup> 2011 earthquake or in the most intense earthquake of 13 June, partly due to use of steel with less than the specified Charpy Impact energy. In principle, this broke the continuity of the seismic-resisting system on the west side of the building and should have generated high torsional actions especially around the 6<sup>th</sup> level. Evidence from non-structural linings cracking showed a very slight increase in inelastic demand in the 6<sup>th</sup> and 7<sup>th</sup> storeys, however there was no evidence of enhanced torsional movement. The floor slab on level 6 functioned as an effective transfer diaphragm. This building was repaired and returned to service in May 2013.

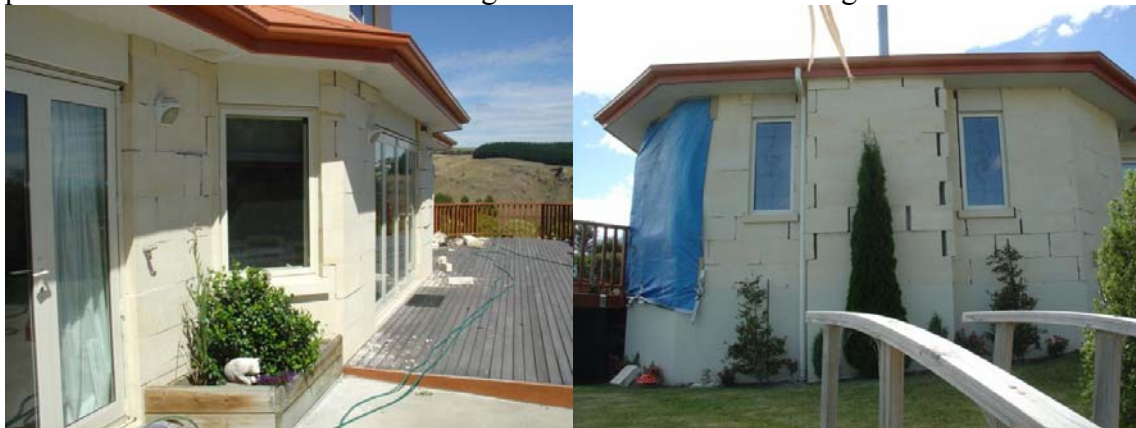
Figure 7 Two storey light steel frame house with Oamaru stone cladding [T Just]

Performance in the Christchurch earthquake series was consistent with this; no damage to minimal hairline cracking of plasterboard linings for houses on good ground. The most outstanding example of LSF performance was a two storey light steel framed house with Oamaru stone cladding, situated very close to the epicenter of the 22 February 2011 earthquake and to a strong motion station that recorded  $PGA_H$  and  $PGA_V = 1.8g$  in that event (a higher  $PGA_V$  was recorded at another station, but that figure is suspect to falling material in the vicinity of the recorder). Figure 7 shows two views of this house, showing the movement of the Oamaru stone on its bedding planes. There was also minor cracking to some internal wall linings. Both were

readily repaired. With the Oamaru stone units being 4 times the weight of a standard clay brick and the acceleration demand being double that of the shaking table

experiments, this was a much more severe test of the light steel framed house system and the most demanding example studied from Christchurch.
