Performance of posttensioned seismic retrofit of two stone masonry buildings during the Canterbury earthquakes

Dmytro Dizhur¹, Sara Bailey², John Trowsdale³, Michael Griffith⁴

and Jason M. Ingham⁵

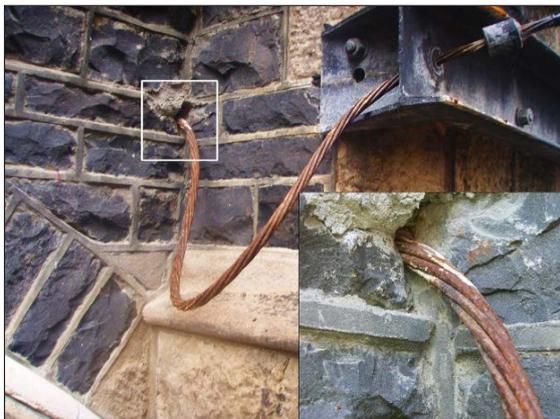
(a) Corrosion of PT steel (after tendon had been released to enable strengthening works)

External damage to the College Hall during the 22 February 2011 event was restricted to the east side of the building, as well as around the dominant window feature on the North face. The damage was consistent with insufficient connection between the roof and the gables, reduction and lack of diaphragm stiffness (Figure 8), as well as differential movement between jointed structures on the east side of the building. Damage was also sustained to the turret during the September earthquake, which was subsequently removed prior to February 22. During the first earthquake in September 2010 the posttension tendons were approximately 26 years old and in most cases a minor to moderate extent of corrosion was observed, as indicated in Figure 7a. The condition of the tendons across the site ranged from

minor surface flecking to significant loss of cross section, dependant on the location within the structure and the environmental exposure. The exterior west side of the building where the posttension tendons were applied performed well, with almost no damage except the failure of one tendon. The cross-section of the failed tendon was significantly reduced at the point of failure, most likely due to the design of the lower anchorage effectively creating a pond around the tendon during wet conditions (Figure 7b), resulting in constant wetting and drying causing corrosion and deterioration of the tendon. Similar damage to the tendons was identified along the length of the wall, but because inspections were only undertaken post-earthquake, it is unknown whether the failed tendon ruptured as a result of the earthquake or had already failed due to the section reducing to an area that was unable to sustain the imposed prestress. Giving consideration to the exposure of the tendons, a limited warranty to such a design would be granted given the current stringent durability requirements. Therefore, for a long-term solution, some further form of protection would be necessary, and given the 26 year old age of the tendons it is concluded that they performed well in the environmental conditions that they were exposed to.

Due to the favourable performance of the posttension tendons, the existing seismic retrofits are in the process of being renewed. The tendons of the Chemistry building are being replaced with stainless steel material to prevent corrosion and the tendons of the Great Hall are being removed from sight and instead ducts are being drilled within the wall to install new tendons, thus preserving the architectural characteristics, protecting the tendons from environmental conditions, and satisfying the elevated post-earthquake seismic improvement criteria for historic buildings in Christchurch.

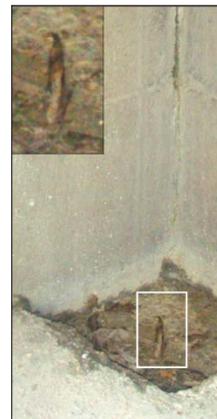
remained intact, with the vertical tendon that failed being part of the College Hall retrofit and being the southern external tendon on the 4th buttress from the northern side of the building. Damage surveys were completed on the TAC complex after the February 2011 earthquake. The damage to the Chemistry building was significant due to failure of the tower above the main entrance, which was subsequently removed. External damage to the Chemistry building was primarily to gables and the main tower, with some minor superficial cracking and loss of stonework at Level 1. As the tower had only received nominal securing, this outcome was to be expected. Gables also performed poorly due to inadequate connection to the roof and low stiffness of the adjacent strengthened flexible diaphragm. The overall structure performed well, particularly at ground level where the posttensioning was applied. Nearly all of the stone damage, broken windows and minor cracking occurred during the 22 February 2011 earthquake due to greater peak accelerations which exceeded current design levels.

(b) Area where pond of water was able to form around failed tendon

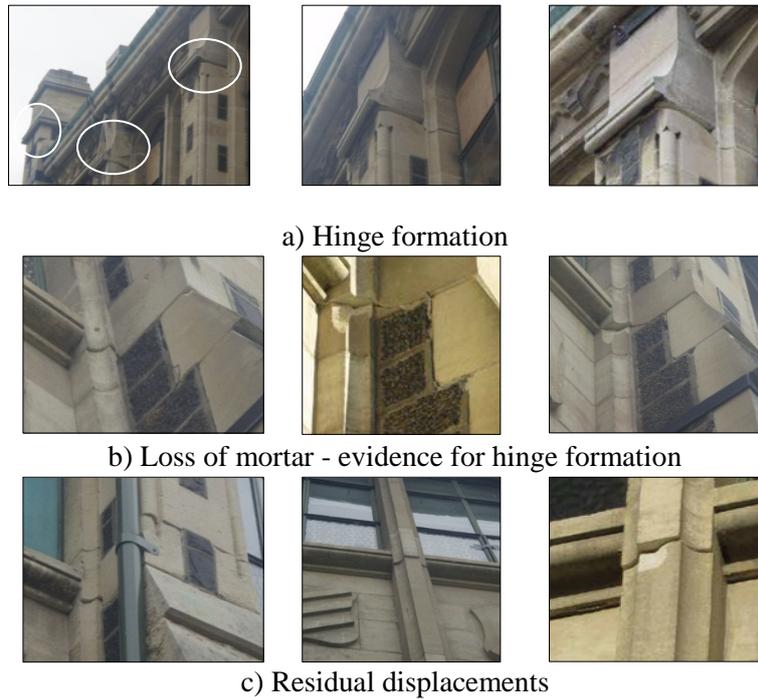
Figure 9: External failures of the Engineering building

Quantifying the performance of the posttension retrofit is difficult, but by comparing the damage to the retrofitted Chemistry building with that of the un-retrofitted Engineering building, key advantages of the posttensioning can be identified. The Engineering building is of similar pier/spandrel construction with a slightly different aspect ratio, but overall provides the best comparison available at the Arts Centre site. A visual comparison of the Chemistry building versus the Engineering building can be seen in Figures 9. The Engineering building suffered from out-of-plane movement indicated by the formation of hinges due to rocking at the top and bottom of the second level (Figures 9a and 9b respectively). At the Chemistry building no evidence of hinge formation at the piers as is evident for the Engineering building. The mortar of the Chemistry building is still intact, indicating that the posttension tendons limited tensile forces that developed in the masonry, minimising any hinging between the masonry units and mortar as shown in Figure 9. Unlike the retrofitted Chemistry building, there was also significant permanent deformation of the second level of the Engineering building as shown by the large overhang in Fig 9c. No identifiable permanent deformation at

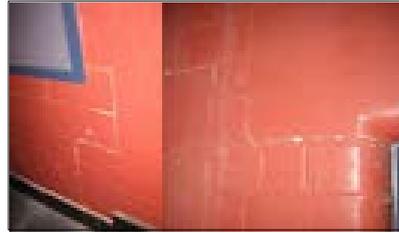
Figure 10: Internal failures of the Engineering building

Figure 10 shows the damage to the interior of the Engineering building, again highlighting the out-of-plane rocking and differential movement that occurred throughout the unretrofitted building. Although the Chemistry building also suffered some internal cracking, the extent of the damage and therefore repairs needed was minimal compared to that of the Engineering building. Based on observations alone it can be concluded that the retrofit of the Chemistry building provided improvements in the out-of-plane loading direction as well as addressed in-plane deficiencies as initially intended with the retrofit design scheme.

d) Ground floor - evidence of differential movement, spalling of mortar and residual displacement common at this level
