Reconnaissance Investigation on the damages of the 2015 Gorkha Earthquake, Nepal

Bipin Shrestha

Center for Infrastructural Protection and Monitoring

October 2015

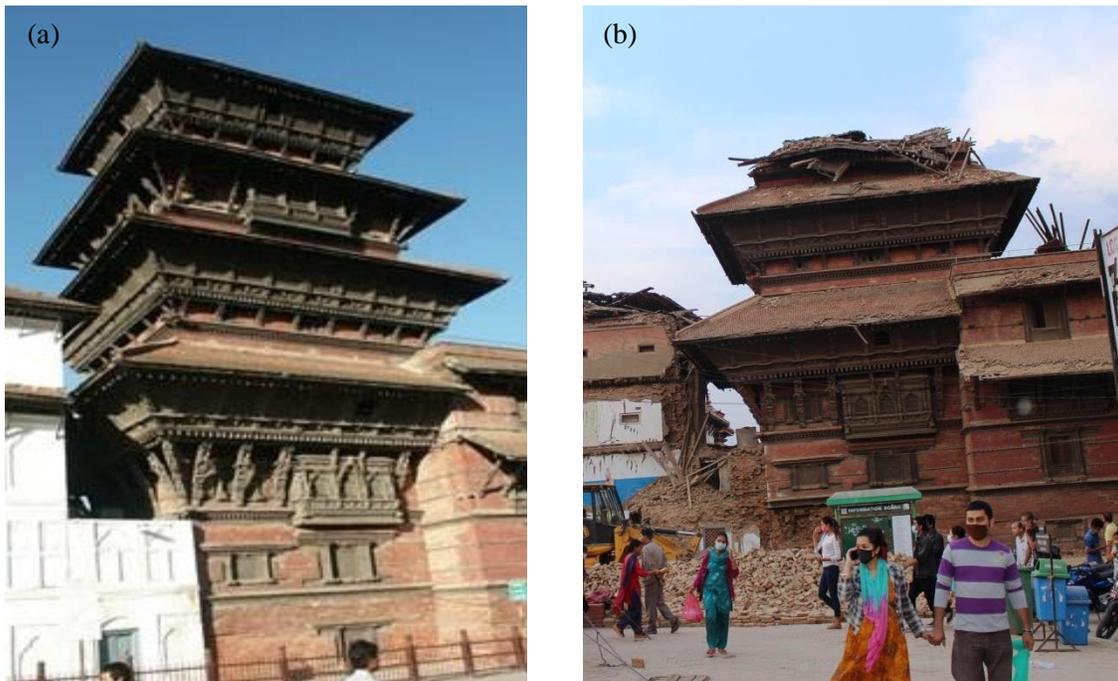
Fig. 10 shows the pictures of 9 storey Basantapur Tower before and after the earthquake. The top three stories of the tower collapsed while other stories despite receiving significant damages did not collapse. The tower was supported on brick masonry wall combined with wooden frames. Fig. 11 shows the pictures of Kastamandap temple, originally built in around the 12th century, before and after the earthquake. The temple fully collapsed during the mainshock of 25th April and claimed the life of dozens of people gathered for the blood donation program. This temple was mainly supported on wooden frames. Fig. 12 shows the damages to the Gaddi Baithak, influenced by European style building built on 1907, on west and south façade. Partial damages to this building include the damages to parapet walls and out-of-plane failure of the masonry structures. Fig. 13 shows the picture of Trilokya Mohan, Maju Degal and Narayan temple before and after the earthquake. The exterior portion of the temples was supported on the timber frames while the inner core was made of a masonry wall. All three temples collapsed during the earthquake of 25th April.

Fig. 10 Nine storey Basantapur tower (a) before earthquake (b) after earthquake

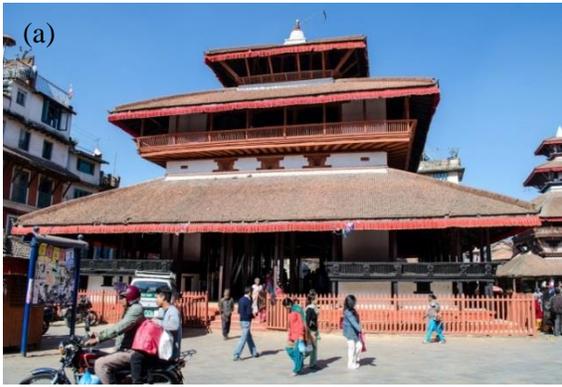
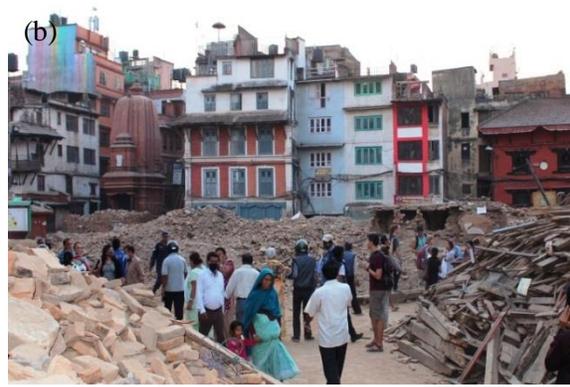
Fig. 11 (a) Kastamandap before earthquake (b) Kastamandap after earthquake

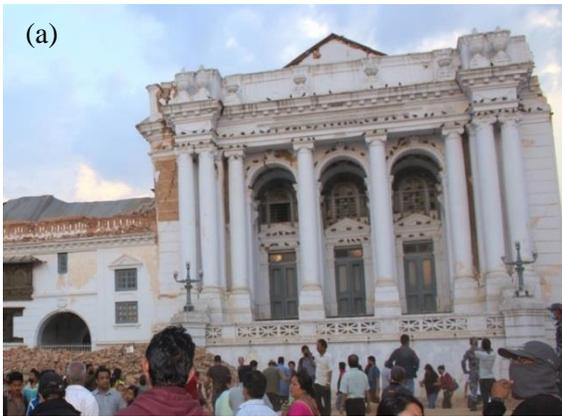
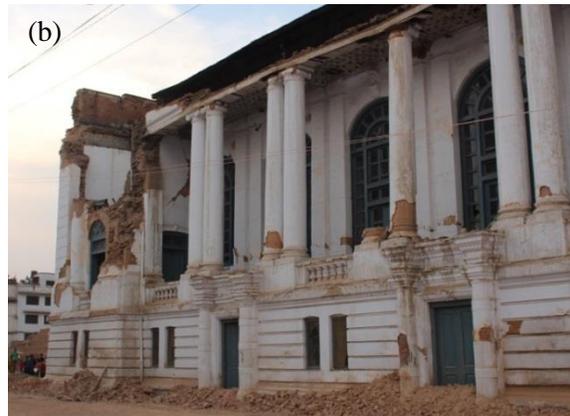
Fig. 12 Gaddi baithak palace (a) west facade (b) south facade

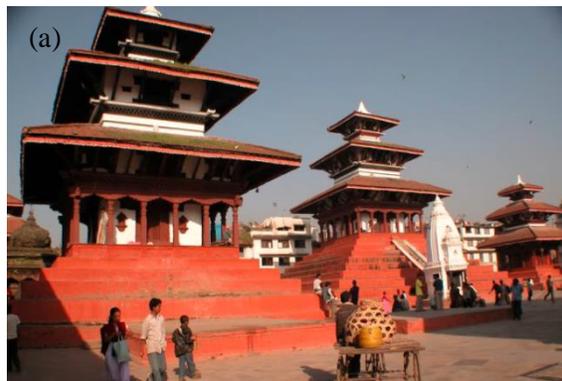
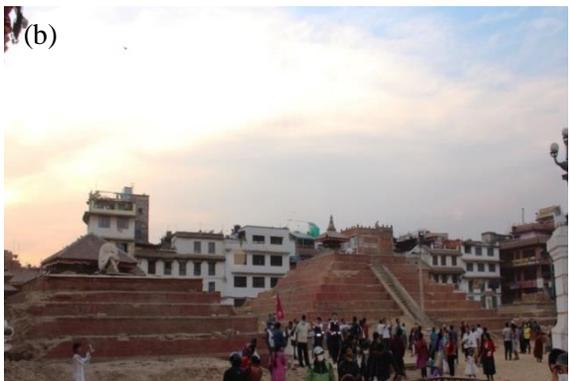
Fig. 13 Trilokya Mohan temple, Maju Degal and Narayan Temple from left to right (a) before earthquake (b) after earthquake

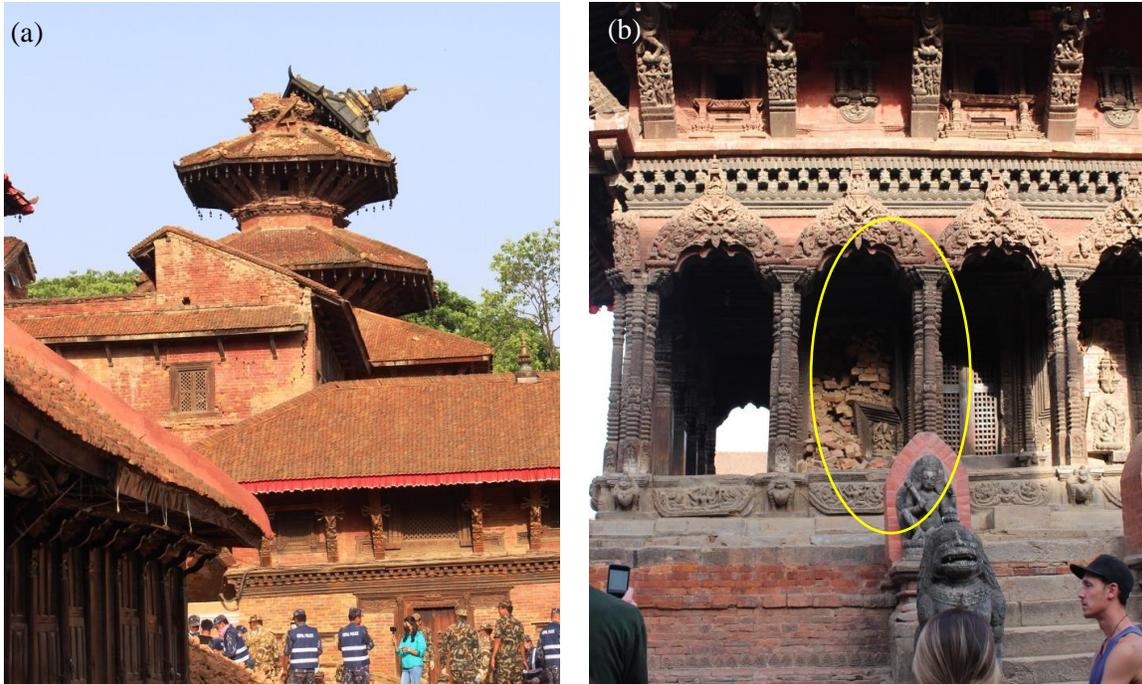
Fig. 14 (a) and (b) present the damages to the roof structures of the Taleju Temple and masonry wall of the Bhimsen Temple at Patan Durbar square. The roof collapse of the Taleju temple could be attributable to the amplification of the earthquake acceleration at the top of the building. In Bhimsen temple, significant damage to the masonry walls was observed in addition to the residual

Fig. 14 (a) Partial collapse of Taleju temple (b) Damages to masonry walls and leaning structure of Bhimsen temple at Patan.

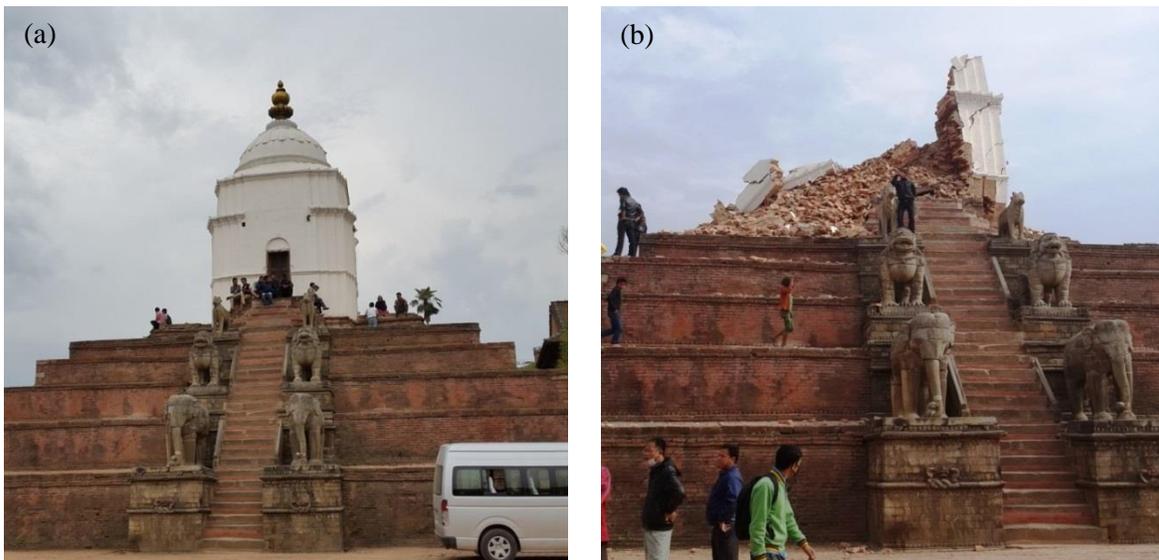
deformation on the ground floor level of the temple. In Patan Durbar square 3 temples (Jagnarayan temple, Harishanker Temple and Mani mandap pati) as shown in Fig. 9 were fully damaged. Fig. 15 displays the picture of Phasi Degal temple of Bhaktapur Durbar Square (BDS) devoted to God Mahadev. The Masonry walls at the three sides of the temple failed during the earthquake after the development of diagonal shear cracks. The remaining portion of the masonry wall as shown in the Fig. 15 (b) was later demolished to prevent any mishaps.

Fig. 15 Phasidegal, Bhaktapur durbar square (a) before earthquake (b) after earthquake.

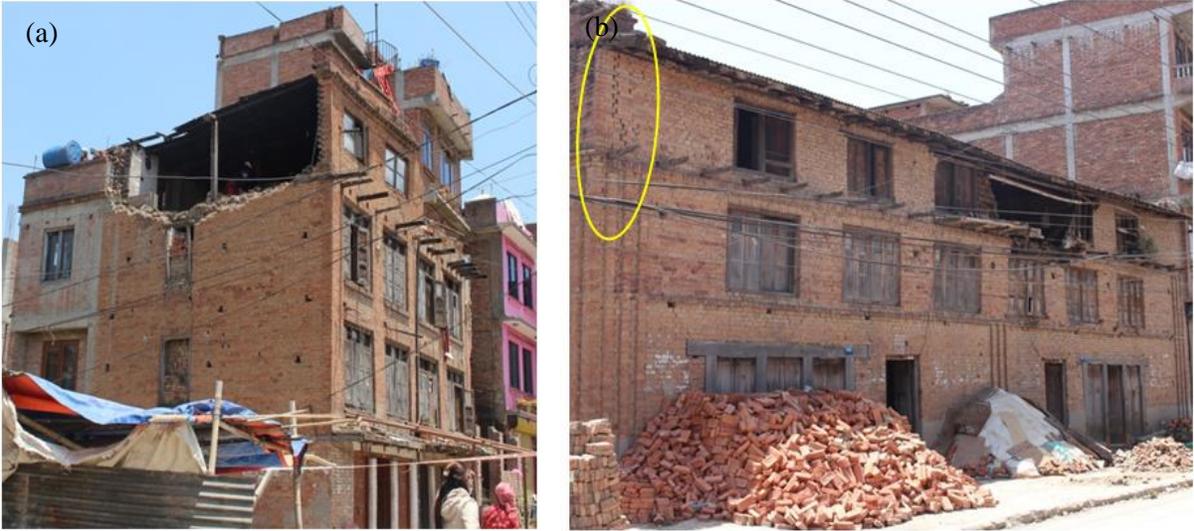
Fig. 16 presents an out-of-plane failure of masonry wall at the top floor of a building. Apparently the masonry walls collapsed even when not taking any vertical loads except the self-weight as seen in the Fig. 16 (a) for building with corrugated metal roofing supported by timber posts. The poor bonding of the mud mortar was unable to prevent the out-of-plane failure of the walls subjected to higher ground acceleration at the top of the building. Additionally, the long length of the unsupported wall, usually created in the traditional building to get open spaces on the top floor, could have contributed to the inferior performance of the masonry walls in the out-of-plane direction. Failure of the connection is also visible at the corner of the walls due to again poor bonding behaviour of the mud mortar. Fig. 17 presents out-of-plane failure and in-plane diagonal cracks in walls of a building. The diagonal cracks initiated from the middle portion of the wall at the roof level of the top floor and terminated nearly to the plinth level close to the edge of the wall. In the background of the building other two building are also visible. Due to the lack of integrity in these structures the walls of the buildings vibrated as a different unit rather than vibrating in unison. As could be seen in the figure a building in the background with Reinforced Concrete (RC) frame infilled with masonry wall not only survived the earthquake but also had very minimal damages. This indicates toward the poor seismic capacity of the traditional brick masonry structures in comparison the RC structures. Fig. 18 presents pictures of diagonal cracks at two facades of a building. Multiple diagonal cracks along with out-of-plane failure are clearly observable on all sides of the building except to the side attached to an adjacent building. This suggests the wall attached to the adjacent buildings might have benefited from the attachment thus enhancing the stability of the walls. Moreover, the absences of horizontal bands (sill, lintels) at

Fig. 16 (a) Out-of-plane failure of wall (b) out of plane failure along with connection failure.

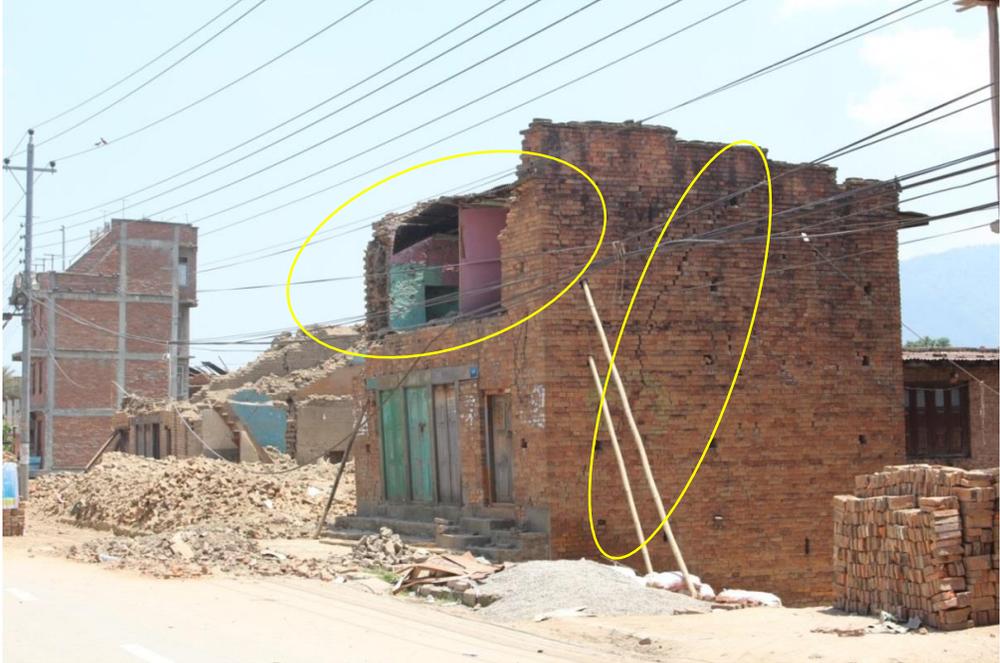
Fig. 17 Out-of-plane failures of wall and diagonal cracking of wall, in the background a RC frame structures with no damage.

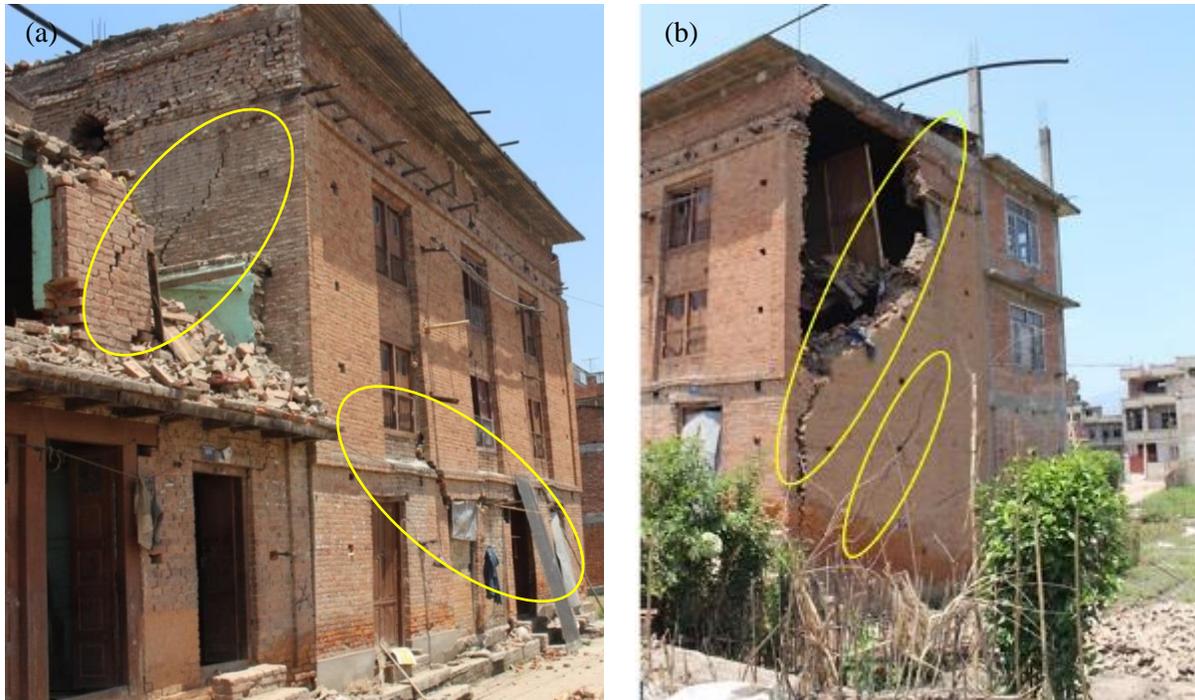
Fig. 18 Diagonal cracking on the walls of a building due to lack of lintel and floor bands.

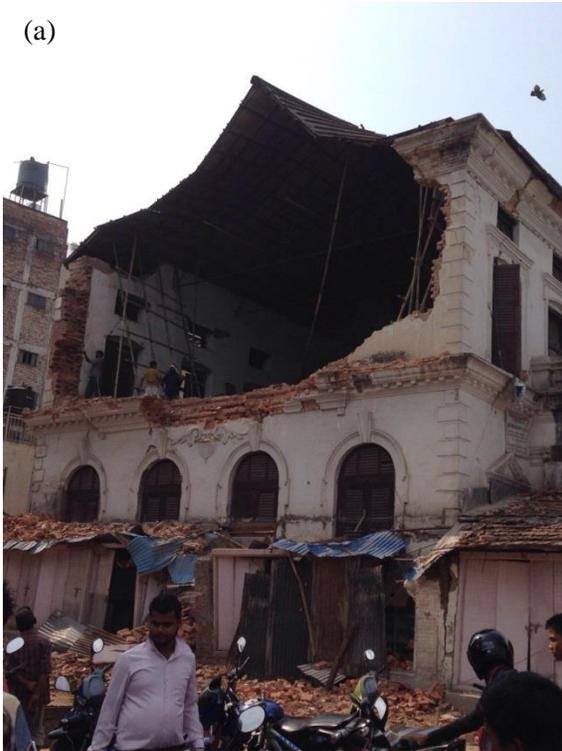
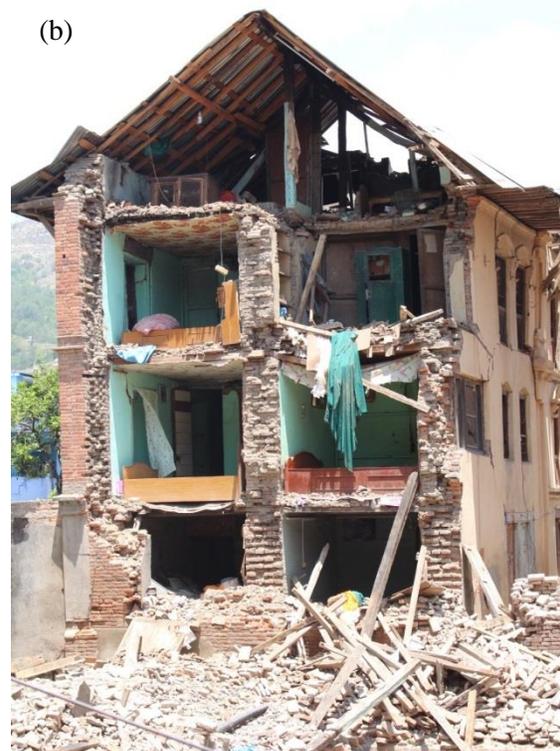
Fig. 19 (a) Out-of-plane failure of wall of Durbar high school, (b) Out-of-plane combined overturning failure of wall.

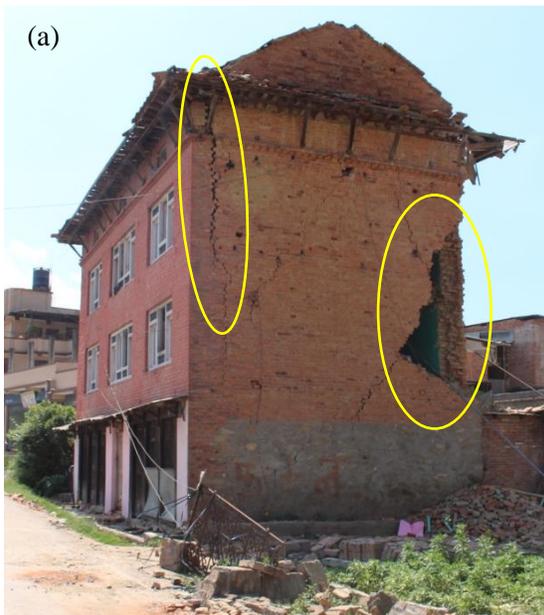
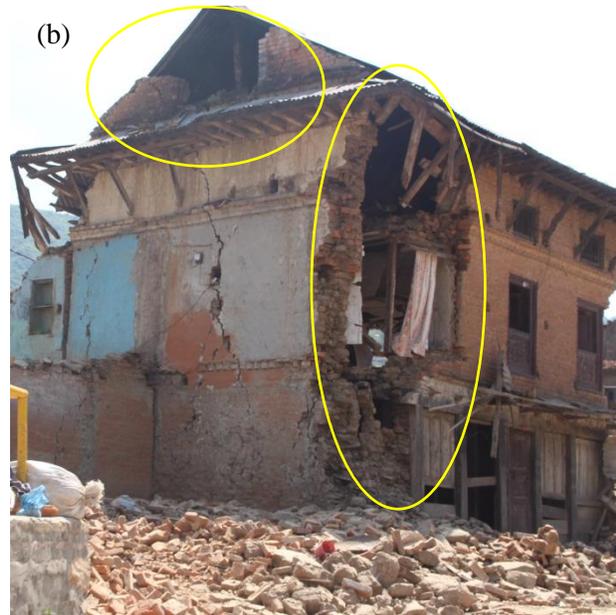
Fig. 20 (a) Failure of walls at corner and wall separation at corner, (b) failure of walls at corner and at gable.

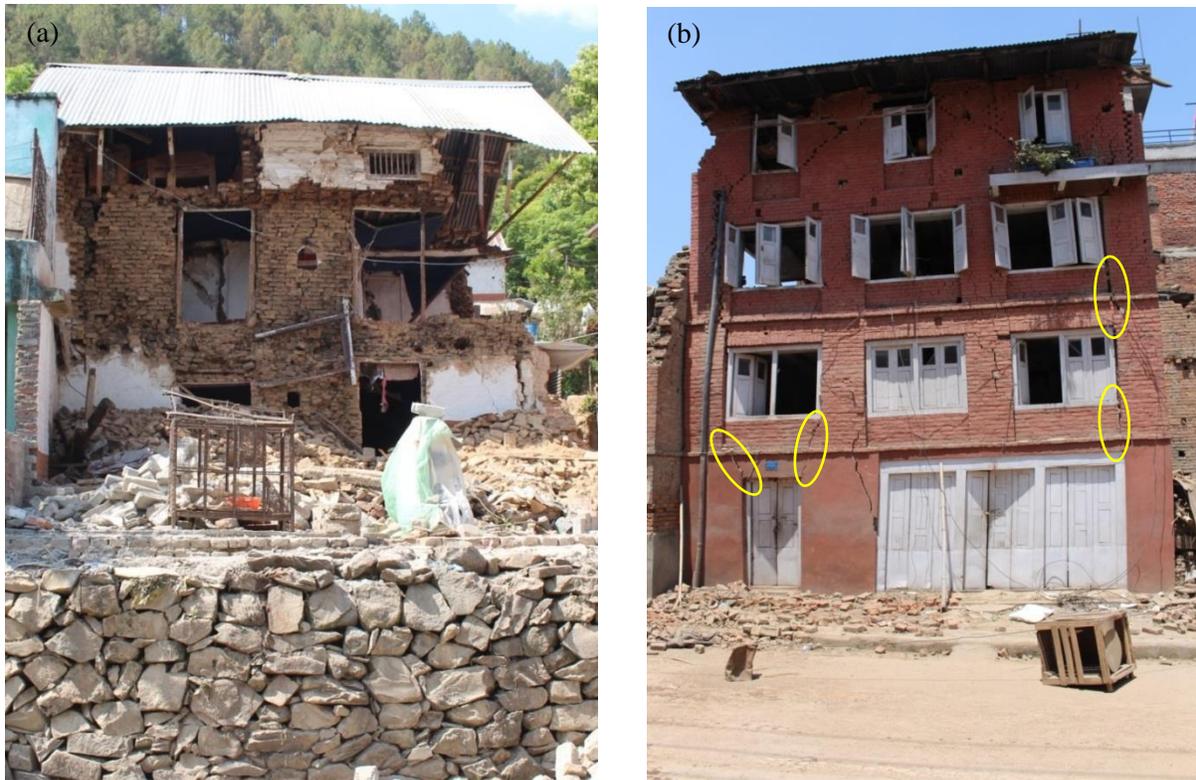
Fig. 21 (a) Splitting of layers of wall, (b) cracking in the building with irregular wall thickness.

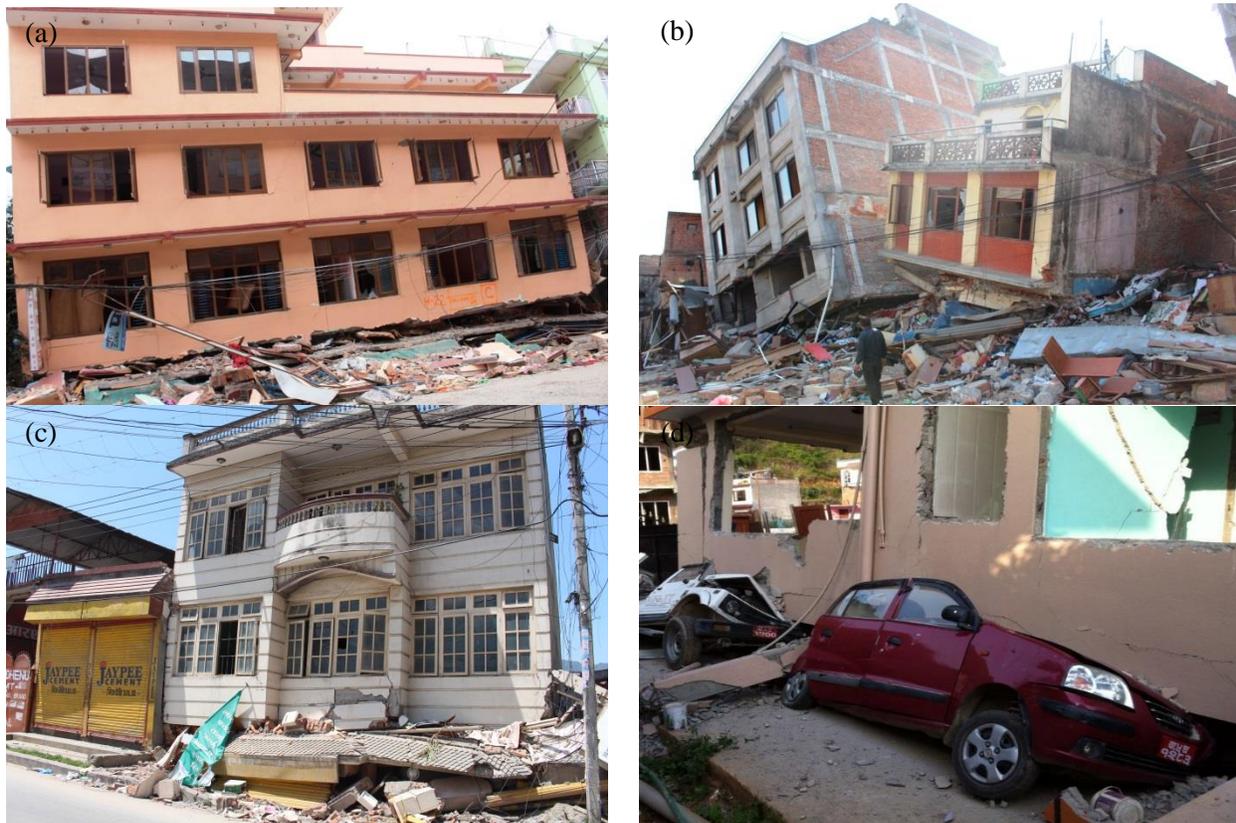
Fig. 23 Soft storey failure of open ground floor at various places of western Kathmandu.

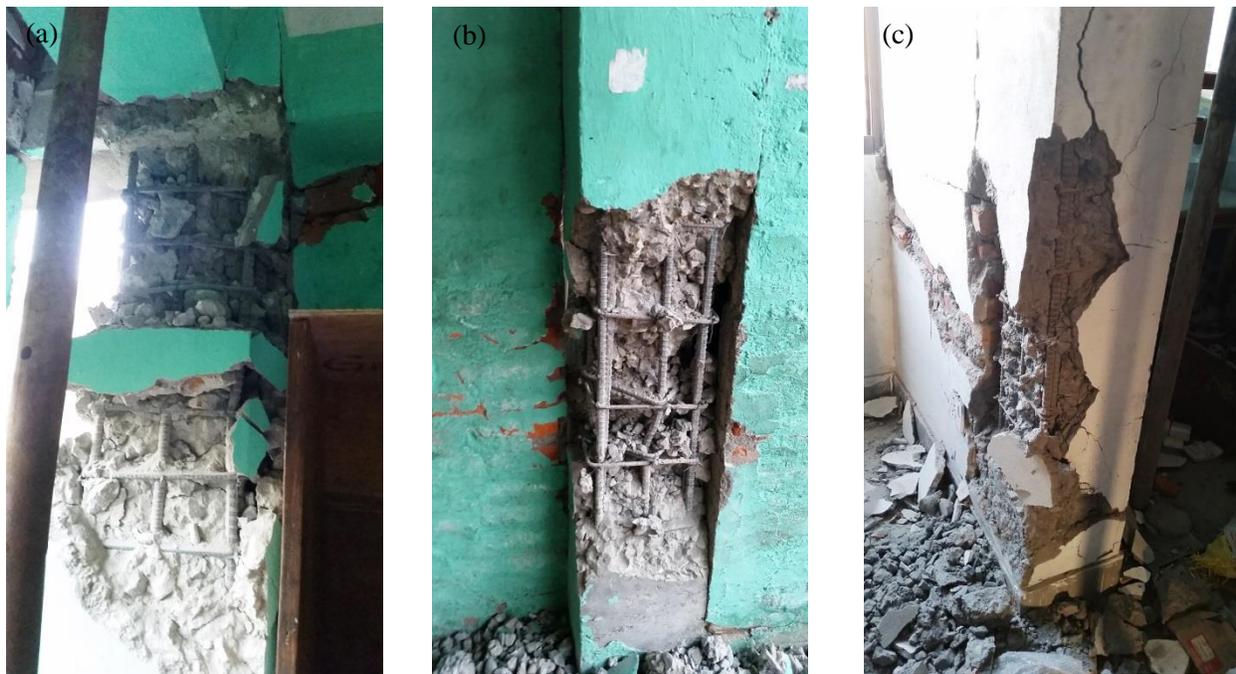
very poor, and its compressive strength in some buildings was lower than the expected strength. Moreover, aggregate used was of elongated shape and flaky and compaction was not done using a mechanical vibrator. Examples of the damage due to the use of low strength concrete observed in RC building are shown in Fig. 23. All these showed that one of the main problems in damaged/collapsed RC building was the poor quality of the concrete.

Fig. 24 Damages due to the poor quality concrete.

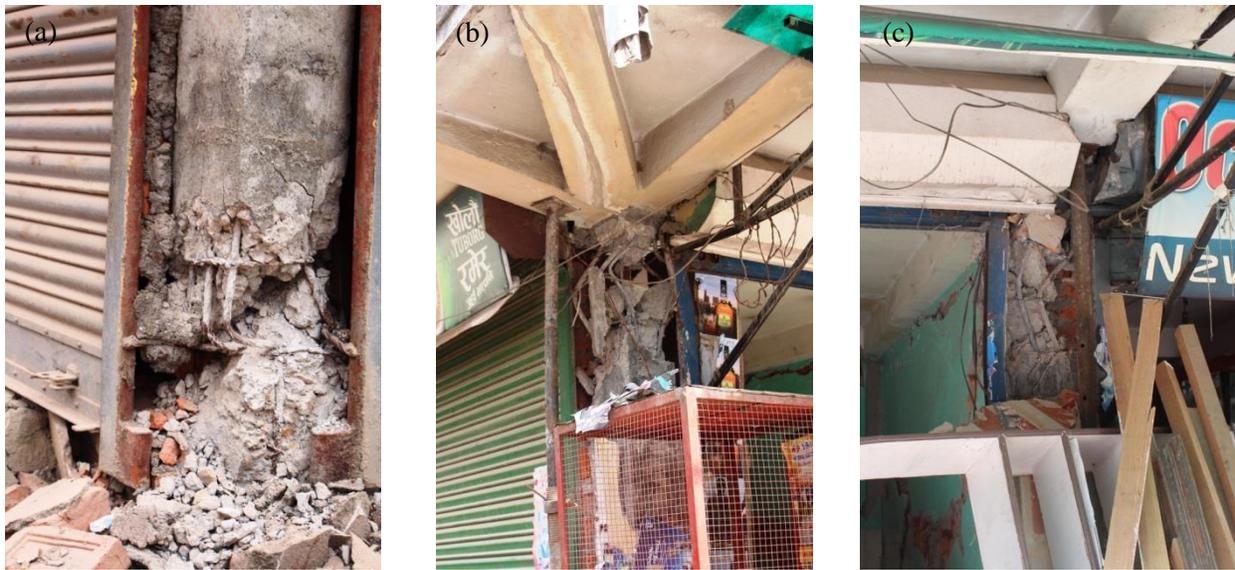
Moreover, the poor detailing of transverse reinforcement at the plastic region of columns, beams and beam-column joint resulted in damages of many RC buildings due to insufficient confinement. The wide spacing of ties resulted in shear failures, buckling of the longitudinal bars and poor confinement of the core concrete. In addition to inadequate transverse reinforcement, insufficient cross-sectional dimension were another reason for the widespread damage. Few examples of the damages due to the combination of poor quality concrete, inadequate confinement and insufficient cross-sectional dimension are shown in Fig.24. Fig. 25 shows the damages to a column of a school college Kathmandu. The close up view of the damaged column revealed that not only the spacing of the transverse reinforcement in large (around 200 mm) but the ends of ties were not bent at 135° , and the length of the hook was less than ten times diameter of the ties as required by the ductile detailing code. The construction of the building was completed only a few years ago. This

Fig. 25 Failure due to the insufficient confinement and low quality concrete at columns.

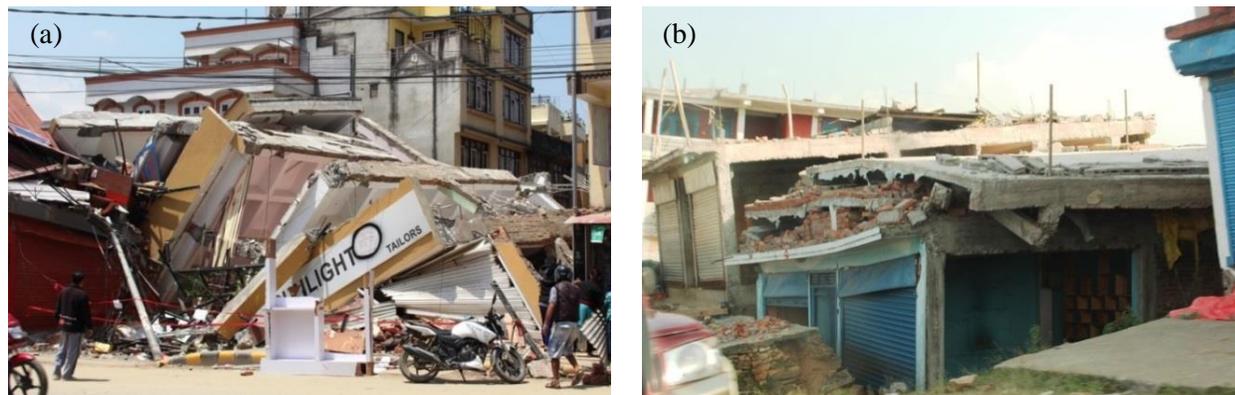
Well-designed RC frames in the seismic regions seek to ensure that hierarchy in the strength of the components of the structures is followed so that building could behave in a ductile manner. In order to resist intense earthquake in ductile fashion, it is required that the damages on the beams precede the damages in columns, due to the risk to the building stability due to damages in columns (Murty 2007). However, such design hierarchy is not enforced by the building codes of the region (such as NBC 105:1993, IS 1893:2002). As a consequence many RC structures, even the newly constructed one in Nepal, have stronger beams compared to the columns. During the earthquake in many damaged buildings, it was observed the supporting columns suffer from shear failure or compression crushing while beams were behaving almost elastically. For example in Fig. 25(a), a building at Kathmandu city had the weak columns compared to deep beams. Not surprisingly, the building collapsed overturning towards its weaker axis. The Fig. 25(b) shows the damage to a building observed at Sindhupalchowk district where the building had collapsed due to the failure of columns whereas the beams were damage free.

Fig. 26 Weak Column strong beam failures and damages.

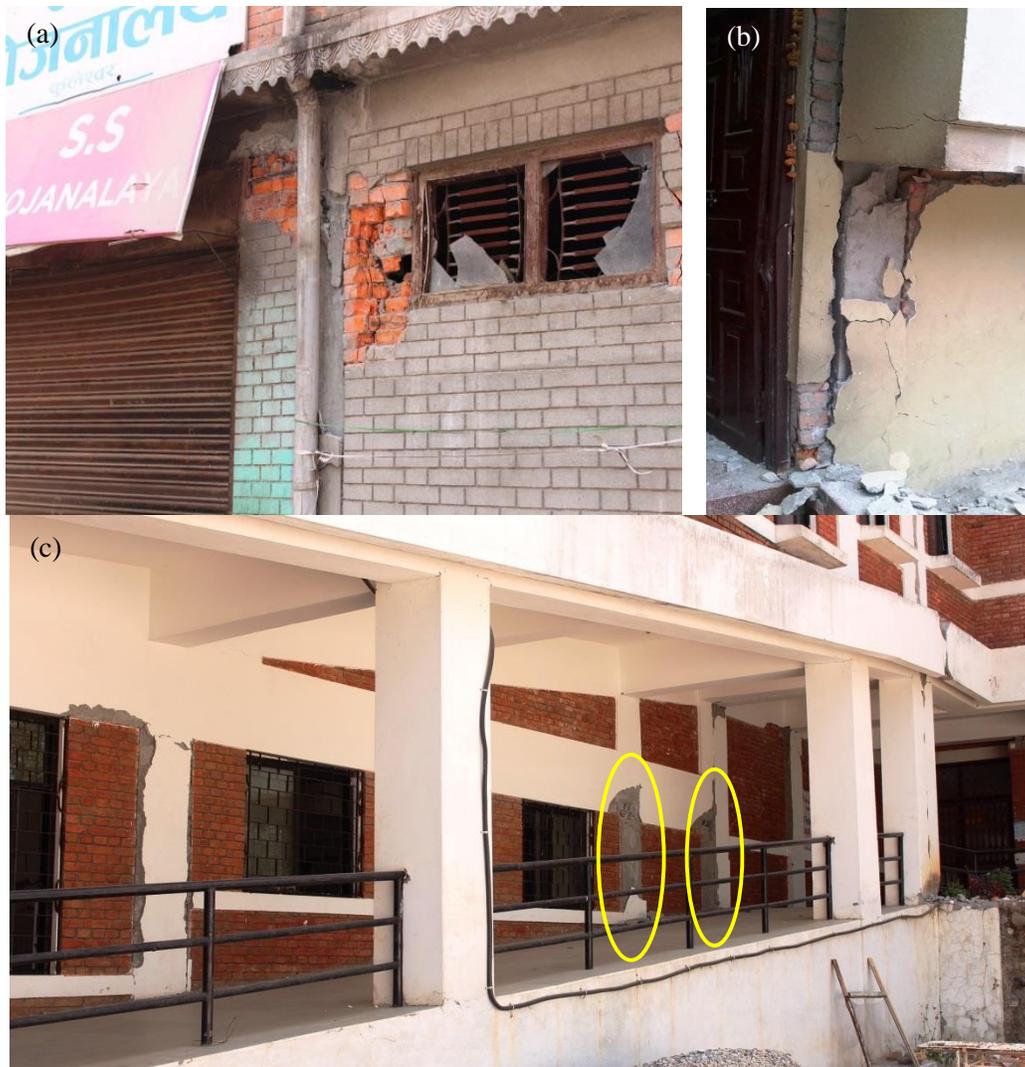
Damages due to the short column were also frequently observed during the field observation. During the earthquake, lateral forces are transmitted to the columns as moment and shear forces. When the length of the column is short, it becomes stiffer and receives higher moments. Since the moment arm is short, the shear force becomes more pronounced could result in the failure of the column. Fig. 26 shows some of the cases of damages due to the short column effects observed in the field. The first two pictures, taken in Kathmandu, show the damages to the columns due to the influence of the placement of openings in the infill wall and bisection of the column by landing beam, respectively. The bottom picture (Fig. 26(c)) shows the damages to the columns of district hospital at Chautara, Sindhupalchowk district caused by short column effect due to the construction on the sloping ground.

Fig. 26 Damages due to Short column effects.

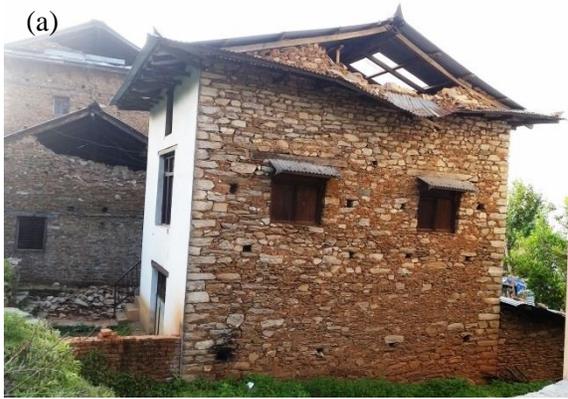
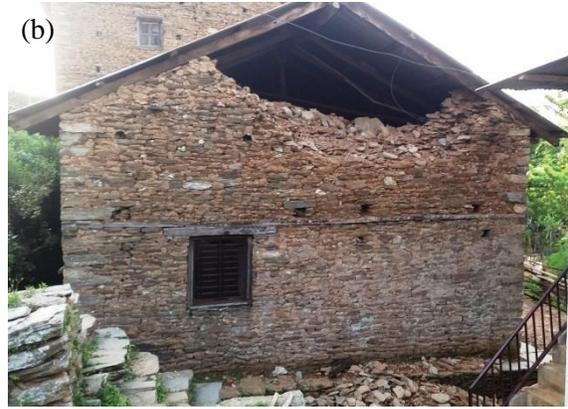
Fig. 27 Out-of-plane failures of roof gable walls.

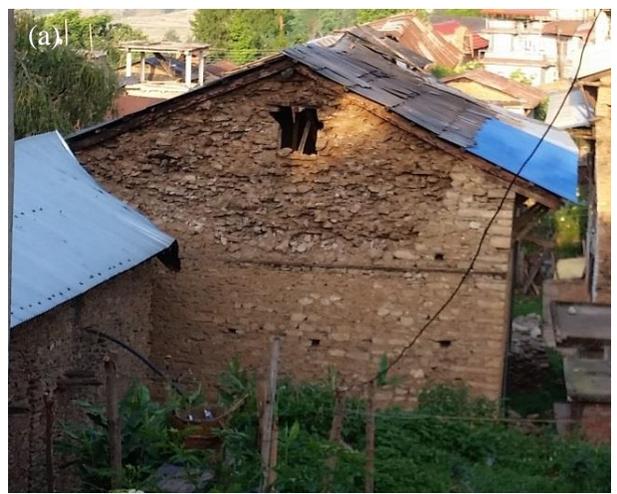
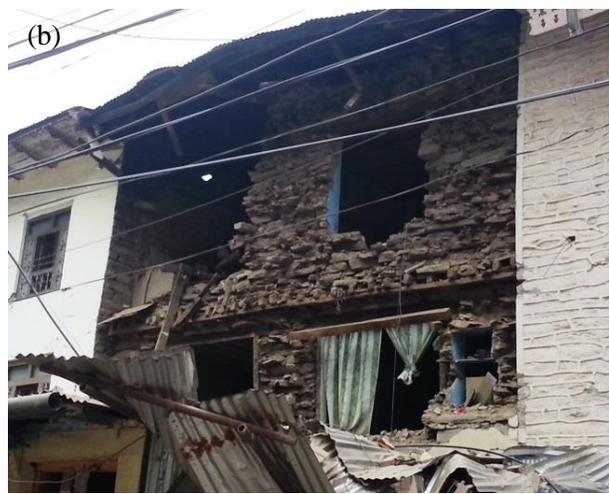
Fig. 28 Delamination of wall wythes.

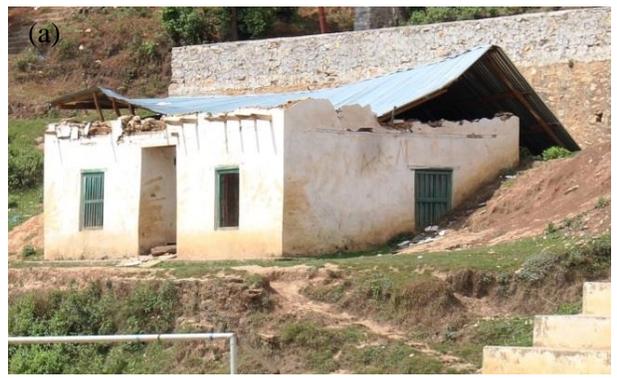
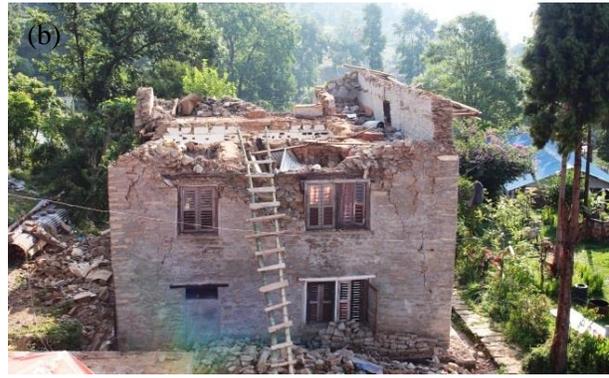
Fig. 29 Failure of roof structures.

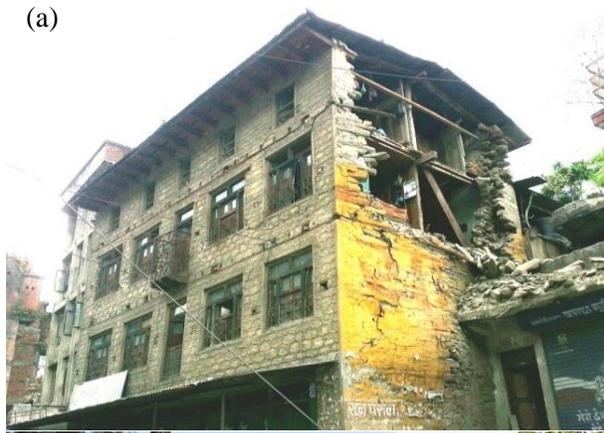
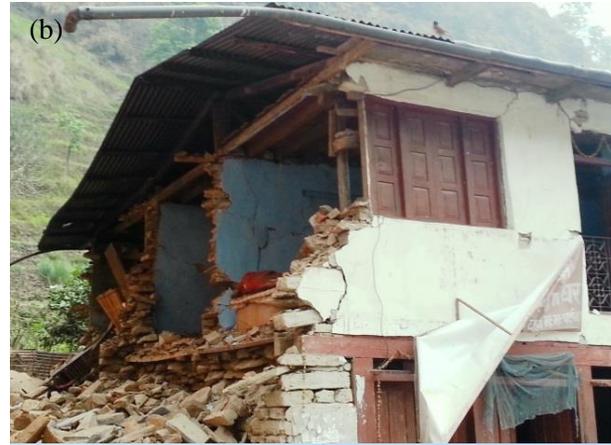
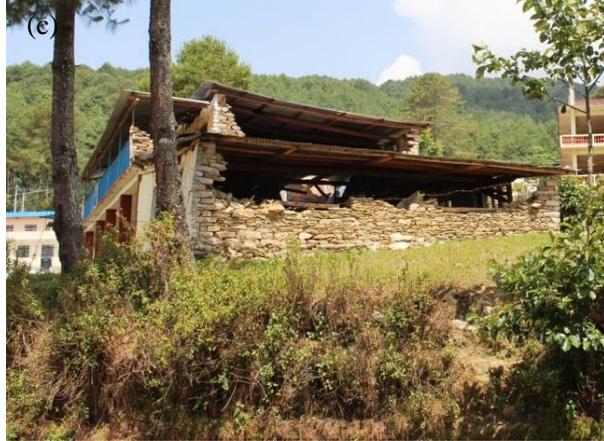
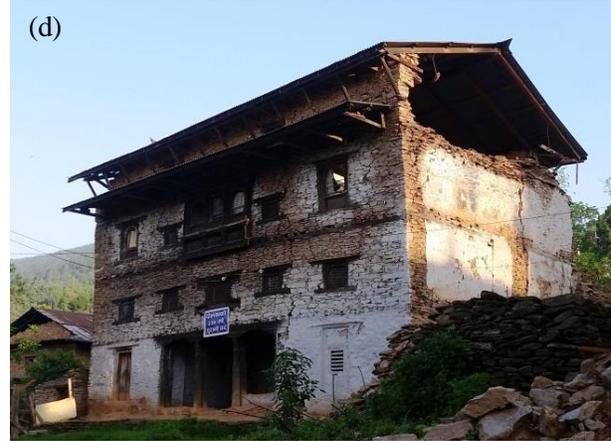
Fig. 30 presents the out-of-plane failure of the stone masonry walls. As previously mentioned the floor and roof on these kinds of buildings are not properly anchored to the walls. Moreover, connecting ties to the walls, such as lintel and sill bands, are usually not provided thus the buildings lacks the integrity required to resist seismic loadings. Consequently, the walls of the buildings can vibrate as a single unit and could collapse in the out-of-plane direction. In multi-storey buildings, this usually occurs at higher floor levels due to amplified acceleration at the top of the structures. However, the failure is also possible in single storey structures due to the long walls without any cross wall bisecting it (Fig. 30 (c)). In some cases, the out-of-plane failure was combined with overturning failures, such as in Fig. 31. The entire wall separated from the adjoining walls and overturned into the ground due to its large inertia. Again the lack of connecting element between the walls, and walls and roof are clearly visible.

Fig. 30 Out-of-plane failures of stone masonry walls.

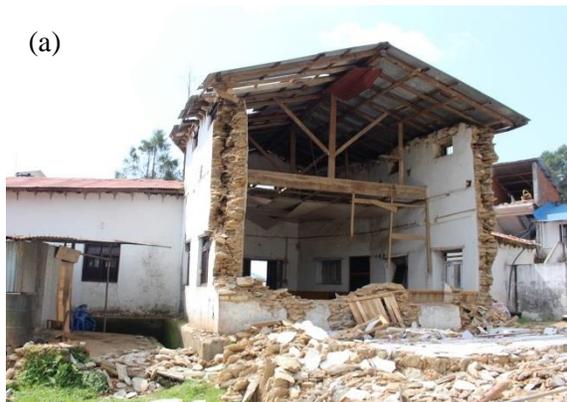
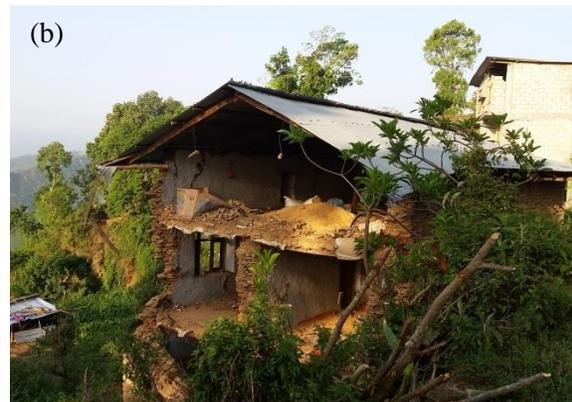
Fig. 31 Out-of-plane cum overturning failures of stone masonry walls.

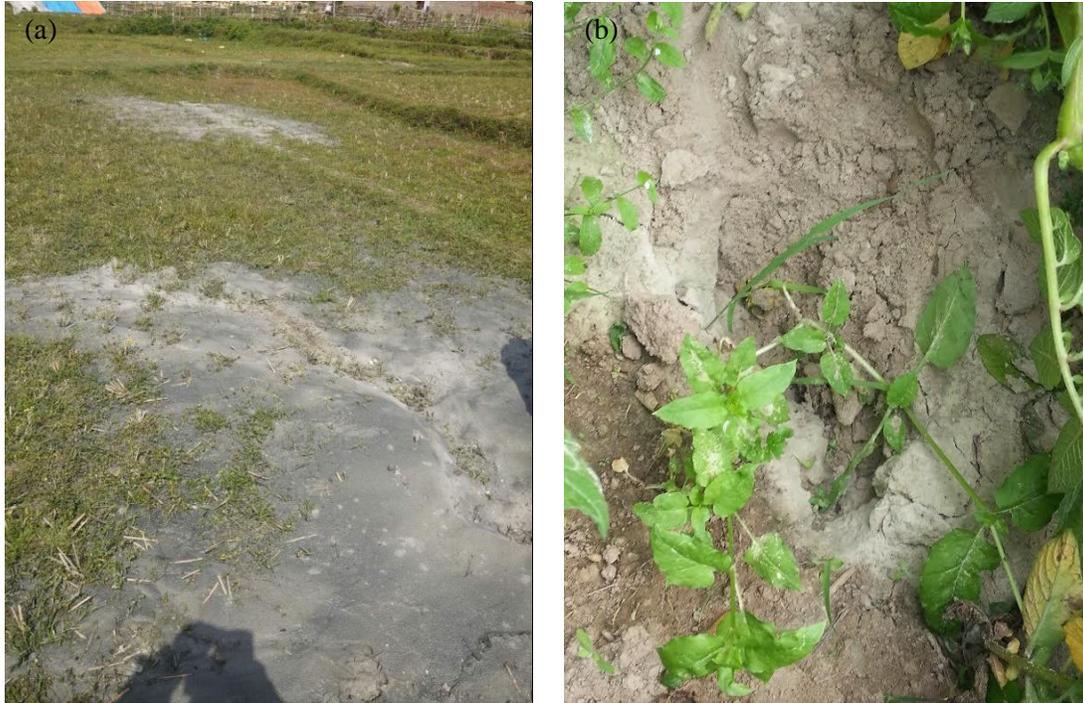
Fig. 33 Liquefaction observed at Kathmandu Valley during the Gorkha earthquake.

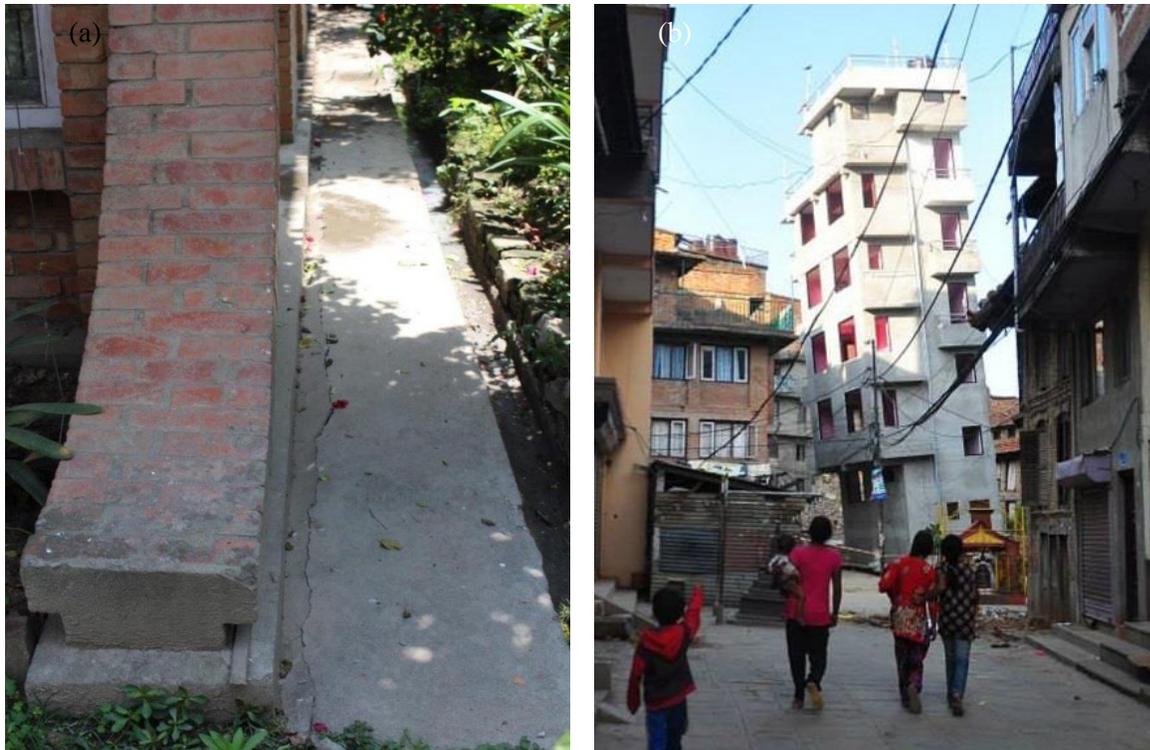
Fig. 34 Settlement induced damages in buildings.

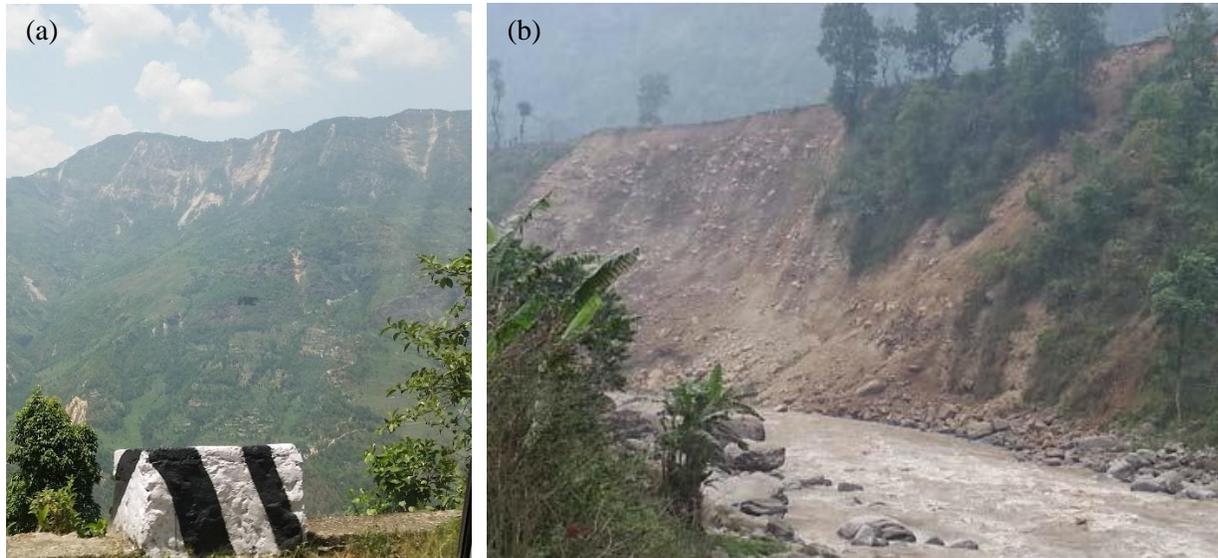
Some of the representative landslide and slope failures observed by the authors during their field visit to Sindupalchowk and Dolakha district is presented here. Fig. 36 shows representative cases of slope failure and landslides observed during the field visit.

Fig. 36 Landslide observed from at Sindupalchowk and Dolakha district.

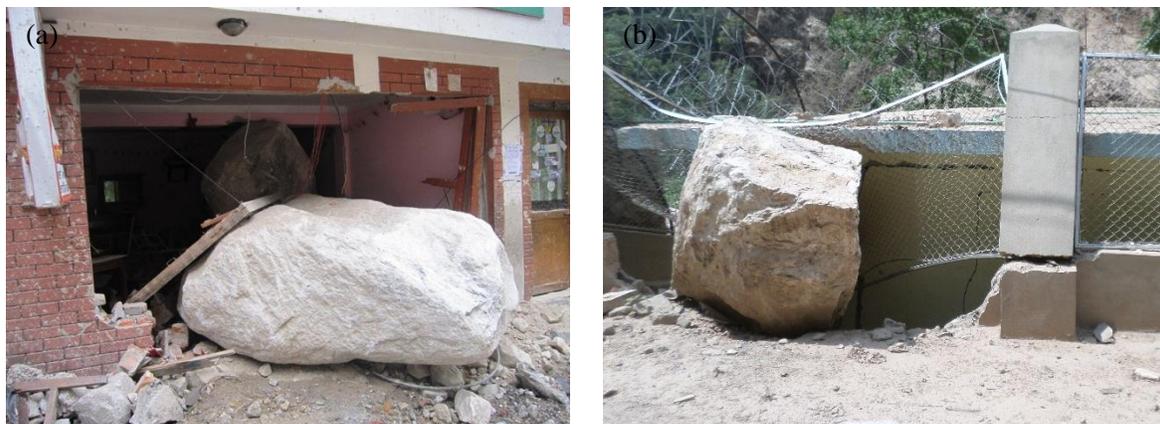
The earthquakes resulted in the instability of rocks slopes and resulted in falling of large rocks. In few incidences, buildings built close to the slope were hit by the falling rocks. Rock fall also led to damages to the vehicles on the road. In many cases, the stones were large and had sufficient energy to damage the buildings significantly. Few representative cases of such damages observed during the field visit is presented here. Fig. 37 presents some the damages observed at Sindupalchowk and Dolkha district.

Fig. 37 Rock fall impact on the built structures.
