Lessons Learned from the Nepal Earthquake 2015

T. Pokharel and H.M. Goldsworthy

Department of Infrastructure Engineering, University of Melbourne, Parkville, 3010, Australia.

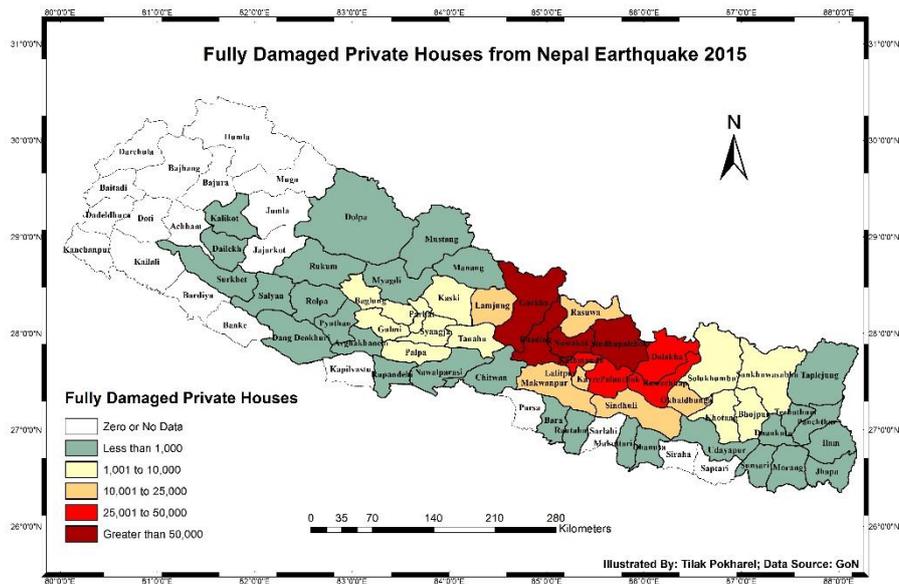
Figure 4: Fully damaged private houses from Nepal Earthquake 2015

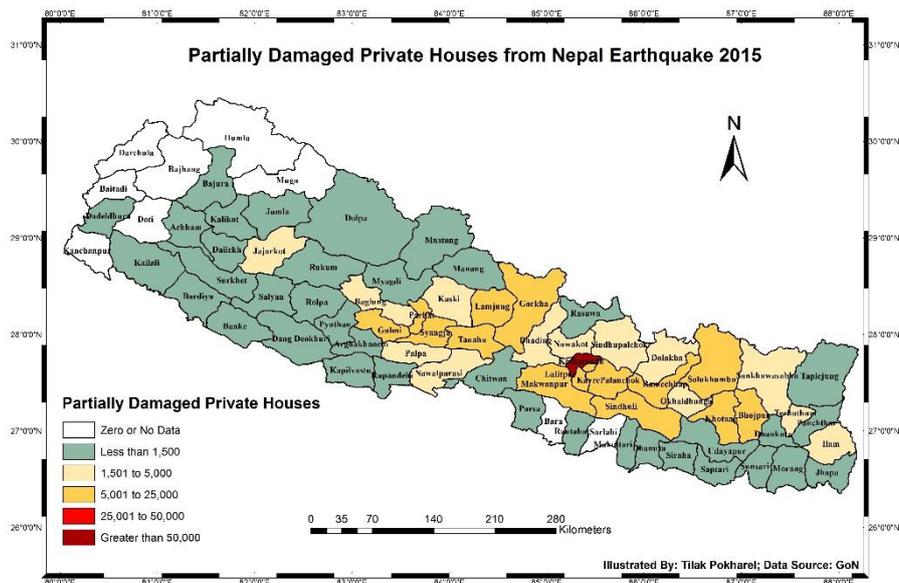
Figure 5: Partially damaged private houses from Nepal Earthquake 2015

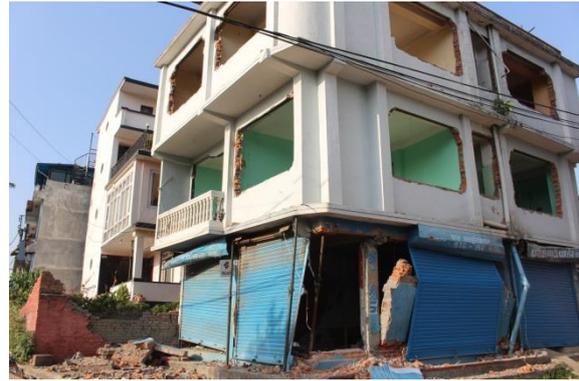
One of the major problems current buildings have is the soft storey effect particularly at (but not limited to) the first storey. This is either because the owner wanted open spaces to sell/rent to the merchants who prefer open space to sell their goods, or for parking purposes. By doing so, the stiffness and the shear strength of that floor decreases significantly and the damage concentrates at that level as shown in Figure 13. Figure 14 and Figure 15 show the soft storey effect in the ground floor. There were shops at both buildings and the stiffness of these stories were significantly low as compared to the stories with brick masonry infill (Pokharel 2015). Figure 16 shows the result of having a weak storey at the third level. The third level was constructed of unreinforced masonry whereas the storeys above and below incorporated RC elements. The weak third storey collapsed completely.

Figure 14: Formation of plastic hinges at the end of the RCC column due to the soft storey effect in Kathmandu.

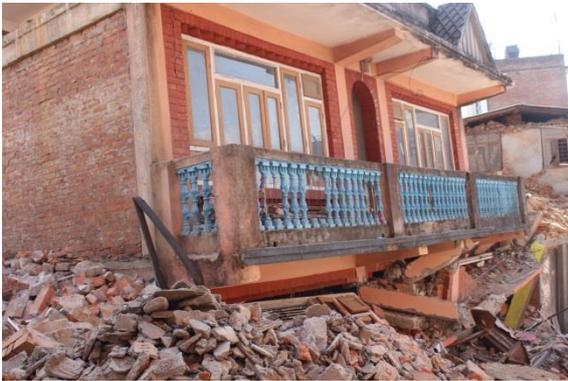
Figure 15: Soft storey effect where bottom storey of the building has suffered damage while the upper story is intact in Sindhupalchowk.

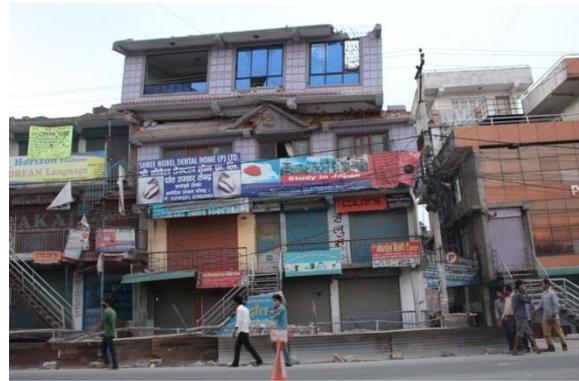
Figure 16: Third storey of the building has collapsed due to the weak storey effect in Kathmandu. The building had RCC moment resisting frames except at the third storey where there was load bearing brick masonry.

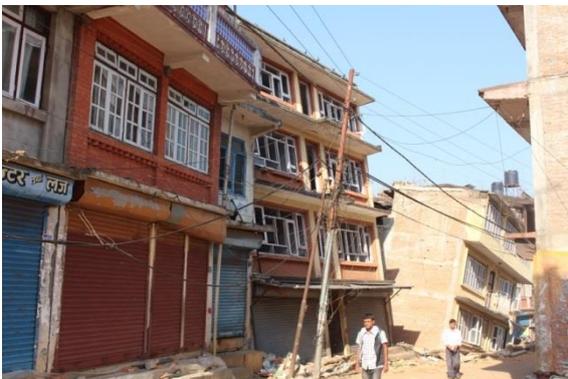
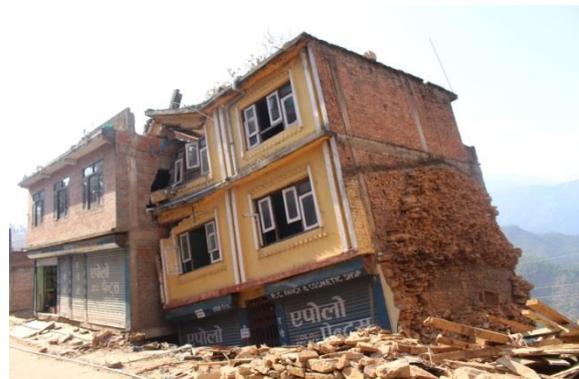
Figure 17: Soft storey failure causing tilting of building.

In some cases, some of the load bearing elements of the building failed while other members survived in the soft storey effect, resulting in the tilting of the building. Figure 17 shows some pictures of soft storey failures leading to the tilting of buildings.

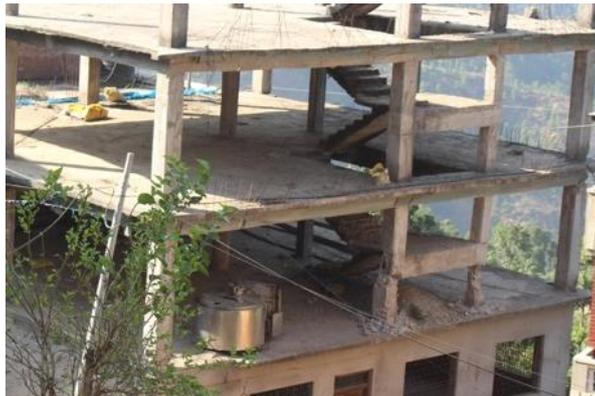
The effect of short columns is often overlooked in the design and construction of the buildings. The short column effect can either result from partial height infill walls, the addition of an extra connection beam to support a staircase, or from sloping ground as shown in Figure 18. When there is a short column in a structure it attracts more lateral shear forces and needs to be designed accordingly. One of the observed effects of short columns due to staircase is shown in Figure 19.

Figure 19: Effect of short column in buildings.

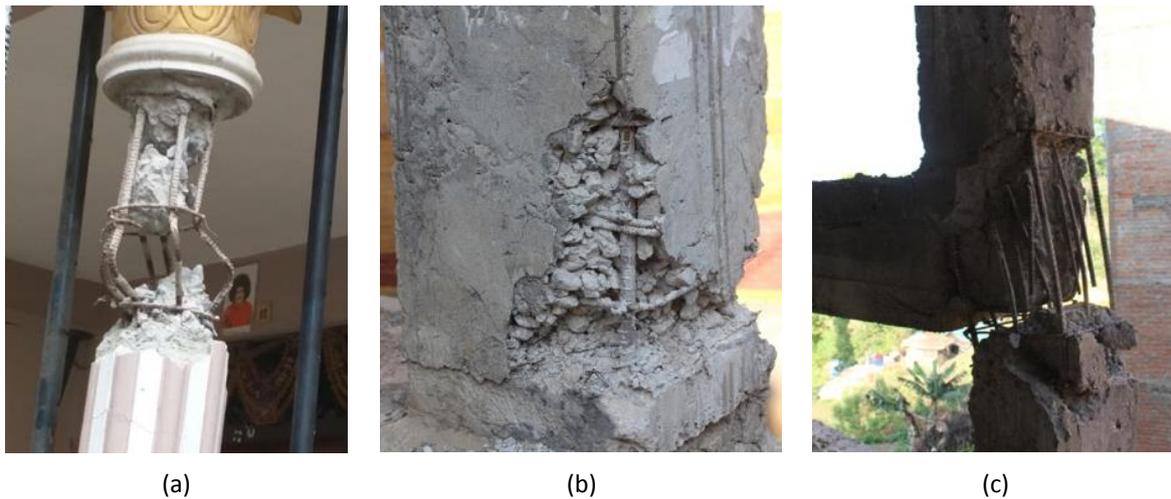
Another major problem with current design and construction practice in Nepal is detailing of reinforcement in reinforced concrete structures. The quantity and quality of the reinforcement used in these building is often inadequate in terms of achieving the required capacity. Strength hierarchies are often not considered, and appropriate detailing is not employed, resulting in non-ductile behaviour. Some of the common detailing problems are insufficiently large spacing of ties in columns and beams, inadequate anchorage of reinforcement, improper bending of hooks, insufficient reinforcement in the connection regions, not enough cover, and improper splicing of reinforcement. Figure 20 shows some of the detailing problems.

Figure 20: Problems in detailing RCC buildings. (a) Inappropriate spacing of ties, (b) bending of hooks to 90° instead of 135° and (c) insufficient shear reinforcement at critical region.

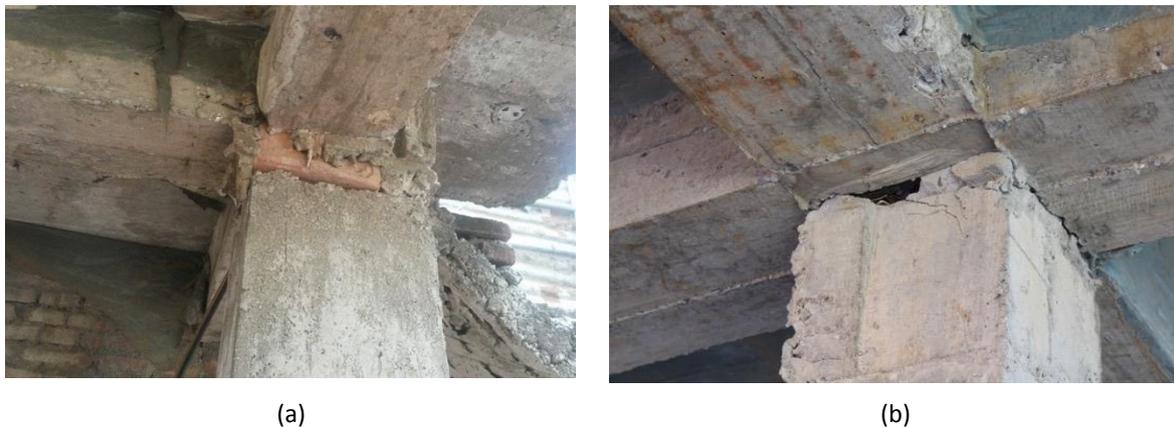
Problems with construction quality were observed at several places. This included mixing of concrete, compaction and placement of concrete, inappropriate use of formwork, and use of recycled reinforcement. Figure 21 shows some of the problems with placing and compaction of concrete in a beam column connection region. It is not common for the material and construction quality to be inspected by an independent inspector at site though there is a provision for this in the code.

Figure 21: Problems with construction quality. (a) brick in beam column connection and (b) cavity in beam column connection

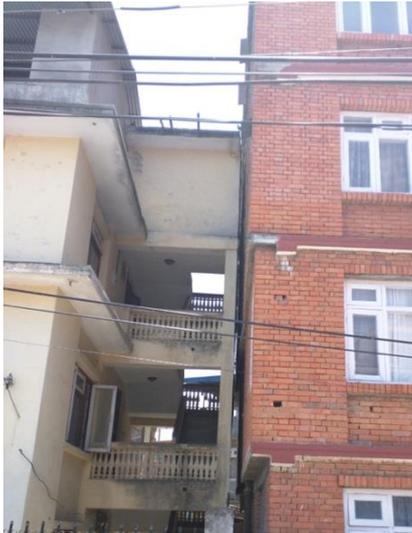
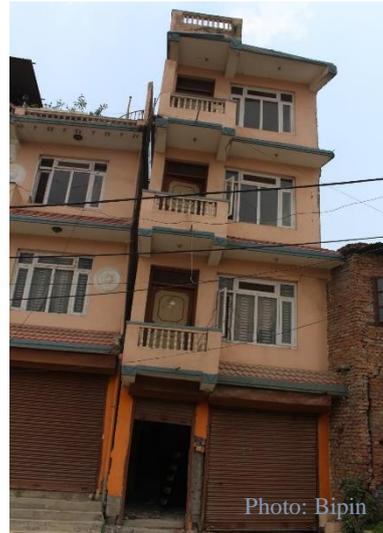
Seismic pounding was also observed at some places. If two buildings do not have seismic joints or a sufficient gap between them and their natural period is different, they collide with each other during the earthquake which causes damage in the weaker structure. If the floor levels of the two colliding buildings are different, the damage will be more severe as the stiff floor hits the other building at the middle of the column. Figure 22 shows the effect of seismic pounding where the floor levels are at different heights.

Figure 22: Seismic pounding between two buildings with different period.

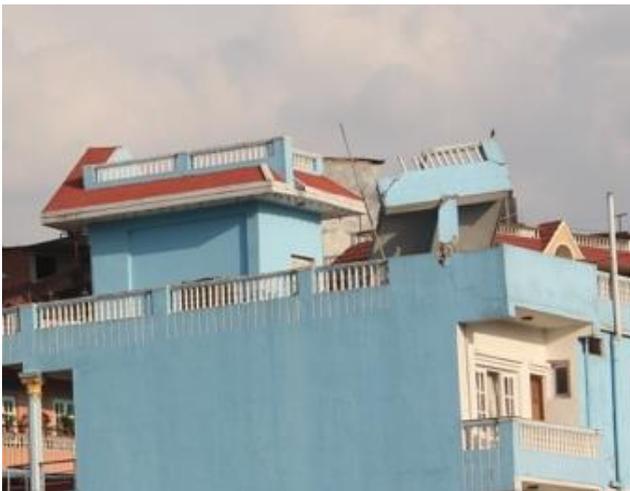
Figure 23: Non-structural damage. (a) Failure of water tank support at top and (b) failure of partition wall in a high rise apartment.

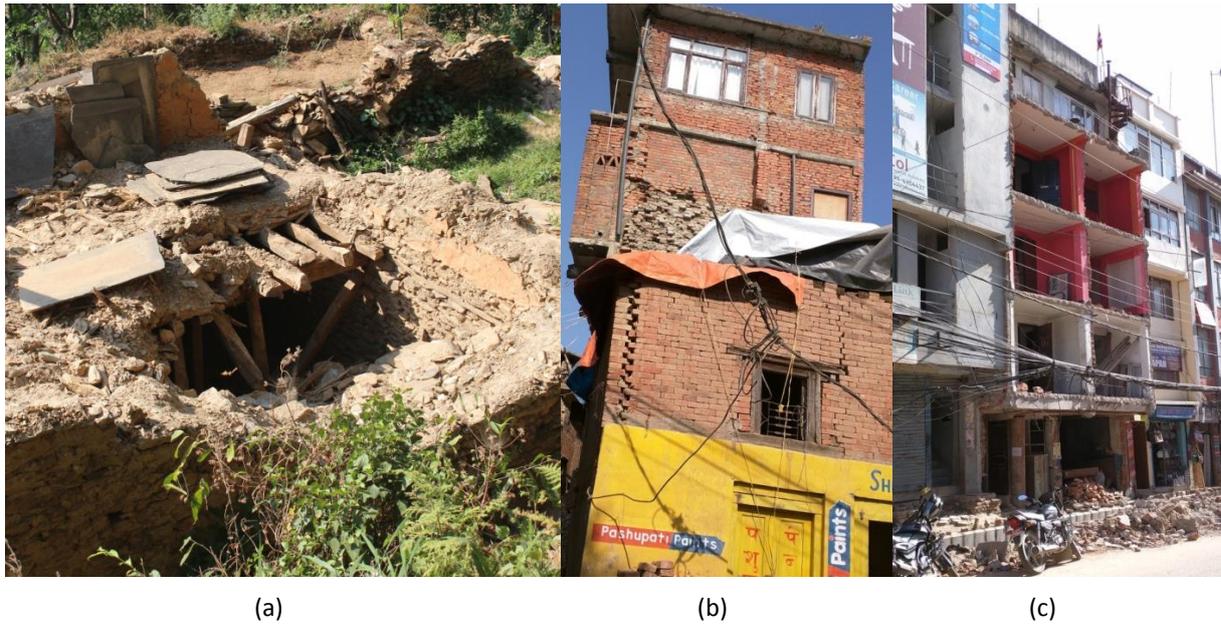
More than 60% of the buildings in Nepal are of unreinforced stone/brick masonry. Most URM buildings use mud as the binding material rather than cement mortar; the mud mortar is very poor in binding stones/bricks together. Most of the casualties in the 2015 Nepal earthquake were from the collapse of URM structures. These buildings were not designed to resist large earthquake forces and became death traps for the occupants. There are several causes of insufficient earthquake resistance including improper choice of construction material, insufficient diaphragm/connection, and lack of maintenance for old structures. Figure 24 and Figure 25 show some of the damage in URM structures.

Figure 24: Problems in URM construction. (a) lack of proper binding between small stones, (b) lack of proper confinement of wall and use of heavy concrete floor on weak brick masonry and (c) lack of anchorage of masonry infill walls.

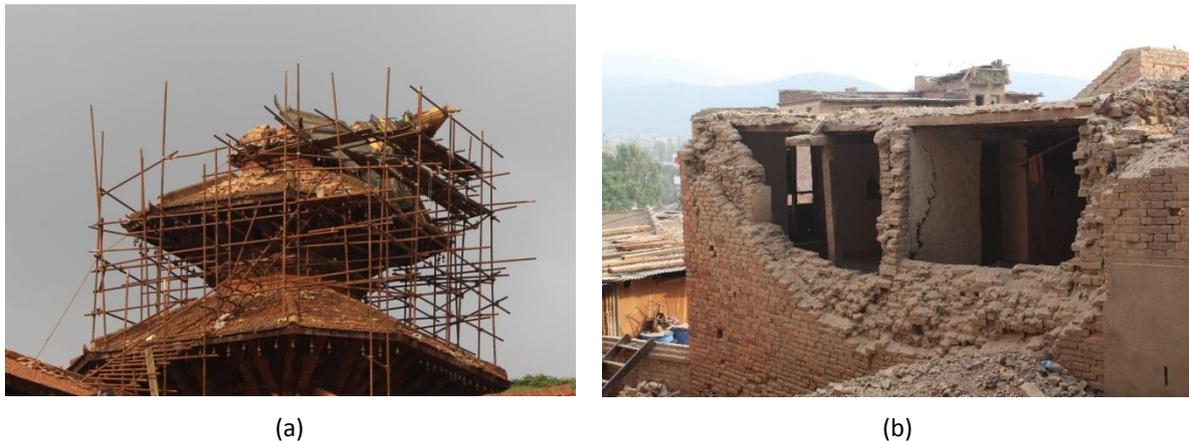
Figure 25: Damage in URM structures. (a) Failure of heavy metal pinnacle of a temple due to the lack of proper anchorage and (b) lack of integrity between two layers of brick wall and of connection to the roof.

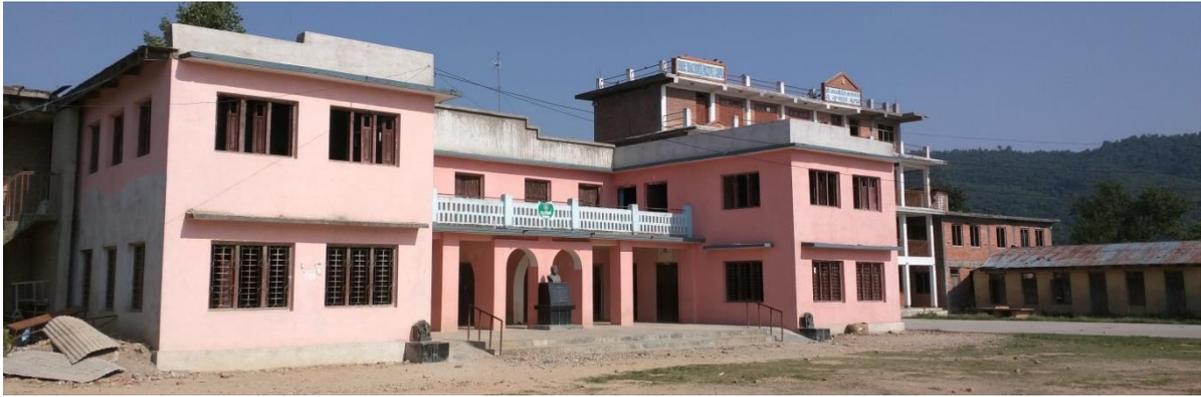
For the buildings that are already constructed, a detailed assessment has to be done. Those buildings that have survived this earthquake might not survive in the next one. Retrofitting is required if their capacity (force and displacement capacity) is less than the demand based on the design codes. Many schools and hospitals had been retrofitted before the earthquake hit and most of them performed well during the earthquake. Figure 27 shows a retrofitted building in Bhaktapur which was operational after the earthquake while the other buildings in the same vicinity were heavily damaged. The retrofitting methods and techniques should use local material and human resources to make it sustainable. Nenyang Technological University (NTU) and the National Society of Earthquake Technology (NSET) have retrofitted some schools in Nepal by wrapping the beams and columns with low cost materials like wire mesh. These schools withstood the M7.8 earthquake and served as shelters for the displaced people after the earthquake (Khew 2015).

Figure 27: Retrofitted school at the middle with the green safe tag on it. Other buildings on its left and right were heavily damaged.
