# Seismic Vulnerability Assessment of Brick Masonry Houses with Street Survey in Developing Countries

Kainat Batool <sup>1</sup>, Gulelalah Ayaz <sup>2</sup>, Majid Ali <sup>3</sup>

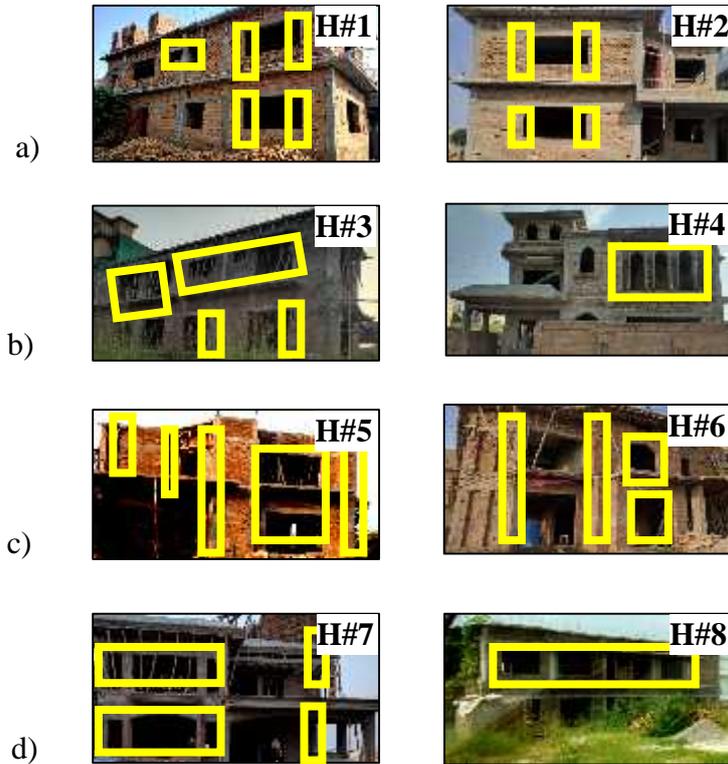
The construction trends of external walls of brick masonry houses of 10 Marla are shown in Figure 2. It can be seen that opening widths and percentages are properly given in "no risk" houses. Only few vertical stiffeners are missing at some uncritical locations like doors and windows. In the external walls of "low risk" houses, vertical stiffeners are provided only at corners and junctions. The vertical gaps between openings are appropriate. The opening widths are within limits and openings are centrally located. There is diversity seen in external walls of "moderate risk" houses with no special measures, even corner stiffeners are missing. Plan and elevation dimensions are in accordance to the nominal brick size used in English bond (see Figure 2c). In "high risk" houses, there are many openings in external walls with no special measures. Stiffeners at two of the four corners are missing. If the larger openings are provided without vertical stiffeners at their edges then it can cause diagonal cracking in brick walls. The horizontal and vertical gaps between openings are also not properly given. In high risk houses, there are brick masonry columns beside large openings (see Figure 2d)

Figure 2: Brick masonry houses of 10 Marla: (a) H#1 and H#2 at no risk, (b) H#3 and H#4 at low risk, (c) H#5 and H#6 at moderate risk, and (d) H#7 and H#8 at high risk

For under-construction houses, following strengthening techniques can be applied: (i) polypropylene bands (arranged in a mesh fashion and embedded in a mortar overlay) can be used to reduce the risk level, (ii) angle sections and steel plates can be used at the connection of perpendicular masonry walls to enhance the seismic performance, and (iii) using rebars in masonry (i.e. making it reinforced masonry) to compensate the provision of vertical stiffeners can be applied to reduce the risk level.

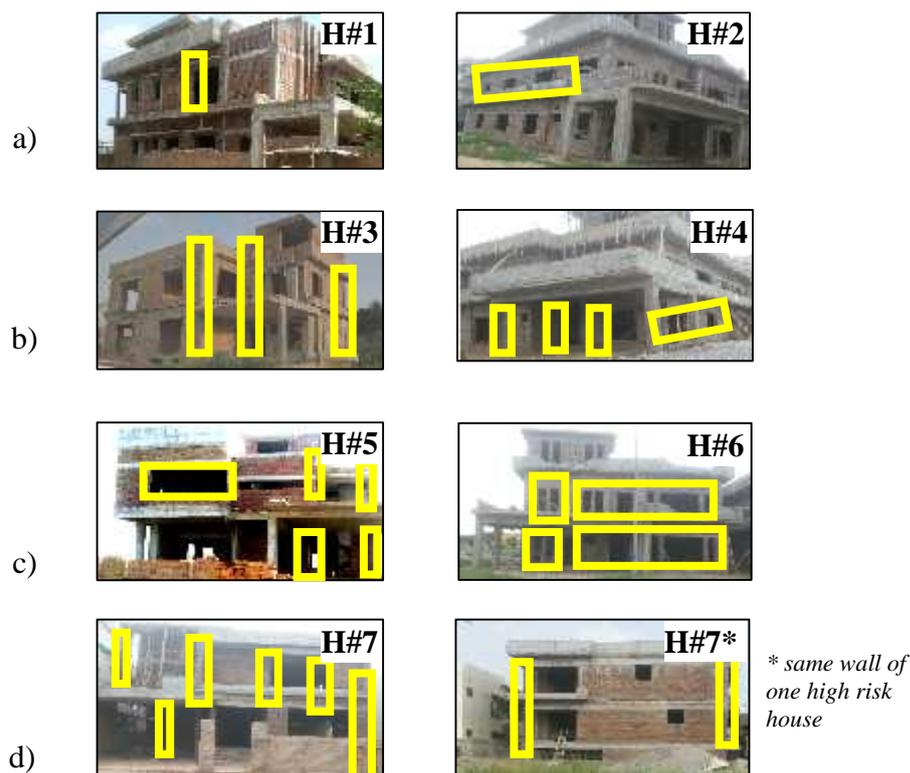
The construction practices of 20 Marla brick masonry houses are shown in Figure 3. In the walls of "no risk" houses, lintel band can be observed which is running throughout the wall. Vertical stiffeners at critical locations are given. Limits for opening widths are followed. The percentage opening of "low risk" houses seems to be fine. One vertical stiffener at critical location (i.e. corner) is missing. Also, stiffeners at uncritical locations are missing. In "moderate risk" houses, stiffeners at some critical locations are not provided. Limits for percentage opening is also not followed in moderate risk houses. Missing vertical stiffeners at corners and other critical locations creates poor connection between two right angled load bearing walls which can cause fractional or full collapse of walls. Also, if lintel bands are not

provided properly, then it can cause out-plane failure of load bearing walls. All of the four corner stiffeners are missing in "high risk" house. Also larger openings without any special measures are provided on all external walls. Achs and Adams (2012) developed the rapid visual screening method to categorize structures based on several parameters to capture the effects of possible damages under earthquake loading. Furthermore, the outcome of the proposed methodology supplied a good prediction of the damage distribution within the pilot area considered. But, in this project, risk evaluation study is carried out by conducting street survey of grey structures which have focused entirely on the flawed construction practices being followed.

Figure 3: Brick masonry houses of 20 Marla: (a) H#1 and H#2 at no risk, (b) H#3 and H#4 at low risk, (c) H#5 and H#6 at moderate risk, and (d) H#7 at high risk
