Use of Pine-Needle Reinforced Composites in Kashmir, Pakistan – A Critical Review

Amir Hayat¹, Hamza Khan², Riaz Ul Haq³ and Majid Ali⁴

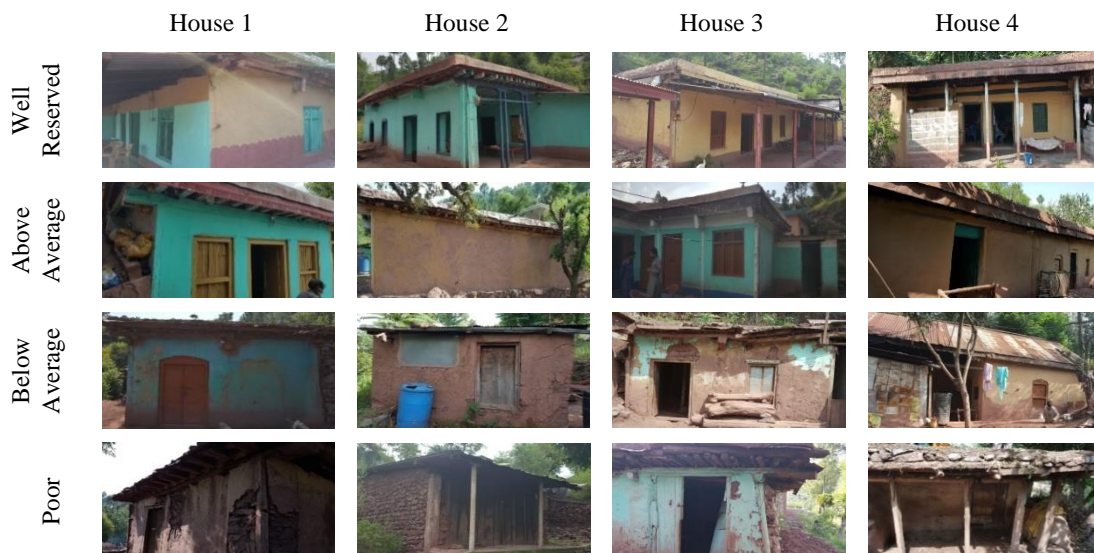
Fig. 2 Selected houses of different conditions in Kashmir Pakistan

Selected houses of different conditions (i.e. well reserved, above average, below average and poor) are shown in Figure 2. Wooden stiffeners (i.e. columns) are used in almost every house. The conditions of these houses are also dependent on these wooden stiffeners. Because, with the passage of time, these wooden stiffeners are liable to vermin attack. In addition to this, shrinkage due to weather, regular maintenance and labor expertise are also important factors. In rainy season, the mud starts eroding with water and ultimately cracks appear. It is also observed that, due to capillary action, walls get wet in areas of high water table. That is why, regular maintenance is very necessary. Stone masonry is not properly adjusted in the walls of below average and poor houses by inexperienced labors. Well reserved houses have good quality of construction and are maintained regularly.

Well reserved houses are made of good mud/soil type. The bond between soil, pine needle and stone is proper. This is so because soil is retained by pine needle. Above average houses are not well maintained and soil type is not as good as that of well reserved. By little repairs, these houses can be made useable for residence also. Below average houses are in sever condition and soil type is very poor. But the pine needle holds the mud together. These houses can be useable only after repair for storage purposes. Poor houses cannot be repaired so it is better to demolish and reconstruct.

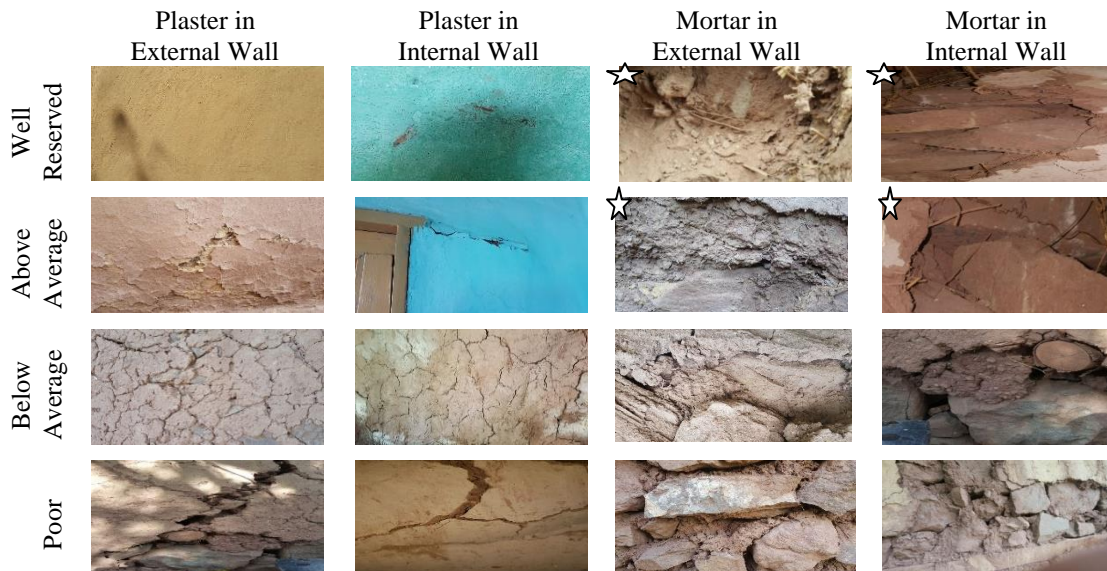
Observed cracking pattern in plaster and mortar of exterior and interior walls of load bearing walls with pine needle reinforced mud are shown in Figure 3. It may be noted that the plaster was intentionally removed to check mortar in walls of well reserved and above average houses. Cracks usually develop due to shrinkage because of loss of moisture. Only hairline cracks are found in plaster of well reserved houses. Minor spalling and zig zag cracks are found in above average houses which are not severe and need little repair. In below average houses, diagonal and zig zag cracks are developed which are thin and deep. These are the severe cracks and need major repair. Poor houses are more severe because of diagonal and horizontal crack and major spalling. So, poor houses need reconstruction.

Fig. 3 Observed cracking pattern in plaster and mortar of exterior and interior walls

(Note: ☆ means plaster was intentionally removed to check mortar)

The cracks in the external and internal walls of below average and poor houses can be repaired by replacing the existing plaster with new one. For the cracks across the wall thickness, remove plaster, anchor pine-needle mesh and replaster both sides of wall.
