Evaluation of Seismically Retrofitted Masonry Substation Buildings

Noor Aina Misnon^{1,2}, Dmytro Dizhur³, John Mackenzie⁴, Shannon Abeling⁵ and Jason Ingham⁶

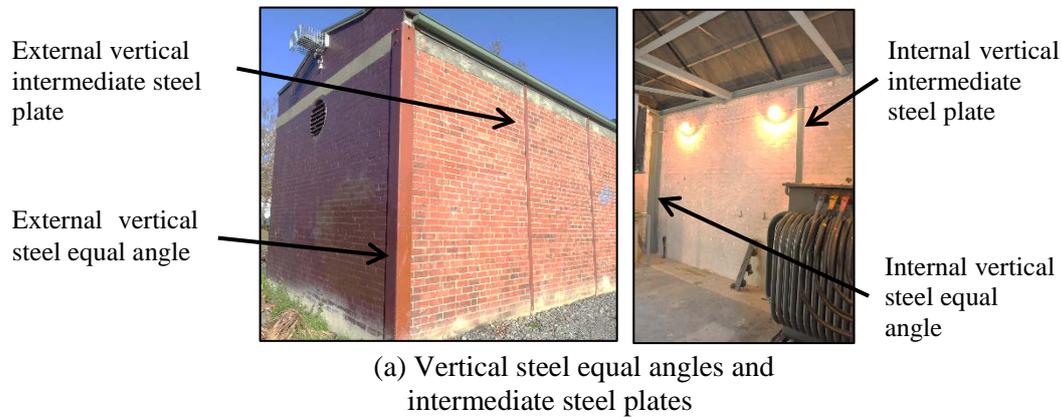
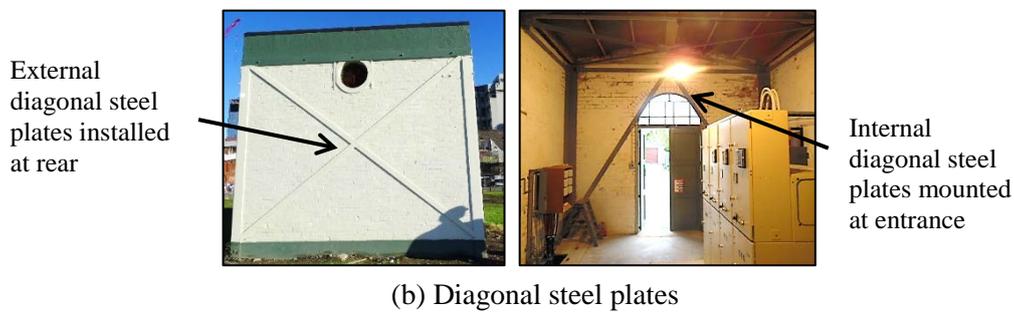
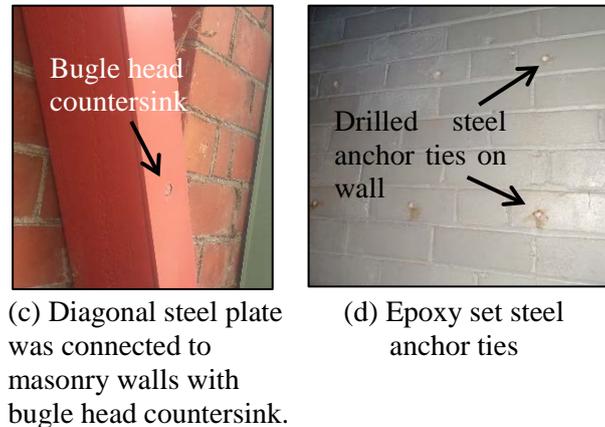
Traditional retrofitting methods of reinforcement, braced steel frame, and anchored steel ties were used for walls retrofitting work. The braced steel frame consists of vertical and diagonal steel members. These members were installed at corners of the substation buildings and walls either externally, internally or a combination of the two. These buildings contain a large number of equipment such as switch gears, transformers etc. thus, retrofitting members were positioned in the most convenient places. Priority was given to interior but where accessibility was not possible, the steel members were installed externally. The vertical steel angles were common at the corners and intermediate walls of the buildings (Figure 5a) while diagonal steel members were generally mounted at the entrance and the rear walls (as seen in Figure 5b). The intermediate vertical steel plates improved out-of-plane behaviour of URM by effectively reinforcing the walls as tension members and also by holding down the concrete perimeter bond beam at eaves level and the strip foundation to confine the URM walls. Meanwhile, the diagonal steel plates were added to improve both the out-of-plane strength of the masonry walls and to provide reliable in-plane shear strength to the front of the overall building. Fasteners known as bugle head countersinks (Figure 5c) were epoxy set to connect the diagonal steel plates to the masonry walls. Both steel members (vertical and diagonal) provided additional confinement to the masonry walls of the substation buildings.

The use of anchored steel ties assisted in reducing the chance of out-of-plane failure of the outer walls from earthquake shaking. As described in Section 2.0, most of the walls of the substation buildings were constructed with double leaves. These leaves generally are not connected resulting in a high risk of collapse of the outer walls. Figure 5d shows an example of a substation building retrofitted with steel anchored ties.

Figure 5: Walls bracing with steel elements as part of seismic retrofit

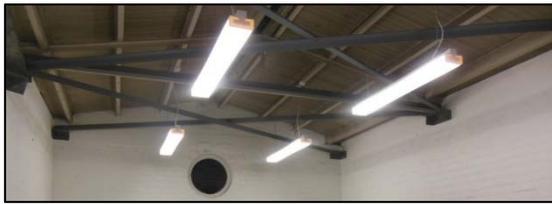
(a) Typical roof bracing of flexible diaphragm

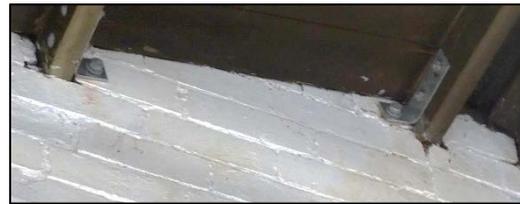
(b) Steel brackets bolted at purlin

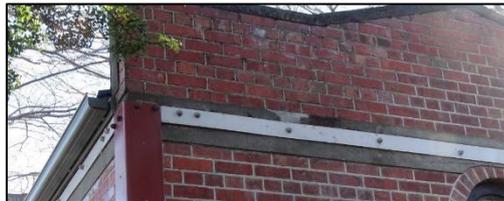
(c) Steel plates mounted on perimeter beam

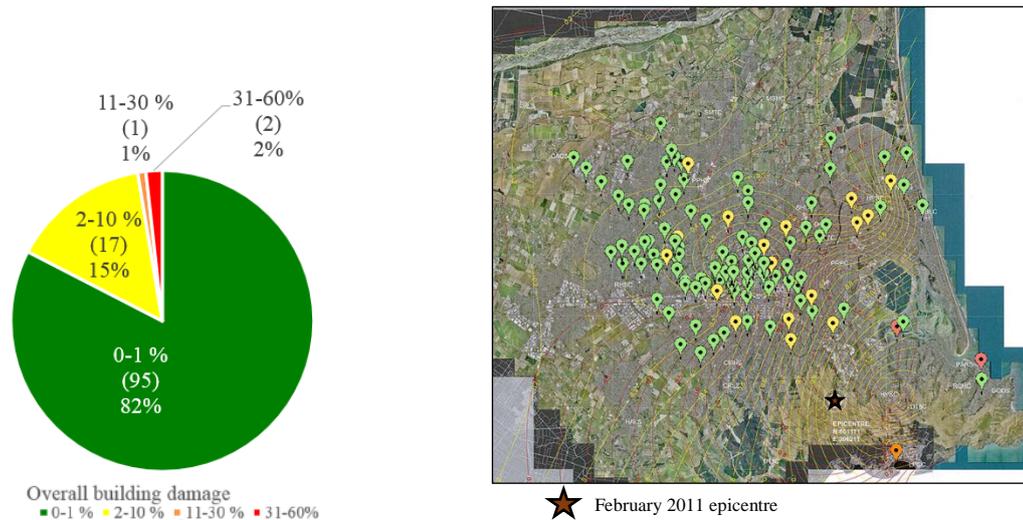
The Level 2 rapid evaluation procedure can only be performed by professional engineers with broad technical experience and these assessments were used to estimate a percentage range of overall building damage as described in Table 2. Of the 115 clay brick masonry substation buildings, 95 buildings were estimated to have 0-1% damage, 17 buildings experienced 2-10% damage, one substation building in Simeon Quay had significant damage, and two substation buildings located at Wakefield Avenue and at St Andrew Hills suffered from 31 – 60% damage.

(a) Analysis of observed buildings damage

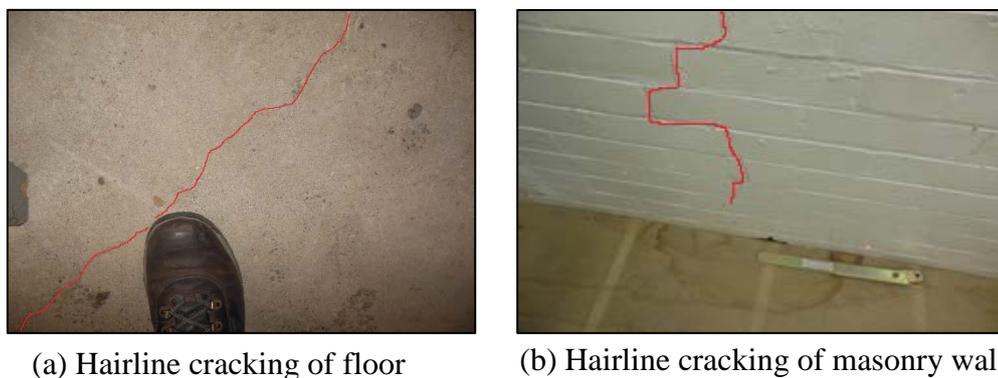
Figure 9: Observations of minor damage

Buildings with a damage estimation rate of 0–1% represented buildings with none to very minor damage (Figure 9) and these buildings could be immediately occupied as no safety concerns were highlighted. 62% (59) of the 95 buildings with minor damage were labelled with green placards, G1 (no immediate further investigation required) while 38% (36) were tagged with G2 (repairing works are required). Minor to moderate damage buildings was about 2–10% (Figure 10) and labelled with green placards (3 and 14 buildings with G1 and G2 label respectively). Most of the buildings assessed with this damage level experienced ground movement or settlement that caused foundation settlement and floor damage (Figure 10c). Re-leveling works had to be performed to those buildings having noticeable foundation movements. Damage that was associated with parapet also could be observed by the parapet movement. Repair works included the provision of addition steel rods for restraining the parapet from collapse.

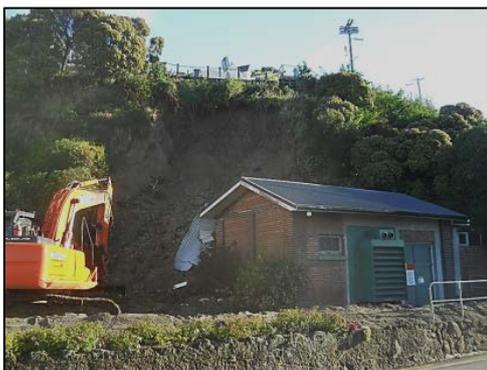
A substation building in Simeon Quay was located at the base of a clay cliff and suffered significant damage due to rock fall from a landslide (Figure 11) that damaged the rear part of the building and caused significant damage to the roof. The strengthened walls performed well with only minor damages being observed.

(a) Rock fall from a landslip hit the rear part of Simeon Quay Substation

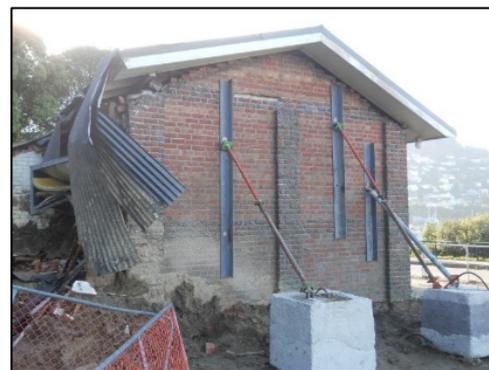
(b) Precautionary propping of Simeon Quay after a severe landslip

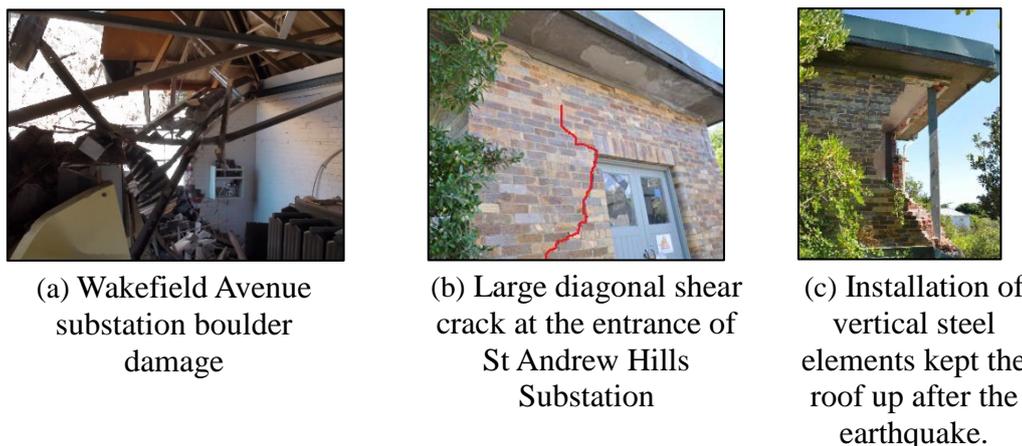
Two substation buildings in Wakefield Avenue and St Andrew Hills suffered heavy (31-60%) damage (Figure 12). Both buildings were close to the epicentre of the February 2011 Christchurch earthquake, with an estimated PGA of 1.2g (Figure 8b). The damage to the Wakefield Avenue substation building was attributed to boulder damage that caused collapse to approximately 50% of the substation building, resulting in the substation building being decommissioned and bypassed. Nevertheless, due to seismic retrofitting, the front portion of the building remained intact. The St Andrew Hills substation building suffered diagonal shear failures and partial collapse of the north and east URM walls due to significant earthquake shaking, although the seismic retrofitting system of the building held the roof up (Figure 12) and the transformer remained operational while demolishing works were undertaken. The building has since been demolished and replaced with a steel kiosk.

Figure 12: Heavy damage to Wakefield Avenue and St Andrew Hills substation buildings
