A multidisciplinary evaluation of URM buildings successfully retrofitted prior to the 2010/11 Canterbury earthquake sequence

Shannon Abeling¹, Dmytro Dizhur² and Jason Ingham³

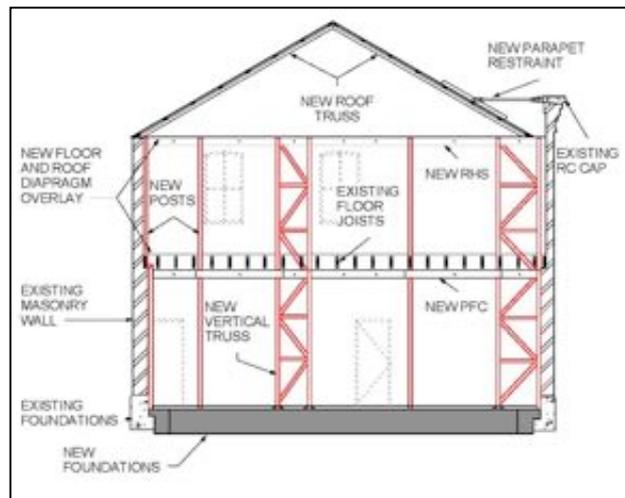
Vertical steel trusses comprised of 100 x 100 x 6 mm square hollow section (SHS) posts with 75 x 75 x 5 mm SHS braces offer a displacement compatible solution that provides additional in-plane stiffness to the masonry walls (Figure 1d). The two storey vertical steel trusses were prefabricated and installed by being dropped through the roof during a stage of construction when the ceiling was removed. New heavily reinforced concrete (RC) foundations were constructed along the perimeter of the building and attached to the existing foundations with 16 mm high yield reinforcement (H16) steel fixings that were epoxy anchored 200 mm deep at 600 mm centres to resist the significant uplift forces caused by the new vertical trusses. The vertical trusses are positioned such that the steel members sit against the three wythe walls on the ground floor and are offset with blocking from the two wythe walls of the first floor. The 100 x 100 x 6 mm SHS posts follow the step in the masonry at the first floor and are installed in selective URM piers to provide walls with out-of-plane stability (Figure 1d).

The parapet restraints from the 1970s renovation were removed and replaced with new 33.7 x 3.2 mm circular hollow section (CHS) braces. The braces were attached to a concrete cap beam that extends along the URM parapet with two 200 mm long M16 epoxy anchors and were bolted to 100 x 100 x 6 mm angles that were screwed through at least three roof purlins into the new timber roof trusses (Figure 1d).

(d) East elevation, showing retrofit

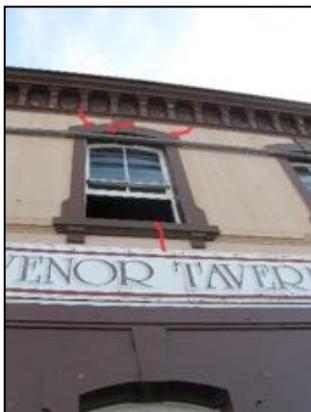
(e) Cracking in exterior façade, after 4 September 2010

The Grosvenor Tavern was in the initial stages of the retrofit work when the September 2010 earthquake occurred. The brick façade experienced minor cracking as seen in Figure 1e but no further damage was reported. The retrofit work quickly resumed and the vertical steel trusses were installed in November 2010. The building was undamaged in the February 2011 earthquake such that the vertical steel trusses remained attached to the masonry walls and there was no differential movement observed between the walls and floor diaphragm. The structural seismic system of the retrofit was proven effective when the building received a green placard upon post-earthquake inspection (Figure 1g). The seismic retrofitting work and building alterations were fully completed in June 2011 and the building is now operational. The Grosvenor Tavern is now the last remaining 19th century URM building on Moorhouse Avenue. The building was awarded a Civic Trust award in 2011 for significant restoration of a heritage building and for the maximisation of complimentary use of a heritage building.

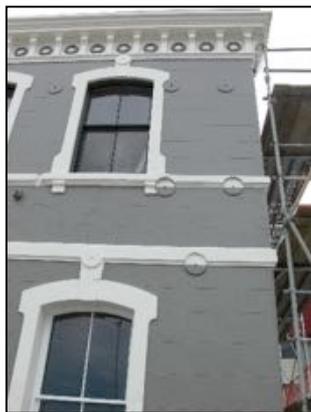
(f) Wall anchors painted to match façade, 2011

Heritage features of the façade are accentuated by being painted a bright white against the grey paint on the masonry, and the anchor end plates that connect the steel frames to the masonry wall are painted to match the façade so that they are hardly noticeable from a distance. The vertical steel trusses are evenly spaced between windows in order to retain views from the building. Windows in the new timber walls are detailed such that they are nearly identical to the façade windows.

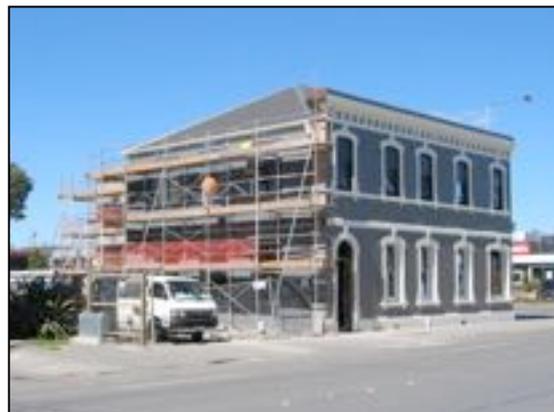
(g) Undamaged building, days after the 22 February 2011 earthquake.

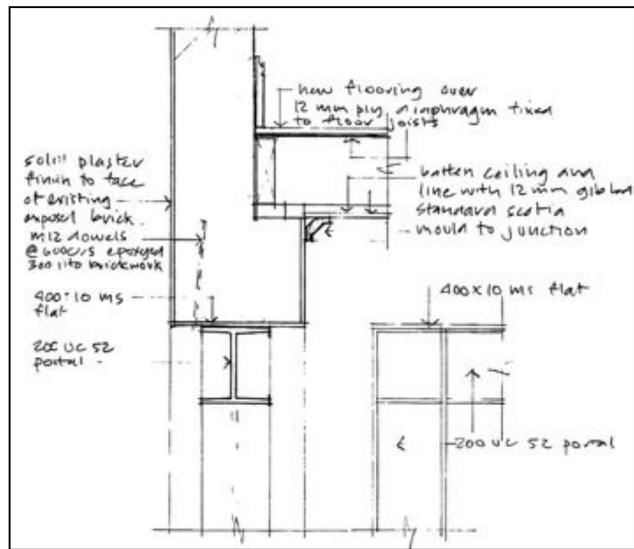
New openings were created in the original southeast and southwest exterior ground level URM walls and MRFs made up of universal columns (200 UC 52) were installed to support the lateral and gravity loads of the new openings. The MRFs were designed to be sufficiently stiff such that they are displacement compatible with the existing masonry walls. The beams are each topped with a 400 x 10 mm mild steel flat bar that is epoxy anchored to the existing masonry with 12 mm diameter threaded anchor bolts (M12) 300 mm long at 600 mm centres (Figure 2d) and the columns are secured to the existing masonry walls with 300 mm epoxy anchor bolts. The original wall foundations under the new MRFs were thickened on both sides by 400 mm of new concrete secured with 12 mm diameter steel reinforcing Grade 300 bars (D12) epoxy set into the existing foundation at 200 mm centres top and bottom. An additional MRF made up of 250 PFCs was constructed on the northeast wall. New beams (250 UB 31 or 200 UB 30) were installed under the existing floor joists in locations where interior masonry walls were removed.

(d) Detailing of MRFs

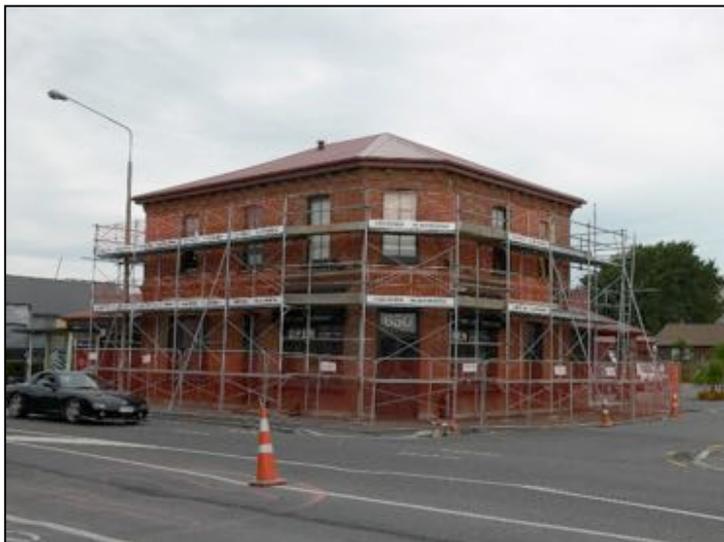
(e) Exterior repairs underway after 22 February 2011

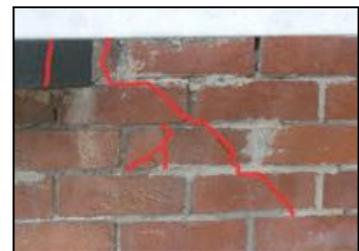
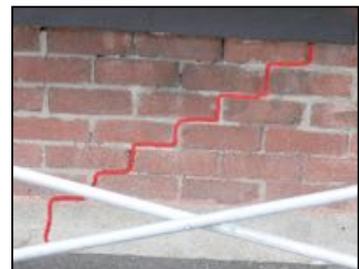
(f,g) Cracks in exterior walls, after 22 February 2011

The exterior brickwork of the Smokehouse building did not experience any visible cracking in the September 2010 earthquake. However, vertical cracks at the front corner section, minor horizontal cracks above one of the piers on the second level, and minor cracks around the in-fill window were found on the interior. Repair work was underway when the 22 February 2011 earthquake occurred (Figure 2e). Additional cracking on the interior and new damage to the exterior brickwork was found (Figures 2f,g) and the building received a yellow placard (restricted use – short term entry). The damage was readily repaired and the Smokehouse building reopened soon after the earthquake. The performance of the retrofitted building that resulted in minimal interruption to the business operations, coupled with the architectural attention to heritage features, allow this retrofit to be regarded as an exemplar.

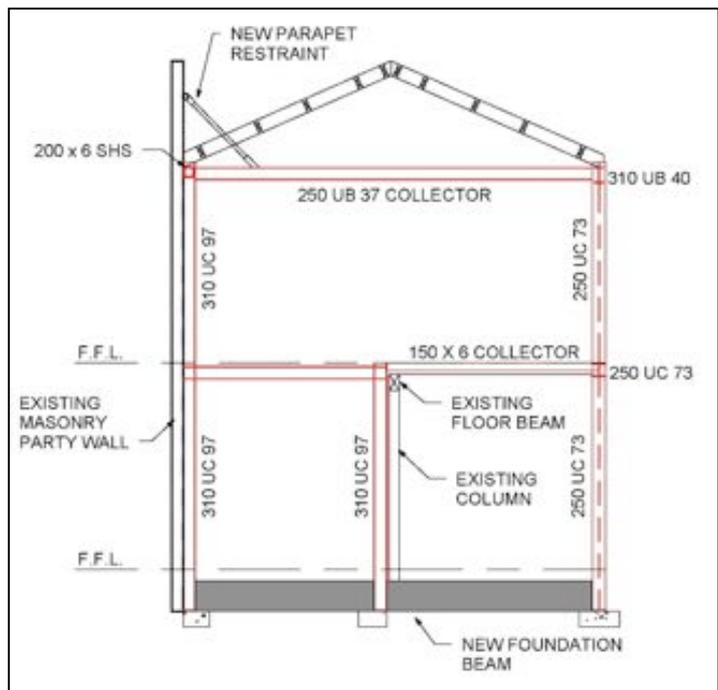
posts. The columns of the new steel MRFs were installed in line with the existing timber columns (Figure 3d,g). The MRF along the north wall is made of full height 310 UC 97 columns with 200 x 6 mm SHS beams positioned below the roof truss (Figure 3g) and the UCs are connected to the masonry wall with two epoxy set M12 bolts at 400 mm centres. The SHS beams are welded to 100 x 10 mm plates at 750 mm centres that are fixed to the masonry wall with epoxy set M16 bolts. The MRF to the south is made up of full height 250 UC 73 columns with 310 UB 40 beams at the roof and 250 UC 73 beams with 150 x 6 mm mild steel (MS) flat collectors at the first floor (Figure 3g). Single story 310 UC 97 columns were installed next to the existing interior timber columns and are connected to the north wall with 460 UB 67 collector beams and to the south wall 150 x 6 mm MS flat plate collectors (Figure 3g). The north and south MRFs are connected with 250 UB 37 collector beams at the roof (Figure 3g).

(g) Typical frame elevation looking east, showing retrofit
