The Newcastle Earthquake and the Masonry Structures Code AS3700

Adrian W. Page¹

Abstract

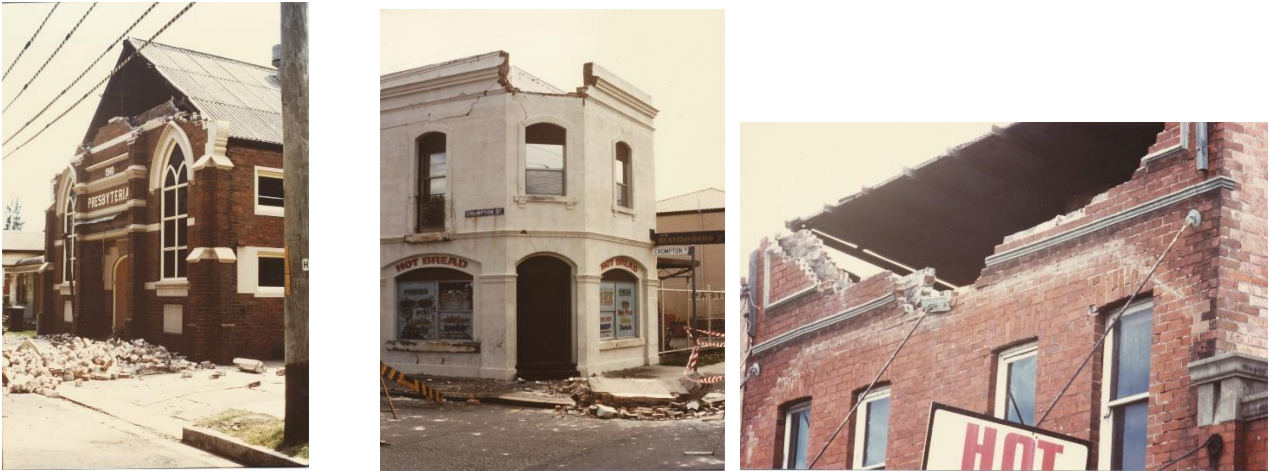
Figure 1. Damage from face loading (Page)

produced by a lateral load acting on a brittle material with low tensile strength. As shown in Figure 1, damage from face loading includes failure of free standing elements such as parapets and chimneys, gable end failure, damage to walls from flexural cracking, excessive frame deflections, and sliding on damp-proof courses. This effect is exacerbated when the masonry lacks appropriate edge support (as in untied gable ends).

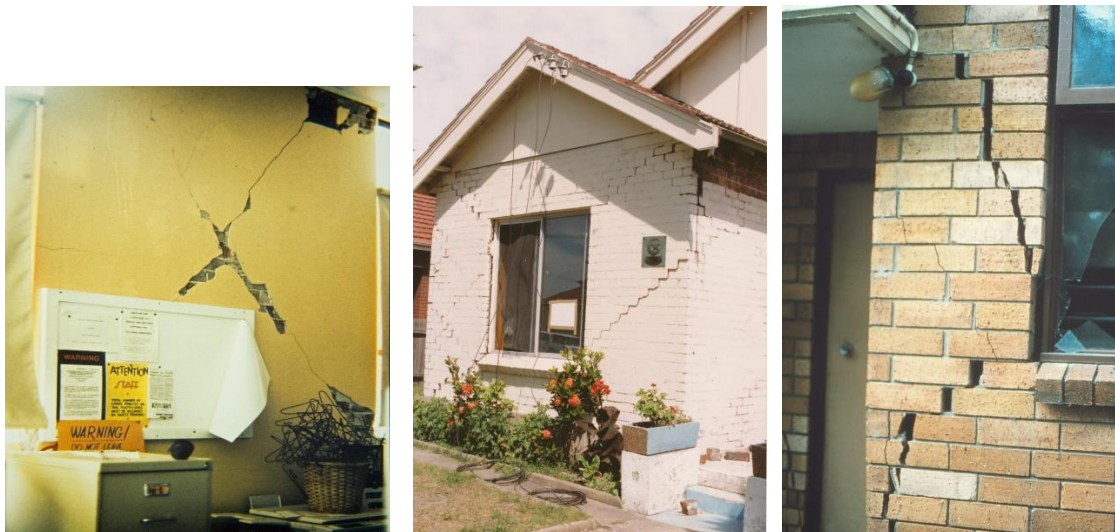
Figure 2. Damage from in-plane loading (Page)

When the ground motion is parallel to the wall, racking damage results. This can be relatively minor (in the form of fine diagonal cracking), or quite substantial cracking and damage requiring major repair (Figure 2). If timber floors or roofs do not have the necessary level of stiffness to act as effective in-plane diaphragms, excessive lateral deflection of the buildings will occur at these levels, with consequent distress in walls attached to the floor or roof system.

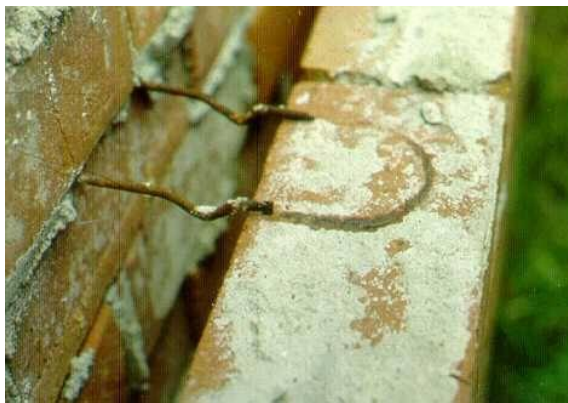
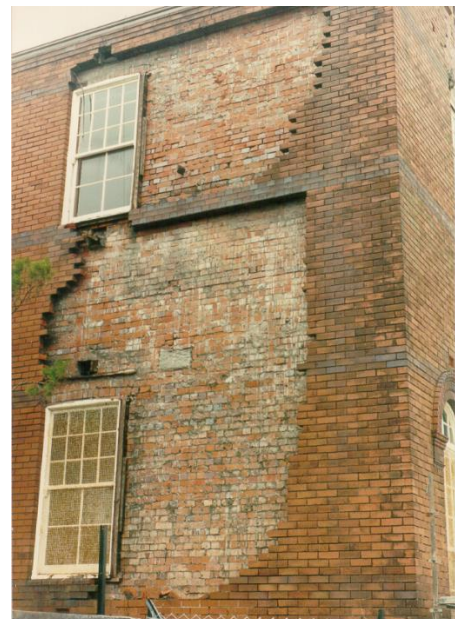
Figure 3. Wall tie corrosion (Page)

Deterioration of buildings was a contributing factor to damage, and in general, older buildings fared worse than their modern counterparts for this reason. Most of these buildings were constructed from brick cavity masonry with weak lime mortar joints (often in a state of deterioration). The strength of the masonry was low, as was its capacity to anchor wall ties. There was already evidence of masonry deterioration in older buildings prior to the earthquake, and this phenomenon is almost certainly not confined to Newcastle. Wall tie corrosion was widespread and worst in exposed walls and in buildings located close to the coast, with the worst corrosion occurring in the bed joints of the outer leaf of cavity walls. The presence of corroded or inadequately anchored ties resulted in the loss of support for cavity walls against lateral loading, with subsequent distress or failure (Figure 3).

The aftermath of the Newcastle Earthquake revealed significant problems related to the various aspects of masonry durability, particularly with regards to ties and fitments in older structures. In particular, the corrosion of wall ties in the bed joints of the outer leaf of exposed, south facing cavity and veneer walls was fairly common. It is likely that these ties could have been corroded for some time, but this only became apparent when the walls were subjected to significant face loading from the earthquake event. It is also important to note that since the bulk of the corrosion occurred in the bed joints of the outer leaf, this would not necessarily be revealed by any form of optical inspection of the wall cavity.

The review of the durability provisions of AS3700 after the earthquake resulted in significant revision and enhancement of the provisions to ensure adequate durability performance of the mortar, masonry units, reinforcement and built-in components (including wall ties) under the full range of exposure environments ranging from “*interior protected*” through to “*exterior severe marine*”. For each exposure environment, requirements for masonry unit salt attack resistance grade, mortar class, durability class of built-in components and reinforcement cover are provided.

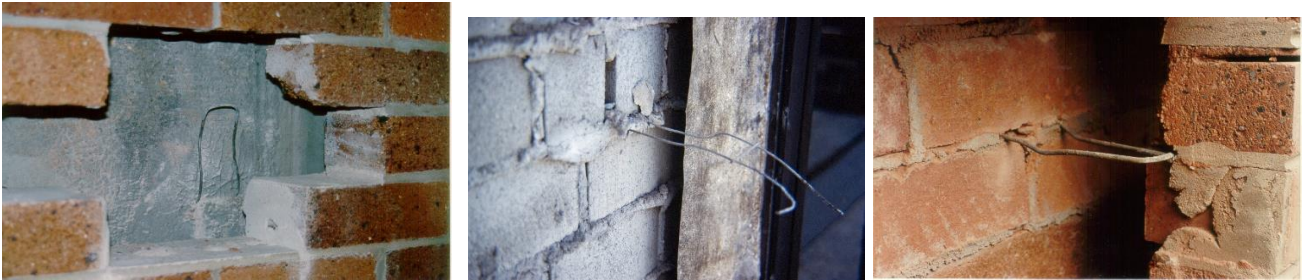
The ability of masonry to resist lateral loads depends upon its inherent strength, (particularly its bond strength), and its effective support and attachment to the other elements of the building. Shortcomings in these areas were common, with glaring examples even in modern "supervised" engineering structures. These included wall ties being bent down and not engaged, complete omission of tying systems, low bond strengths due to abuse of mortars (particularly overdosing with plasticisers), no provision for movements between wall and frame, and generally poor standards of workmanship (see Figure 4). It was apparent that,

Wall tie “abuse”

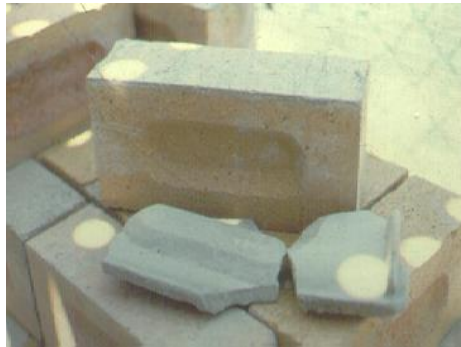
*Loss of bond due to overdosing
Mortar plasticisers*

As previously described, there was widespread evidence of poor masonry bond strength in both new and old construction. Subsequent research indicated that the prime cause of the bond strength reductions was the lack of adherence to the AS3700 mortar requirements, and in particular, the use (and overdosing) of plasticising agents such as air entrainers or fire clay (Sugo et al. 1996). Figure 6 shows the results of a Newcastle bond study on the influence of air entraining agents on bond strength (note that field observations revealed overdosing rates up to 40 times the recommended level). In-depth studies of the influence of other supplementary cementitious materials on bond strength were also carried out (Lawrence et al. 2008), with the outcomes being reflected in the revised masonry standard.

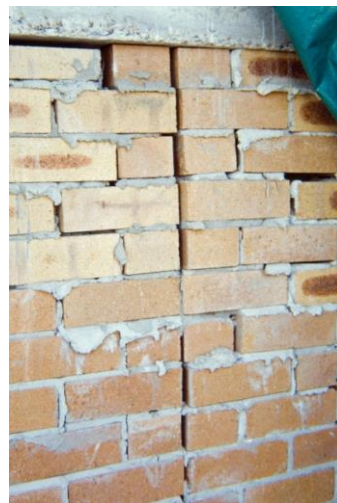
Poor workmanship
