# Seismic Upgrade of Heritage Masonry – A Case Study of St Peter’s Cathedral in Adelaide

**Keywords:** Heritage construction; seismic retrofit; historical stone masonry

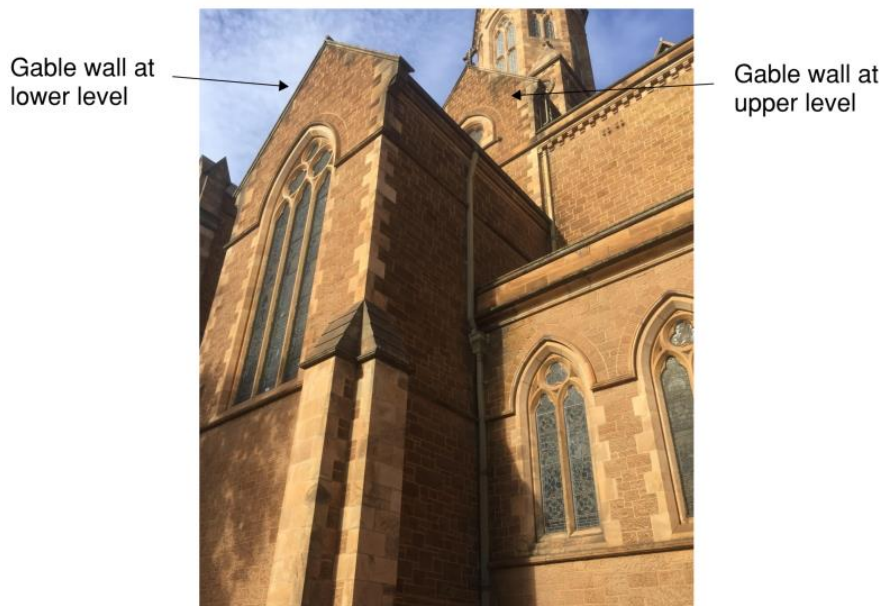
The two gable end walls strengthened thus far are located on the south-west face of the cathedral adjacent to the lantern (one at the upper and one at the lower level) as shown in Figure 4. The walls each contain a rose glass window above which approximately 2m of vertical

spanning gable wall was situated. Each gable wall has a width of about 6m at the eave level and 3m at the ceiling level (above which the strengthening was implemented), height of 3.5 m above the eave level, and thickness of nearly 1 metre. Given this height-to-thickness ratio, each wall should be capable of resisting a peak ground acceleration of approx. 0.1g (assumes height amplification factor of 3). Nonetheless, while the walls are relatively stout they were poorly connected along their edges back to the roof structure. The retrofit/strengthening object was therefore aimed at improving the connection of the gable wall to the pitched roof structure so that any out-of-plane movement of the gable wall would engage the full stabilising force provided by the roof structure. Figures 5 and 6 show the triangular backing woodwork that was tied to the gable wall with long adhesively anchored bolts. These bolts served the dual purpose of anchoring the timber frame to the gable whilst also ensuring that the inner bluestone and outer sandstone masonry layers of the gable were adequately pinned together. The backing timber frame was then connected to the gable roof structure with diagonal bracing to engage the full roof structure. Timber was chosen as the preferred material owing to its ease of procurement and installation. This resulted in a solution that was able to improve the out-of-plane resistance of the gable wall without being visible from the outside. This approach was used for both gable walls that have been strengthened to date.

Figure 4: Gable end walls adjacent to the lantern, shown on north-west side.

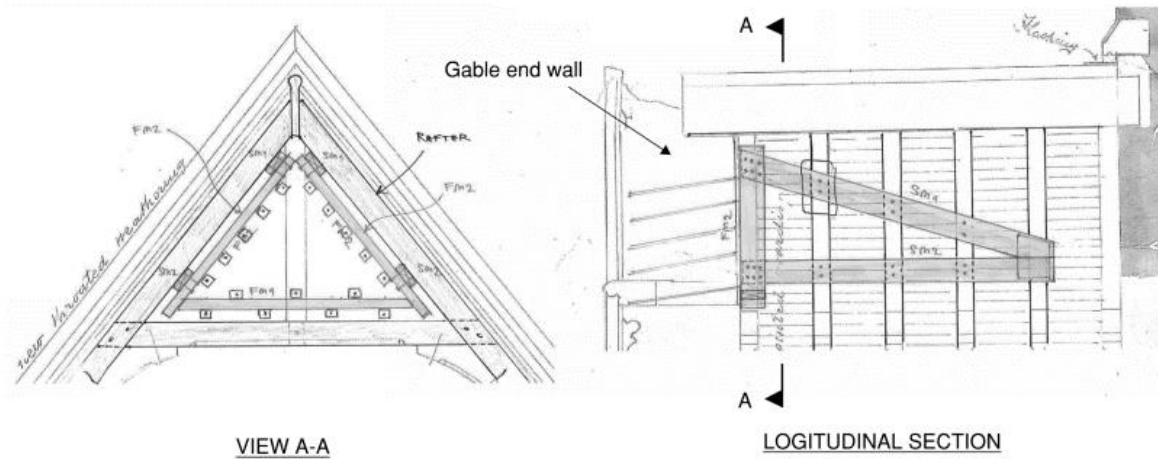
Figure 5: Strengthening concept for gable end walls.

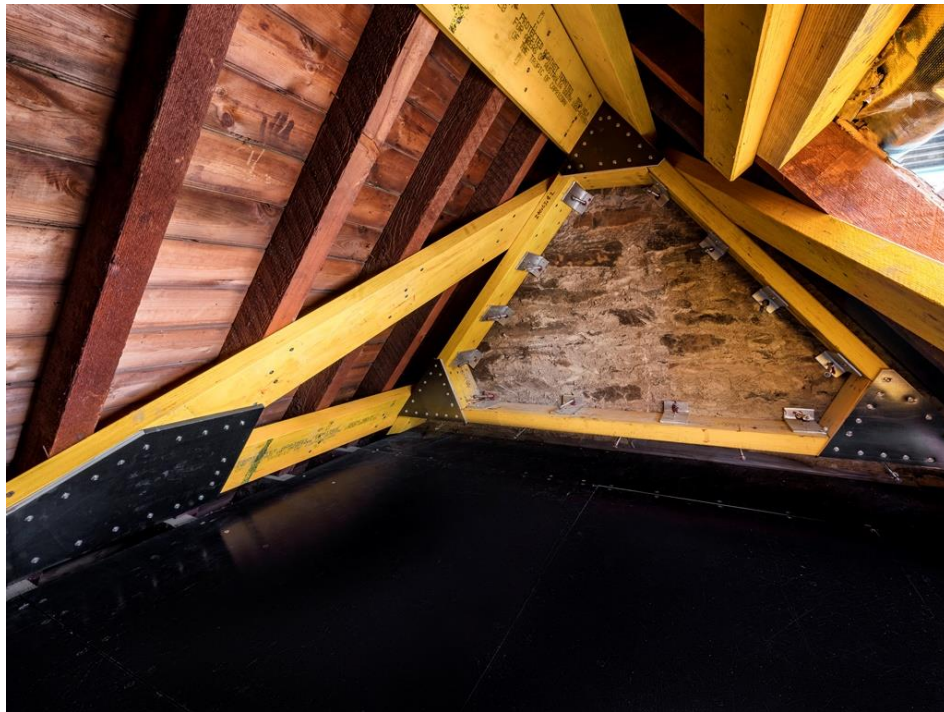
Figure 6: Internal view of gable wall strengthening. (Image courtesy of Chris Oaten, Insight Visuals)

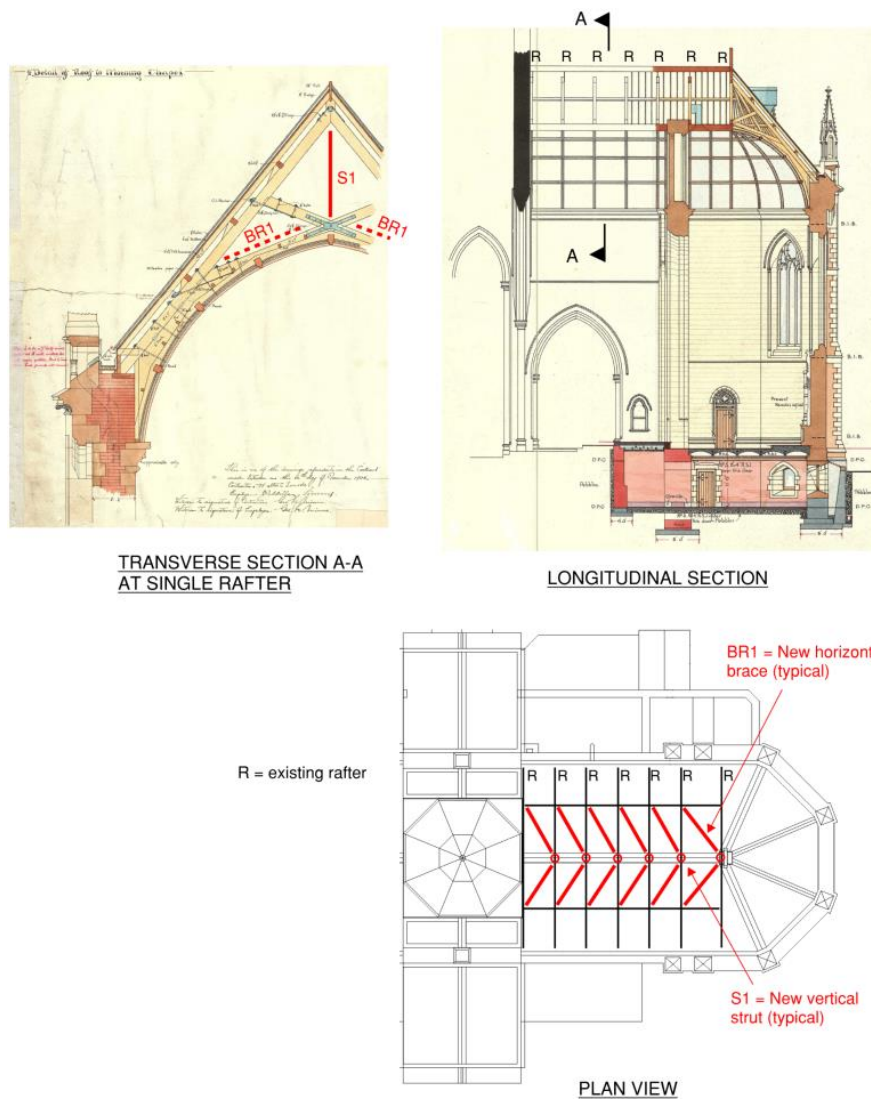
The Lady Chapel is located at the north-west end of the cathedral as shown in Figure 3. The main object of this strengthening work was to increase the horizontal diaphragm stiffness of the roof structure at this location in order to reduce the potential for large out-of-plane deflections in the longitudinal external side walls by engaging the stiffness of the transverse internal and external cross-walls. The work was complicated due to the vaulted ceiling of the Lady Chapel (refer transverse section in Figure 7) which meant that it was not possible to provide the ideal stiffening solution which would have been to fully bridge between the external walls to maximise the resulting diaphragm stiffness.

Figure 7: Scheme for stiffening of the Lady Chapel roof diaphragm.

As a pragmatic compromise to accommodate these limitations, a series of timber diagonal braces were installed at the upper level above the arched ceiling as shown in Figures 7 and 8. Each brace spanned across individual vertical roof 'rafter trusses' to increase the horizontal stiffness of the overall roof diaphragm through horizontal truss action. Vertical timber struts were also installed to deal with the vertical component of force generated from the inclination of the remedial bracing with respect to the horizontal plane. This solution meant that the retrofit remained concealed within the roof space thus providing no visible impact outside of the ceiling space.

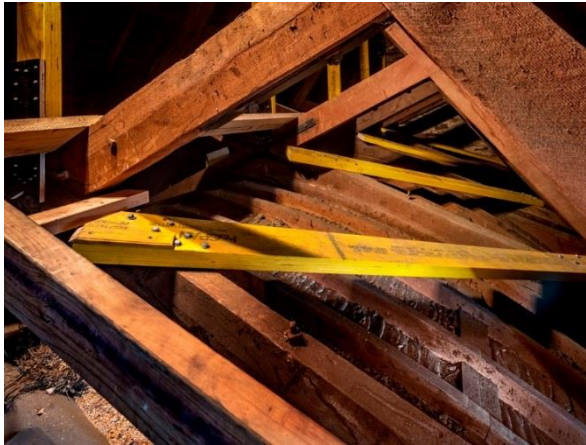
(a) Diagonal braces

Figure 8: Lady Chapel roof strengthening details. (Image courtesy of Chris Oaten, Insight Visuals)

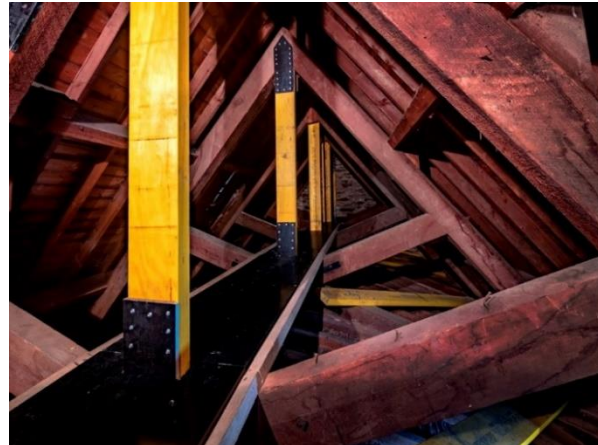
(b) vertical struts
