## Seismic Vulnerability Assessment of Selected High-Rise Building in Lae City, Papua New Guinea -

<sup>1</sup>Robin Baru, <sup>2</sup>Lincoln Sauwa Jnr and <sup>3</sup>Mirzi L Betasolo\*  
*Department of Civil Engineering Papua New Guinea University of Technology*  
*\*Corresponding author: mirzi.betasolo@pnguot.ac.pg*

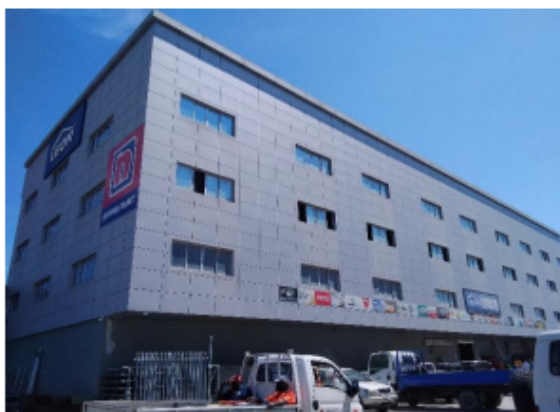
(a) Leon Building

1. Building A (Leon Building) – C1, Concrete Moment Resisting Frame Building
2. Building B (Numberwan Super Haus) – C2, Concrete Shear Wall Building
3. Building C (Morobe Haus) – S4, Steel Frame Building with cast in place Shear Walls.
4. Building D (Papindo Shopping Mall) – S4, Steel Frame Building with cast-in-place Shear Wall

$$S_{L1} = +1.4 (\text{building A}), +1.6 (\text{building C}), \text{ and } +2 (\text{building B and D}) \quad (2)$$
