Structural Monitoring of Bumbu and Butibam Bridges of Lae City, Papua New Guinea

¹Grace Wantepe and ²Mirzi L Betasolo*, ³Nicholas Lambrache
Department of Civil Engineering Papua New Guinea University of Technology
¹grace.wantepe@pnuot.ac.pg
³nicholas.lambrache@pnuot.ac.pg

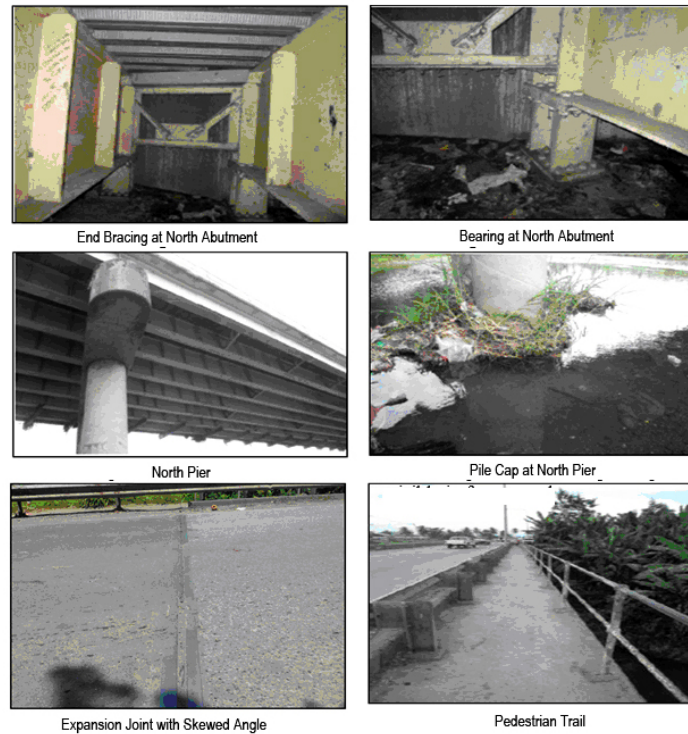
Figure 10: Photos of Butibam Bridge

According to the Level 1 results, the general assessment of the Bridge is reasonable, where most conditions of the components are satisfactory or require minor maintenance and repair or painting. The majority of the bridge components' conditions were satisfactory, as shown below in Table 1, and an overall bridge structure condition rating of 2, as shown in the graph in Figure , which means the Bridge is generally in good condition.

As mentioned earlier, the level 1 monitoring was conducted at a frequency of 6 months, and from the results presented, it can be noted that the bridge condition is generally good throughout monitoring except for minor maintenance and repair of road approaches and guard fencing or railings.

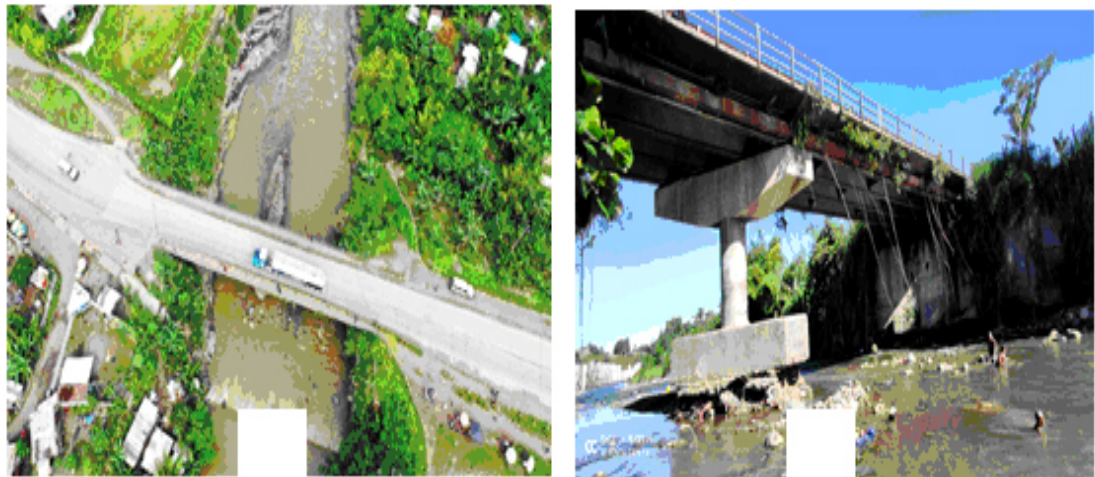
Figure 14: Photos of Bumbu Bridge in August 2020: Aerial View on Left, Longitudinal View on Right

Figure 14, Photos of Bumbu Bridge in August 2020: Aerial View on Left, Longitudinal View on Right shows the aerial view and longitudinal view of the Bumbu Bridge. The pile caps are already exposing the piles due to the happening in the Bumbu River.

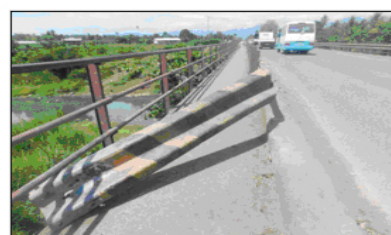
During the inspection on 3rd December 2014, most of the elements of the Bridge were not in good condition. Handrails and guard fencing on both sides of the Bridge were damaged by traffic, as shown in Figure 17 below.

Damaged Kerb on Guard Fence

| Traffic Damaged Members | Requires Handrails/Guard Fencing on Both Sides |

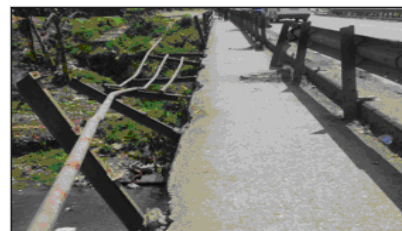
Damaged Handrails

| Component Name | Condition of Components |
|---|--|
| Handrails & Kerbs | Requires Painting and Minor Replacements |

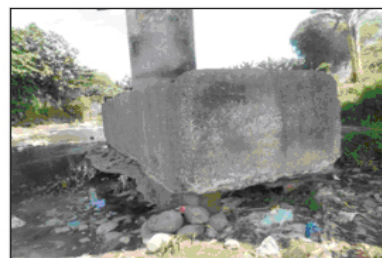
| BRIDGE COMPONENT | | | | CONDITION STATE FOR BRIDGE ELEMENTS | | | | |
|---|--|---|---|---|---|---|---|---|
| 8 | Scouring of foundations | 3 | item | 15 | 30 | 25 | 30 | 2.7 |

Scoring around Mid-Span Pier Foundation

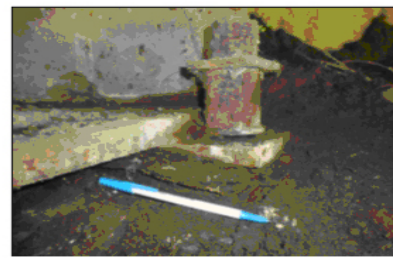
Corrosion of Bolt Connection at North Abutment

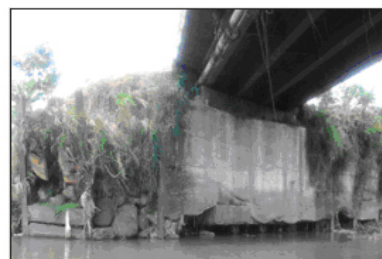
Scour at South Abutment

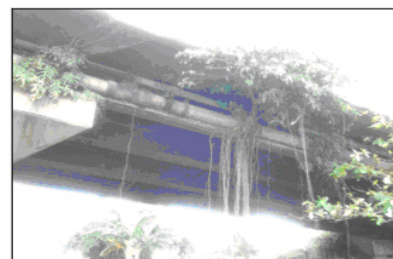
Damage by Plant Growth on Side Girder
