EARTHQUAKE DAMAGE REPAIR AND STRENGTHENING OF CHRIST CHURCH CATHEDRAL, NEWCASTLE NSW

B.J. (Barney) Collins¹, J.W. (Bill) Jordan²

- 1. EJE Architecture Pty Ltd, Chartered Architects, Newcastle, NSW
- 2. Bill Jordan & Associates Pty Ltd, Consulting Engineers, Newcastle NSW

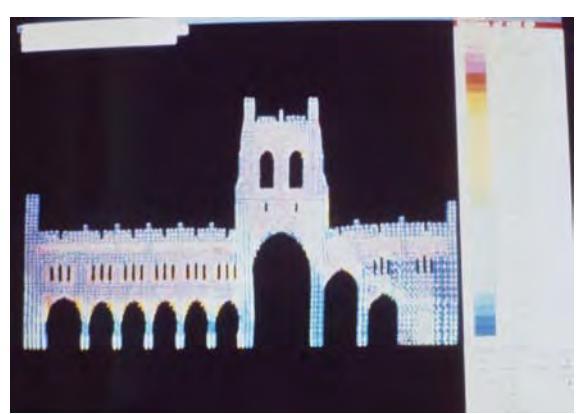
With the design parameters set (see Appendix) a two-dimensional finite element

analysis was carried out using a readily available computer package ("Strand 6"). Different combinations of reinforcement strength and spacing were considered and costed and, in the end, a high strength Grade 316 stainless steel deformed bar was used in sizes from 16 mm to 32 mm diameter. In order to limit the amount of drilling that had to be carried out "Hi-Proof' bar with UTS in range 790 to 920 MPa [N/mm²], depending on size, was Figure 13: Typical FEA output specified. The total length of reinforcing

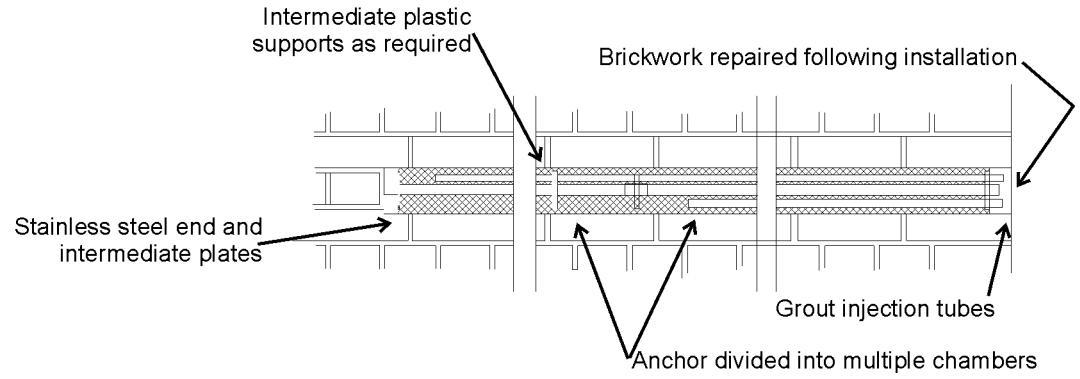
Figure 14: Typical anchor using 25 mm deformed bar in 85 mm diameter hole

The Cintec anchor system has three basic elements: the anchor body which carries the load, the cementitious grout formulated using micro-cement technology and the woven fabric sock which controls the grout. Details of the sock and grout can be found in company literature (Cavity Lock Systems Ltd, current).

The sock design for the Cintec system allows the sock to expand in the drilled hole, and

to its maximum in voids, without the openings in the weave allowing more than the finest fraction of grout to pass through. This "grout milk" contains the inorganic adhesion agents of the grout together with the excess moisture not required for cement hydration. The final expulsion of the excess moisture does not occur until the full sock is pressurized, when the inflated sock becomes hard. This process ensures that the filling of the sock can be monitored by observing a small section, either at the injection end or by way of a small observation hole for remote chambers. For shorter anchors, the Cintec system uses return grout tubes for the monitoring of blind chamber inflation. This was not possible for most of the very long holes on the Cathedral without an increase in hole size, but small monitoring holes at joints could be drilled to the side of anchors and repaired later.

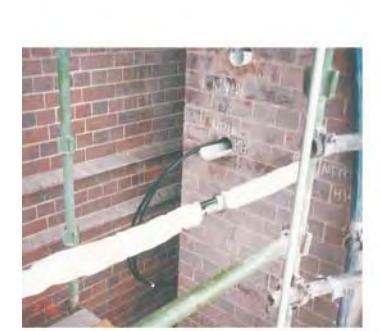
Figure 15: Horizontal anchors assembled during installation

Hydraulic drills were set up by securing them rigidly to the masonry of the building. Guidance of the drills depended on the accuracy of the initial set-up in all but the 32 m long holes, where inspection panels were able to be opened along the line of the holes

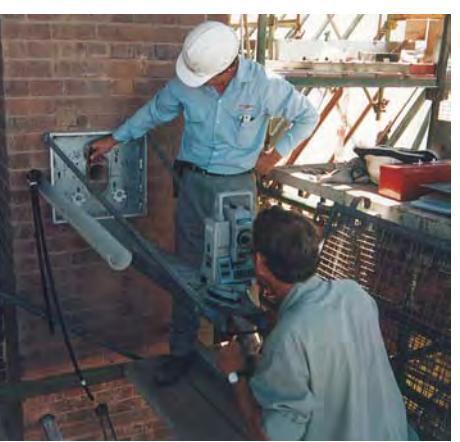
progressive "as executed" survey Figure 18: Drill hole survey documentation;

- locations for drilling were provided by survey directly under the control of the site engineer;
- maintenance of accuracy of alignment of the drill holes was documented as the contractors responsibility to be verified by progressive "as executed" survey

- down-the-hole video was used to verify the integrity of every drill hole;
- the documents provided for drilling to be undertaken in masonry having a compressive strength of up to 70 MPa generally and included the onus of proof on the Contractor to provide for test data confirming any higher compressive strength;
- an issue which proved to be an item of considerable dispute and cost variation, was the internal state of some brickwork internal mortar jointing proved in some areas to be of extremely poor quality both in terms of its low strength and the non-existence of internal joint perpends, resulting in internal brickwork collapse at the drill, drill blockages and difficulties in clearing of the drilling spoil these problems were eventually overcome by down-the-hole grout injection to stabilise the masonry.
