# Performance of posttensioned seismic retrofit of two stone masonry buildings during the Canterbury earthquakes

# Abstract

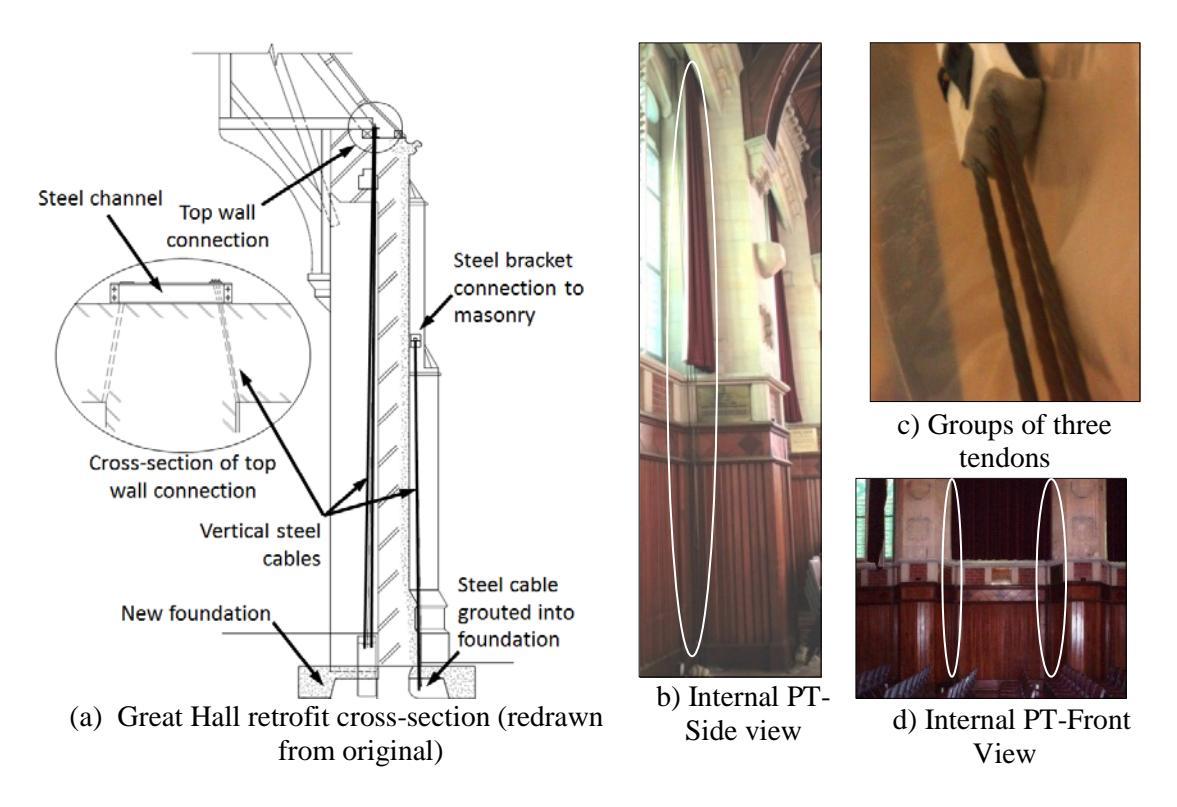
Figure 6: Great Hall retrofit cross-section and condition of the interior posttensioning within the Great Hall following the Canterbury earthquakes

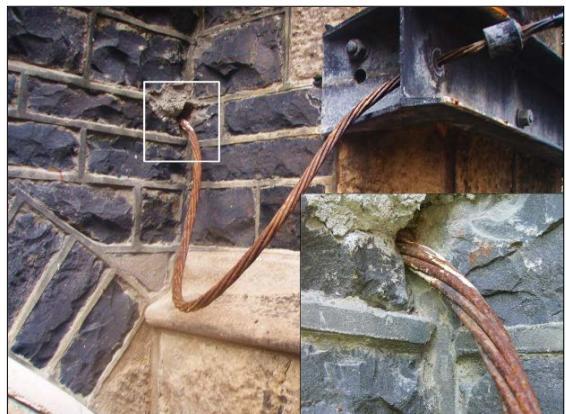
(a) Corrosion of PT steel (after tendon had been released to enable strengthening works)

External damage to the College Hall during the 22 February 2011 event was restricted to the east side of the building, as well as around the dominant window feature on the North face. The damage was consistent with insufficient connection between the roof and the gables, reduction and lack of diaphragm stiffness (Figure 8), as well as differential movement between jointed structures on the east side of the building. Damage was also sustained to the turret during the September earthquake, which was subsequently removed prior to February 22. During the first earthquake in September 2010 the posttension tendons were approximately 26 years old and in most cases a minor to moderate extent of corrosion was observed, as indicated in Figure 7a. The condition of the tendons across the site ranged from

minor surface flecking to significant loss of cross section, dependant on the location within the structure and the environmental exposure. The exterior west side of the building where the posttension tendons were applied performed well, with almost no damage except the failure of one tendon. The cross-section of the failed tendon was significantly reduced at the point of failure, most likely due to the design of the lower anchorage effectively creating a pond around the tendon during wet conditions (Figure 7b), resulting in constant wetting and drying causing corrosion and deterioration of the tendon. Similar damage to the tendons was identified along the length of the wall, but because inspections were only undertaken postearthquake, it is unknown whether the failed tendon ruptured as a result of the earthquake or had already failed due to the section reducing to an area that was unable to sustain the imposed prestress. Giving consideration to the exposure of the tendons, a limited warranty to such a design would be granted given the current stringent durability requirements. Therefore, for a long-term solution, some further form of protection would be necessary, and given the 26 year old age of the tendons it is concluded that they performed well in the environmental conditions that they were exposed to.

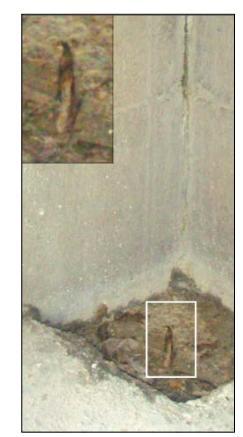
remained intact, with the vertical tendon that failed being part of the College Hall retrofit and being the southern external tendon on the 4th buttress from the northern side of the building. Damage surveys were completed on the TAC complex after the February 2011 earthquake. The damage to the Chemistry building was significant due to failure of the tower above the main entrance, which was subsequently removed. External damage to the Chemistry building was primarily to gables and the main tower, with some minor superficial cracking and loss of stonework at Level 1. As the tower had only received nominal securing, this outcome was to be expected. Gables also performed poorly due to inadequate connection to the roof and low stiffness of the adjacent strengthened flexible diaphragm. The overall structure performed well, particularly at ground level where the posttensioning was applied. Nearly all of the stone damage, broken windows and minor cracking occurred during the 22 February 2011 earthquake due to greater peak accelerations which exceeded current design levels.

(b) Area where pond of water was able to form around failed tendon

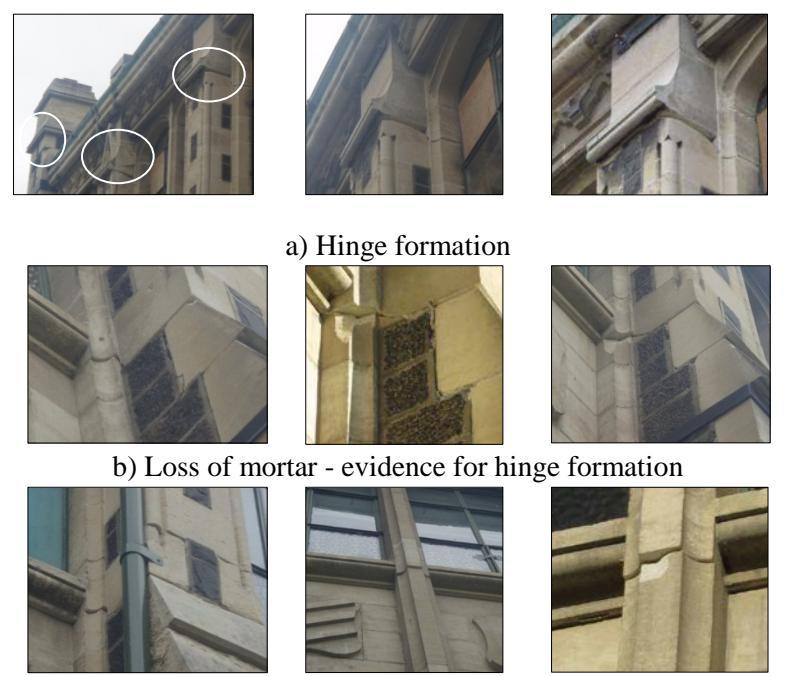
Quantifying the performance of the posttension retrofit is difficult, but by comparing the damage to the retrofitted Chemistry building with that of the un-retrofitted Engineering building, key advantages of the posttensioning can be identified. The Engineering building is of similar pier/spandrel construction with a slightly different aspect ratio, but overall provides the best comparison available at the Arts Centre site. A visual comparison of the Chemistry building versus the Engineering building can be seen in Figures 9. The Engineering building suffered from out-of-plane movement indicated by the formation of hinges due to rocking at the top and bottom of the second level (Figures 9a and 9b respectively). At the Chemistry building no evidence of hinge formation at the piers as is evident for the Engineering building. The mortar of the Chemistry building is still intact, indicating that the posttension tendons limited tensile forces that developed in the masonry, minimising any hinging between the masonry units and mortar as shown in Figure 9. Unlike the retrofitted Chemistry building, there was also significant permanent deformation of the second level of the Engineering building as shown by the large overhang in Fig 9c. No identifiable permanent deformation at

c) Residual displacements

Figure 9: External failures of the Engineering building

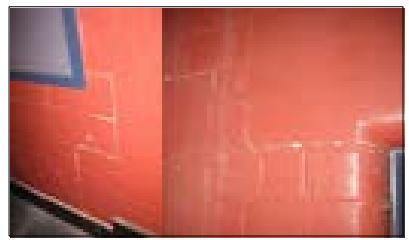
Figure 10 shows the damage to the interior of the Engineering building, again highlighting the out-of-plane rocking and differential movement that occurred throughout the unretrofitted building. Although the Chemistry building also suffered some internal cracking, the extent of the damage and therefore repairs needed was minimal compared to that of the Engineering building. Based on observations alone it can be concluded that the retrofit of the Chemistry building provided improvements in the out-of-plane loading direction as well as addressed in-plane deficiencies as initially intended with the retrofit design scheme.

d) Ground floor - evidence of differential movement, spalling of mortar and residual displacement common at this level

Figure 10: Internal failures of the Engineering building
