Performance of Masonry-Infilled RC Buildings in the M6.0 Mae Lao Earthquake on May 5, 2014

C. Chintanapakdee, A. Ruangrassamee & P. Lukkunaprasit

Centre of Excellence in Earthquake Engineering and Vibration, Department of Civil Engineering, Chulalongkorn University, Bangkok, Thailand.

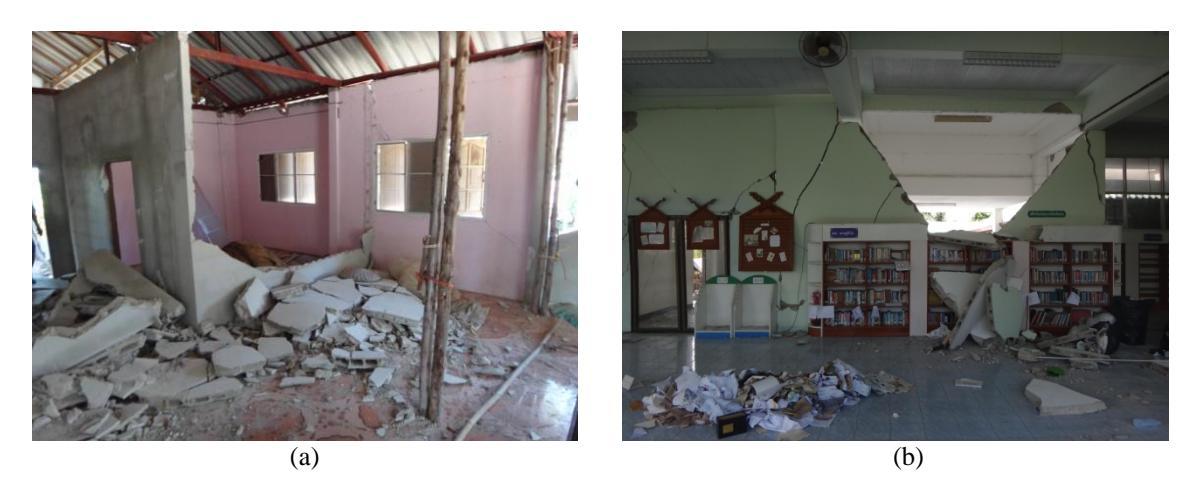
Many new single storey houses were built with the first floor resting on ground (Fig. 3a). Columns are customarily made of precast concrete with a small cross section of 120x120 mm, usually not meeting proper standard even for gravity load requirement. These non-engineered columns have very little reinforcement and are not suitable for seismic-prone area. Although the columns are not very strong, the steel roof beams and cement tiles are rather light-weighted. Masonry walls using hollow cement blocks are popular because of their low cost. The prevailing damage in this type of house is partial out-of-plane collapse of masonry walls due to lacking of anchorage between the wall and column (Fig. 3a). This failure mode caused one fatality in Thailand for this earthquake event as the earthquake occurred during day time. If it had occurred during night time, many more fatalities might have resulted as the walls would have collapsed on to sleeping inhabitants. Figure 3b shows similar out-of-plane masonry collapse in Phan Pitayakom school in Phan district. Although the wall was constructed up to the bottom of the beam, masonry wall still collapsed because there was no dowel bar or

connector to prevent out-of-plane movement of masonry wall away from the beam.

Figure 3. Out-of-plane collapse of masonry walls due to lack of anchorage to the columns at (a) a one-storey house in Mae Lao district; (b) Phan Pitayakom school in Phan district.

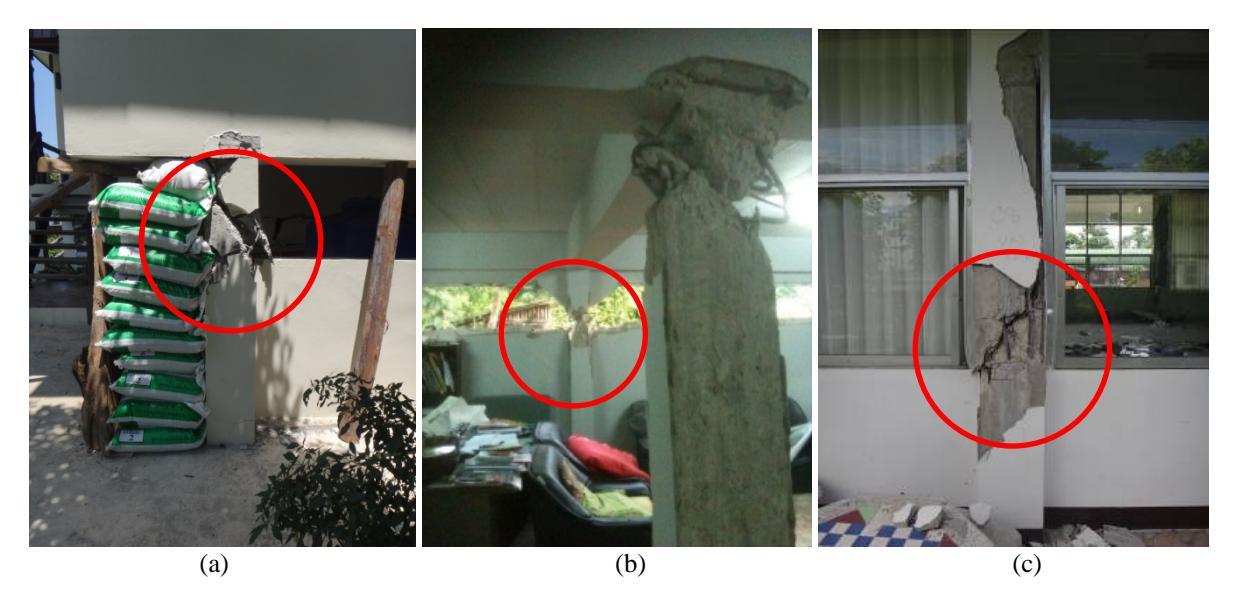
A common feature of traditional Thai houses in rural areas is the elevated first floor above ground to avoid blocking water flow and stay dry during seasonal flood. Such houses are often supported by small non-ductile concrete columns at the ground level with open space, creating a soft storey system which is vulnerable to damage (Fig. 4a). Masonry wall rising up to only partial height of the column restrained flexural deformation of the columns and resulted in shear failure occurring before formation of flexural plastic hinge, which is the so called "short column" effect. School buildings typically have masonry walls about 1 meter tall and glass windows above the masonry walls creating short column effects also. Figure 4 shows such failure type found in many buildings in the affected area.

Figure 4. Shear failure in short columns at (a) a one-storey house in Mae Lao district, (b) a temple; and (c) Phan Pitayakom school in Phan district.

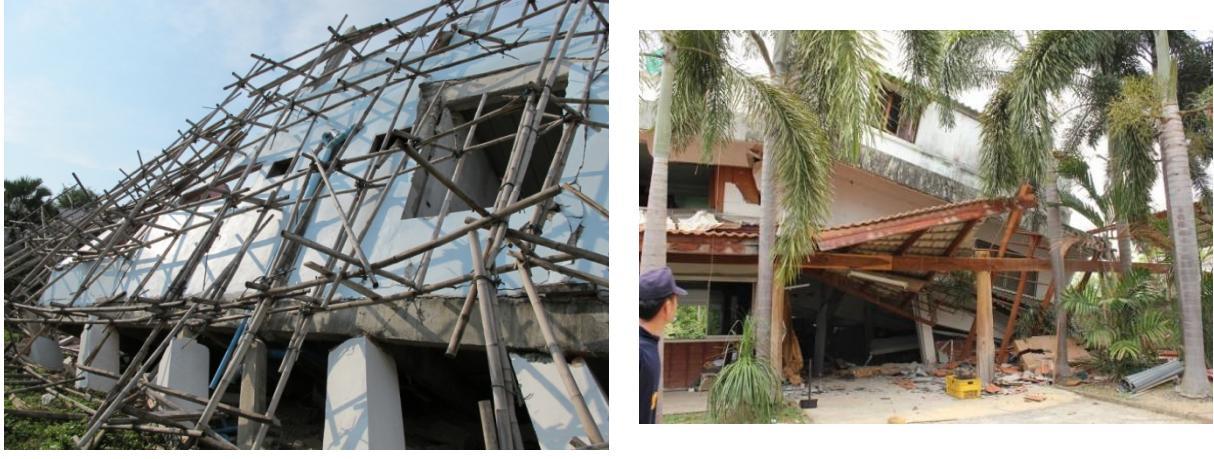
Two to three-storey RC residential buildings similarly feature a soft storey at ground floor with small columns. Two of the collapsed buildings are shown in Figure 5. The three-storey residential building

in Figure 5a had no wall in the first storey as it was intended to be parking garage. Therefore, the first storey was very flexible and weak compared to the upper storeys; thus, lateral deformation concentrated only in the first storey causing collapse of the first storey and the whole structure.

The two-storey building with an extended portion on top in Figure 5b was about 3 km from the epicentre. Besides the soft storey, the building also had torsional irregularity due to the eccentrically placed URM partitions. The building was severely damaged and was on the verge of collapse from the main shock, with shear failure in both unrestrained interior columns and partially-restrained perimeter columns exhibiting short column effect after the adjacent cement block louvers were destroyed. It is noteworthy that all occupants managed to evacuate safely. On the next day with some strong aftershocks the building totally collapsed.

Figure 5. Collapse of three-storey RC buildings with a soft first storey in Mae Lao district.

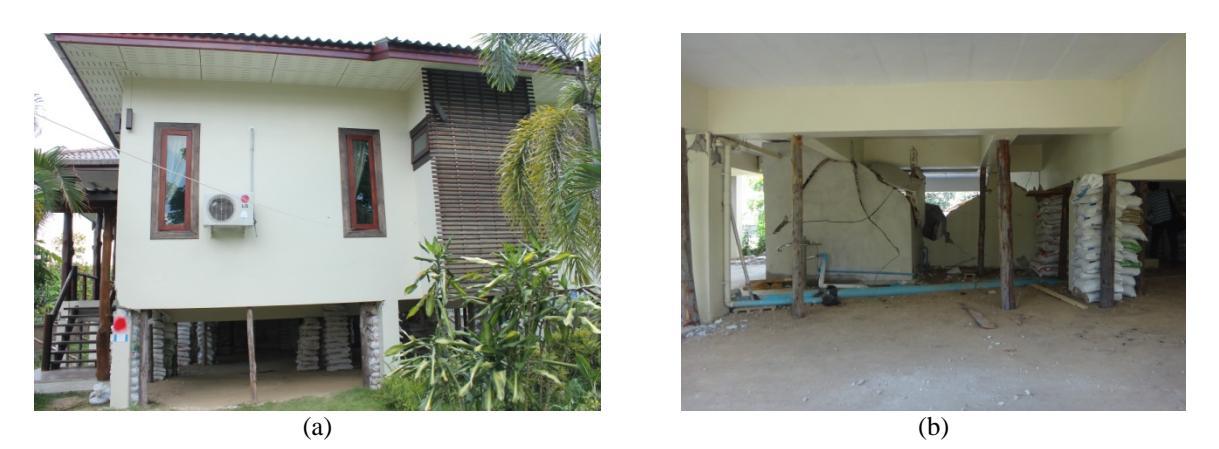
Figure 6 shows that a one-storey house with elevated first floor (same house as in Fig. 4a) was able to escape from soft storey collapse because some panels of masonry walls helped resisting lateral force. Despite being hazard themselves, masonry walls can help resisting lateral load and prevent soft storey collapse if they are constructed appropriately.

Figure 6. (a) An elevated one-storey reinforced concrete house in Dong-mada sub-district, Mae Lao district; (b) masonry infill resisted lateral force and suffered severe diagonal cracks.

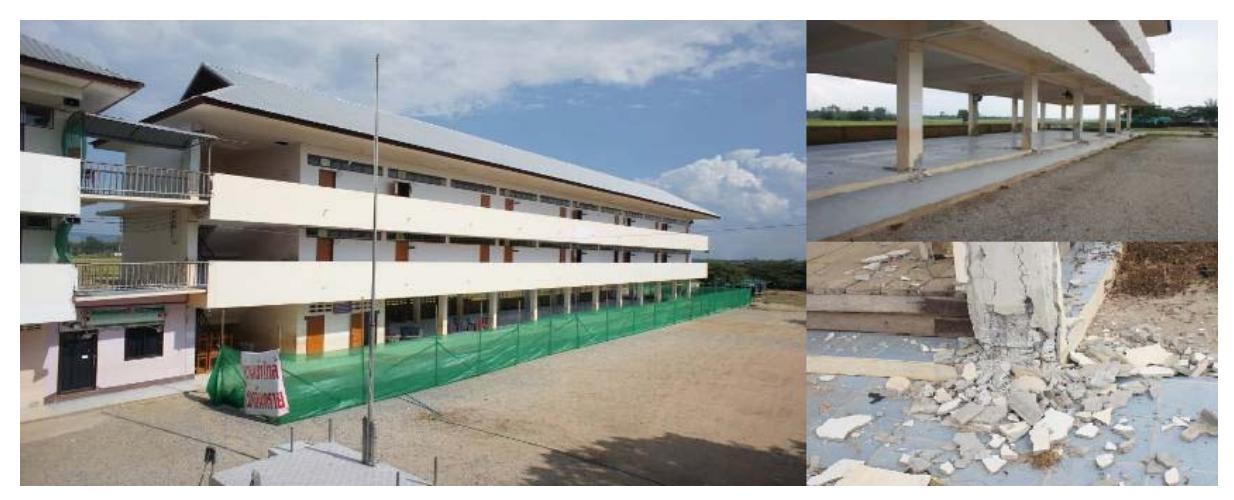
direction. Most schools have 2 to 4 storeys where the ground floor serves as a large open space, creating a first soft storey system. Unfortunately, many recently built school buildings have not been constructed with proper seismic design even though the regulations call for design for a peak ground acceleration of about 0.15g. Consequently, several buildings with a soft storey system coupled with torsional irregularity suffered significant damage. The three-storey RC building at Wat-Muang-Nga kindergarten school in Phan district (Fig. 7) has an open space on the ground floor, except the two end bays to the north of the building which accommodate a staircase and a rest room with URM partitions. Due to torsional deformation, the column farthest from the stairwell was under the most seismic demand, resulting in crushing and splitting cracks at the bottom. Altogether, 14 columns were damaged to varying degrees, mainly in flexural mode.

Figure 7. A three-storey RC school building with a soft first storey coupled with torsional irregularity at Wat-Muang-Nga kindergarten school in Phan district.

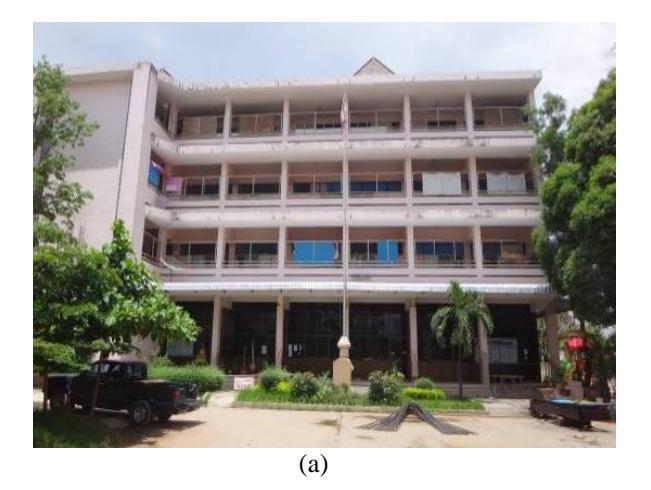
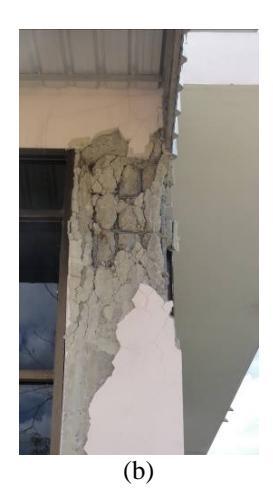
The four-storey RC building at Tesaban 1 school in Phan district (Fig. 8) has an open space with the stiff infilled RC stairwell placed way off the centre of mass of the structure. Eight columns suffered moderate to severe damage, and one corner column (Fig. 8b) was stressed beyond Life Safety Performance Level. The infill panels at the stairwell were significantly damaged. It is interesting to note that another similar building at Ban Don Tan school has essentially the same structural design in general, but the end frame on the other side of stairwell is infilled with a URM panel on the ground floor (Fig. 9a). This infill contributes significantly to reducing the torsional irregularity, leading to less seismic demand on the building and hence less damage than the other building at Tesaban 1 school.

Figure 8. (a) A four-storey RC school building with a soft first storey together with torsional irregularity at Tesaban 1 school in Phan district, Chiang Rai province; (b) severe damage at the corner column.

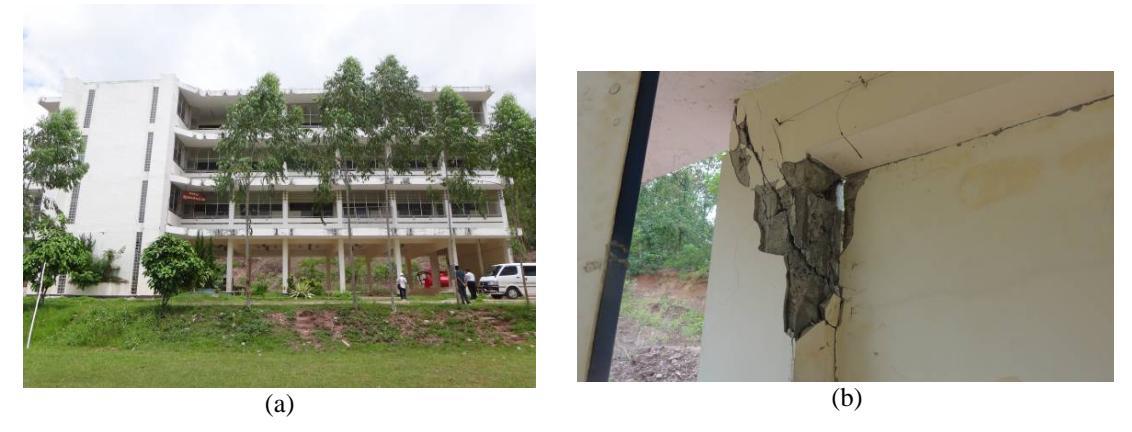
Figure 9. (a) A four-storey RC school building with a soft first storey at Ban Don Tan school in Phan district, Chiang Rai province; (b) shear failure in column and joint.

Although masonry wall in Ban Don Tan school helped reduce torsional irregularity in plan and resist the lateral force in the first storey, the two boundary columns of the URM infill panel on ground floor were severely damaged by the strut force exerted by the large infill panel which is 10 m long (Fig. 9b).

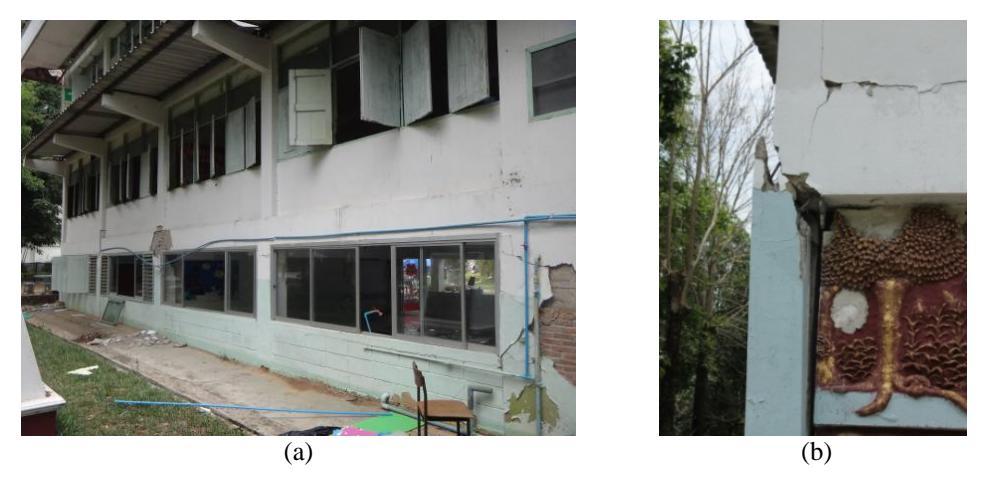
A building at Mae Lao Witayakomschool (Fig. 10a) also suffered shear failure at a beam-column joint of an end RC frame with URM infill panel. The column was so severely damaged in shear caused by the huge strut force from the URM panel that the column was almost pulled out of the joint (Fig. 10b). It is noteworthy that the URM panel provided an alternate load path for gravity load for collapse prevention. Joint failure due to poor construction was also observed at some beam-column cold joints.

Figure 10. (a) Damaged three-storey RC school building at Mae Lao Wittayakom school in Mae Lao district, Chiang Rai province; (b) shear failure of beam-column joint induced by strut force from URM panel.
