Seismic Performance of Non-Engineered Residential Buildings in the 2014 Mae Lao Earthquake

T. Ornthammarath

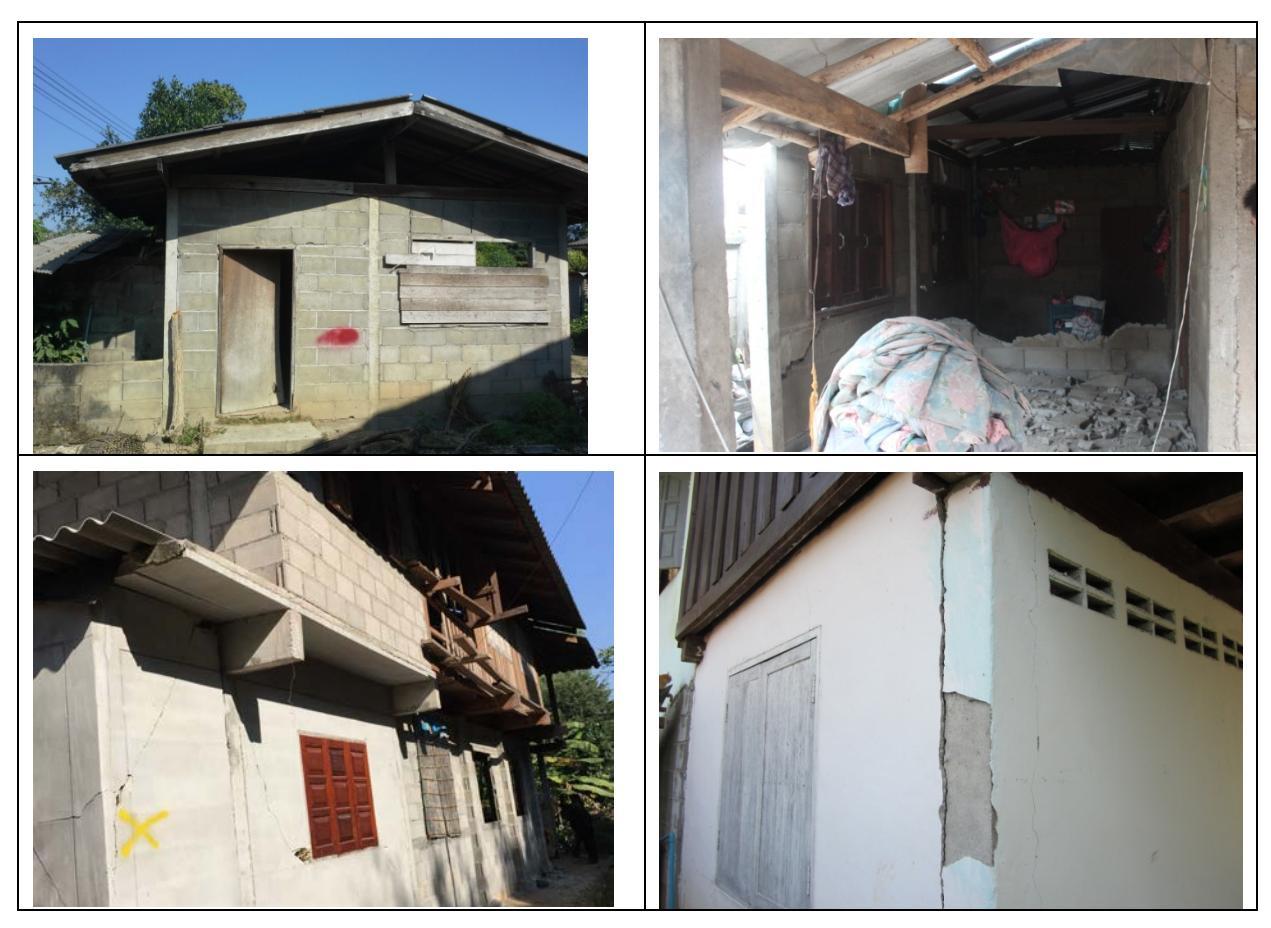
For structural type I, these buildings generally feature small non ductile precast columns. The number of column stirrups typically provided is small e.g., 6-mm-diameter bars at 150–200 mm spacing for $150 \times 150 \text{ mm}^2$ or $200 \times 200 \text{ mm}^2$ columns. Infill, unreinforced masonry panels, generally 70-100 mm thick, is extensively used as nonstructural elements, with a small number of dowel bars connecting the panels and the boundary RC frames. The ultimate compressive strength of concrete in buildings is normally on the order of 18 MPa, or lower. The specified yield strength of reinforcing bars is usually 240 MPa for plain bars and 300 MPa for deformed ones. Bricks and mortar are of extremely low quality, since they are used as nonstructural elements. This type of structures is quite common for low income family and is vulnerable to earthquake. Many such buildings have collapsed in past earthquakes resulting in the loss of lives, (Ornthammarath, 2013; Ornthammarath and Warnitchai, 2015).

The typical red class damage of this kind of building type is a partial or full out-of-plane failure of heavy cement block walls. This wall is generally fixed on the ground with little or no connection to column, which could be referred as free-standing wall. The out-of-plane inertia force acting on the mass of the wall tends to overturn it. Clearly this failure mechanism generally not fulfils life safety performance level. The seismic resistance of the wall is by virtue of its weight and tensile strength of mortar, which is obviously very small. The typical wall height are about 3.0-4.0 m, and the wall slenderness ratio are about 30 - 40. For yellow class damage level, large bending cracks would be

observed as a vertical crack at the edge of the wall since the walls are subjected to the inertia force acting on their own mass. Significant numbers of yellow class damage would generally be observed for walls with cement mortar on both surfaces.

Figure 1 a). Typical characteristic of type I structure b) partial or full failure of infill wall (red class damage) c). Bending crack observed on infill wall (yellow class damage)

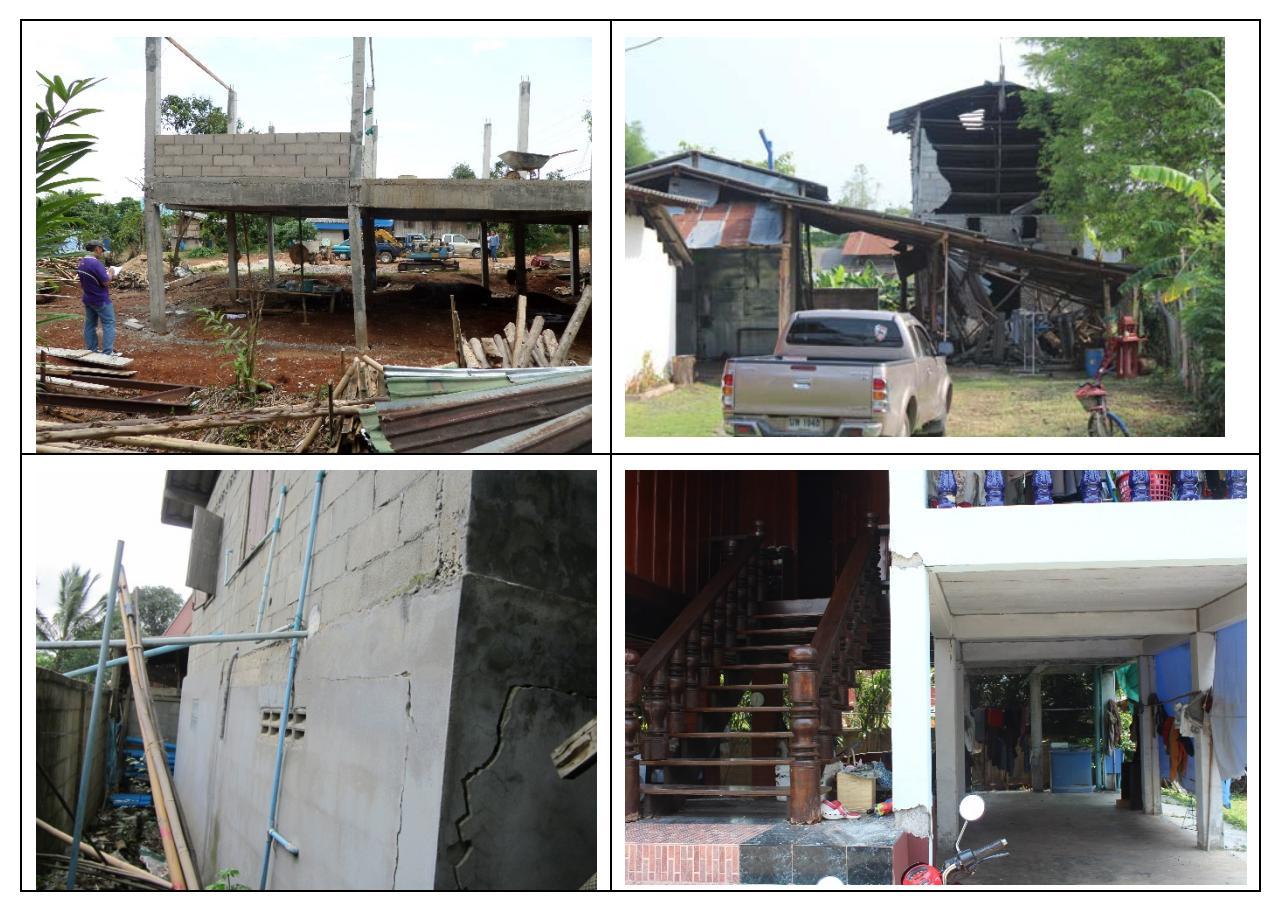
Type II buildings constitute the most vulnerable to earthquake (Figure 2). Their ground story is left open with elevated first floor. Typical column heights are between 1.5 m and 2 m. The second story is generally made of cast-in-place concrete beam. Due to their heavy concrete floor and cement block walls in the second story, large inertia forces are induced during earthquakes. The column on the first floor is either lightly reinforced concrete column as Type I structure or wooden frame. The main problem in this type of building is the incompatibility of the materials used for different stories and their improper connection to each other. All of these factors leading to a soft story failure pattern. Partial out-of- plane collapse of second-story walls or full collapses of the unit are mostly founded. Figure 2 displays a typical collapse of type II building with failure due to soft story effect and poor beam-to-column joint reinforcing details. Clearly this failure mechanism generally not fulfils life safety performance level. For yellow class damage level, large bending cracks would be observed as a horizontal crack at the edge of the column since the columns are subjected to the inertia force acting on upper floor.

Figure 2 a). Typical characteristic of type II structure b) partial or full failure of infill wall (red class damage) c). Bending crack observed on infill wall (yellow class damage) d). Bending crack observed on precast column (yellow class damage)

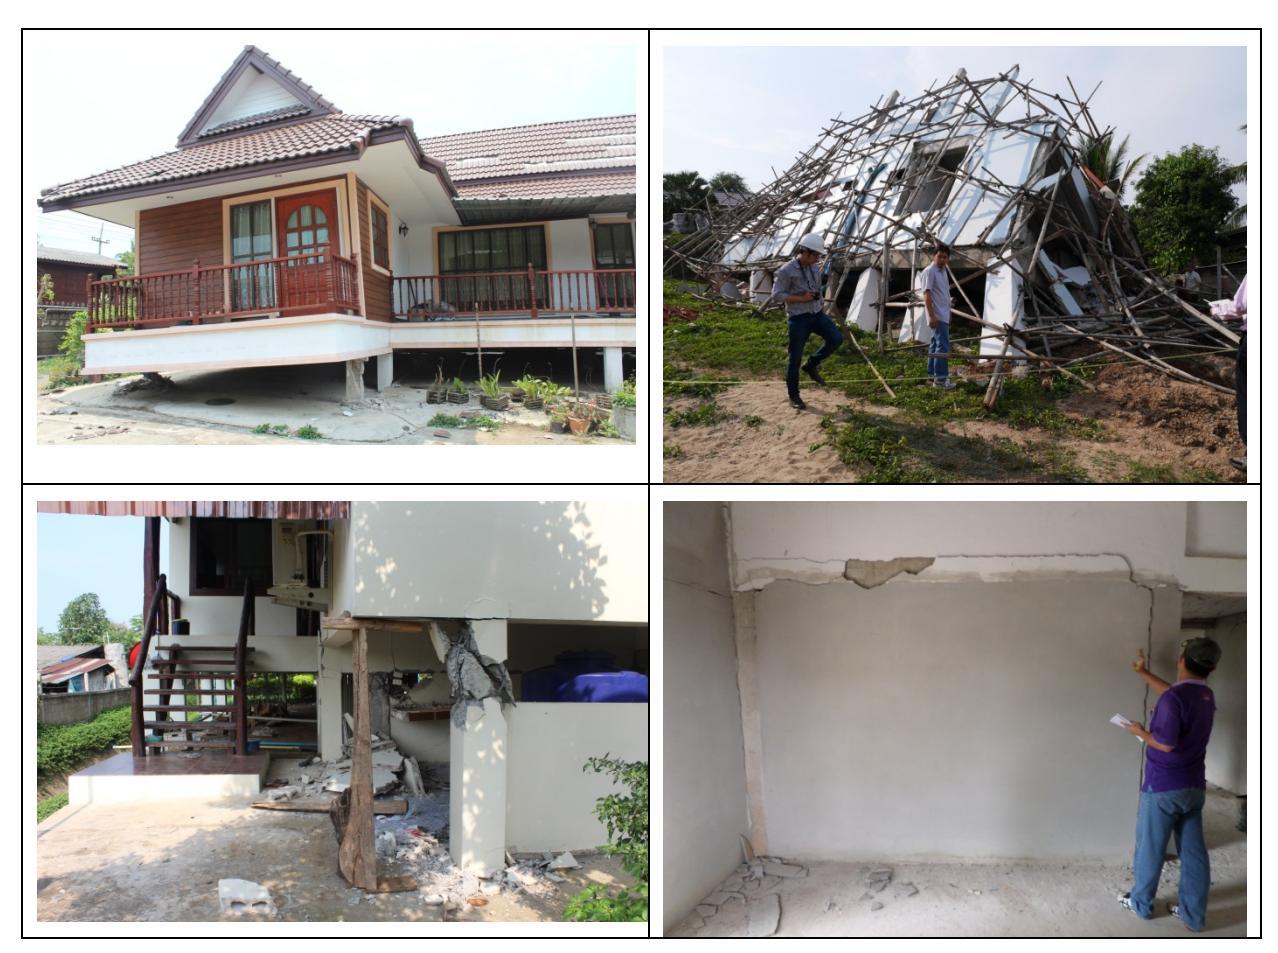
Type III buildings have generally better seismic performance than previous two types since their larger column cross section between 200 mm and 250 mm with at least four 12-mm diameter of longitudinal bars and 6-mm diameter bars with stirrup spacing at 150-200 mm, properly placed horizontal bond beams, relatively better corner connections, and better vertical alignment of openings. This type of building is not earthquake resistant but can withstand earthquakes of moderate intensity since some basic rules of thumb have been considered during construction. The typical failure modes of this type of buildings are variable such as, short column, out-of-plane and in-plane failure of non-structural walls, soft story. For buildings of this type, if there are elevated floors between 0.3 m and 0.5 m,

severe shear failure of column with vertical bar buckling occurred due to short column failure type is quite common.

Nevertheless, severe damage of type III buildings could also been found if these structures are extended to 3 or 4 story heights, in which the ground story is kept opening without partition walls. The story height of the first floor is almost 25 % more than the upper stories. Consequently, soft and weak stories caused heavy structural damages. For yellow class damage level, damage would be observed at some parts of structure such as short column due to small openings, as a horizontal crack at the edge of the column since the columns are subjected to the inertia force acting on upper floor. Another typical but severe damage of buildings in this type is due to non-structural partition walls made of briquette. These non-structural walls formed compression struts and induced forces in adjacent columns near joints. This led to shear failure of columns, as shown in Figure 19. Buckling of longitudinal bars also occurred, indicating loss of gravity-load-carrying capacity.

Figure 3 a). Typical failure characteristic of type III structure b) soft story failure of 3 story RC frame (red class damage) c). Short column failure due to openings (yellow class damage) d). Bending crack observed on infill wall (yellow class damage)

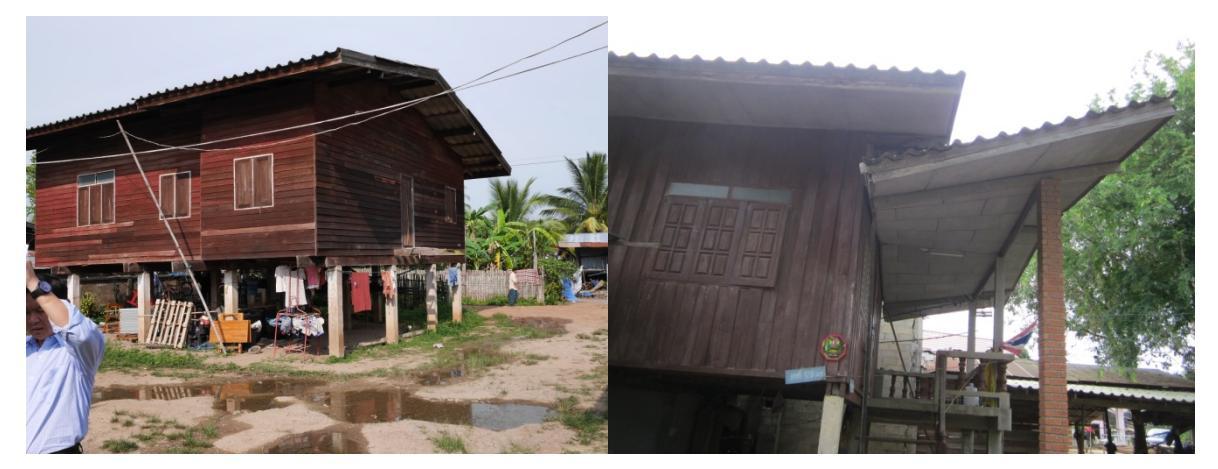
Type IV buildings are traditional Thai house, Figure 4. Wooden columns, beams, and slabs are the loading members to resist both the lateral and gravity loads. Wooden house with elevated first floor is less damaged comparing to type II buildings since it is light and more flexible. However, the older buildings of this type the more vulnerable could be expected since the quality of wooden is deteriorated over time. Leaning to one side or partial failure of roof are the most common damage (yellow class damage) pattern of type IV buildings; however, total collapse case has not been reported.

Figure 4 a). Typical characteristic of type IV structure b) partial failure of roof (yellow class damage)
