Performance of as-built and retrofitted URM parapets during the 2010/2011 Canterbury earthquakes

D. Dizhur¹, M. Giaretton², M. Brisacque³, F. da Porto² & J. Ingham¹

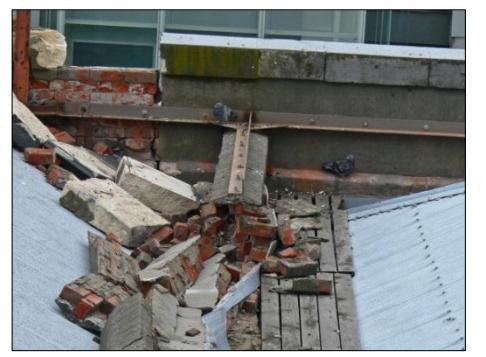
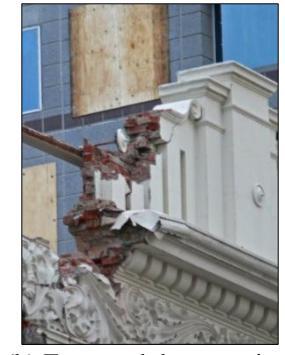
(a) Rear view (b) Front and damage view (c) Design scheme Figure 10. Examples of parapet retrofit with the addition of a steel strip on the back of the parapet connected with plates

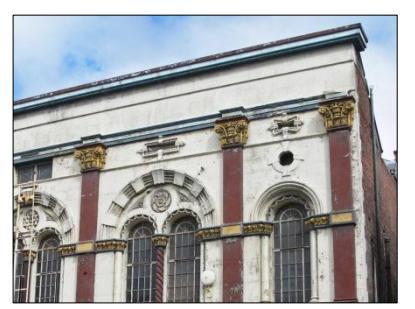
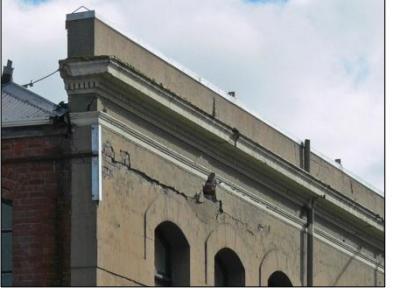
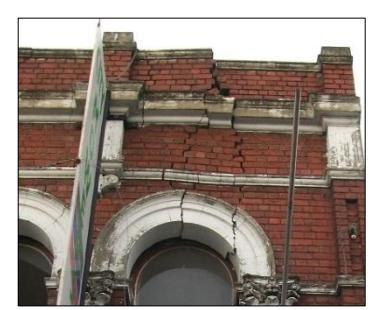
- Standing parapets, Figure 12, includes: (a) no visible damage, (b) visible horizontal cracking highlighting the initiation of rocking behaviour of the parapet, and (c) other visible cracking in the parapet related to in-plane failure of the full façade or pounding effect of nearby structures.
- Collapsed parapets, **Figure 13**, includes: (a) partial collapse of the parapet, (b) full collapse of the parapet only, or (c) collapse of both the parapet and the wall.

(b) Horizontal cracking

(c) Other types of cracking

Figure 12. Examples of failures categories considered in standing parapets

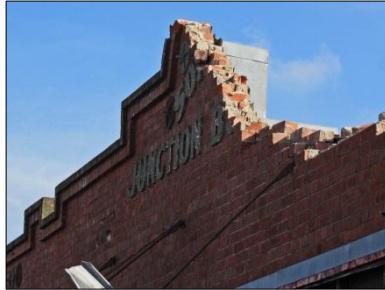
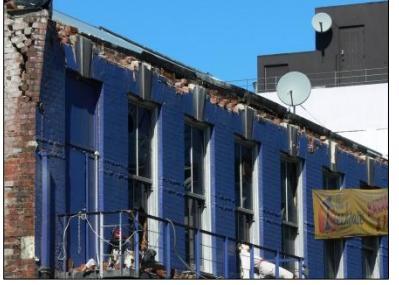
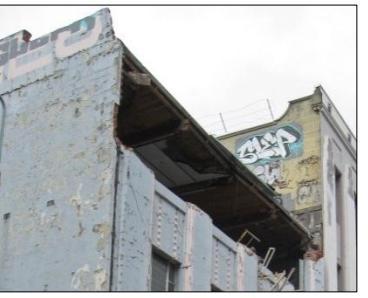
(a) Partial parapet collapse

(c) Parapet and wall collapse

Figure 13. Examples of failures categories considered in collapsed parapets

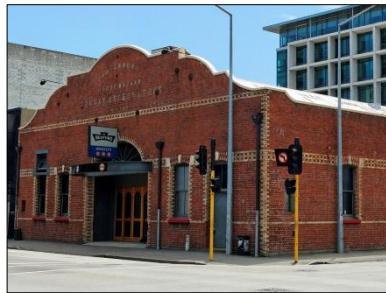
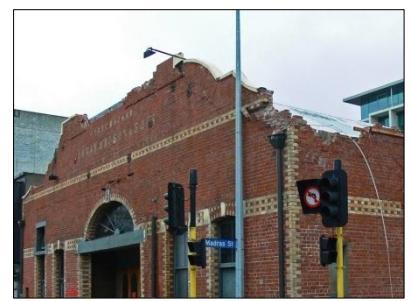
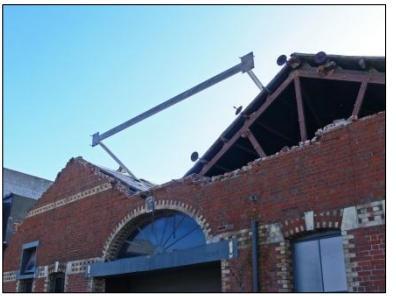
Figure 14 presents an example of progressive damage to a parapet after different earthquakes.

(a) Former Canterbury Horse Bazaar, prior to earthquakes

(b) Partial collapse after 22 February 2011 earthquake

(c) Parapet and wall collapse after 13 June 2011 earthquake

Figure 14. Examples of progressive damage to retrofitted parapet

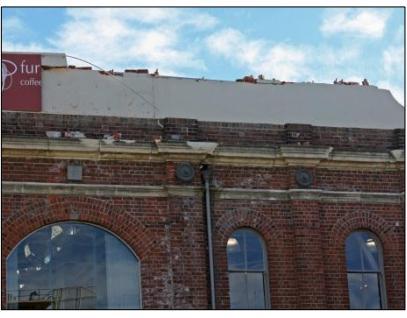
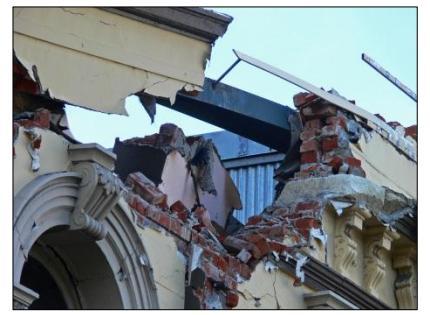
the cause of collapse of the masonry parapet under the beam or the collapse of both the parapet and the concrete beam due to the increased mass, see **Figure 19a**.

The typical failure modes of steel braces mounted behind the parapet were: (i) horizontal cracking corresponding to the location of the horizontal steel beam, followed by collapse of the remaining unretrofitted part above, **Figure 19b**, (ii) failure due to short embedment of the ties adopted to fix the beam to the parapet, and (iii) horizontal cracking at the base of the parapet. Typically collapse was observed when the parapet was retrofitted using only steel braces locally fixed with ties and plates, without the presence of a horizontal steel beam, as shown in the building in **Figure 20** where both systems were adopted. The use of horizontal steel strips fixed to the parapet with plates resulted in the collapse of the parapet due to the absence of connection to a primary structural element, **Figure 19c**. Horizontal cracking at the location of the steel strip was observed when the steel strip was applied to all the perimeter parapets as a ring beam. In some cases it was recognised that the horizontal steel strip had occasional vertical steel bars acting as struts.

(b) Bracing back to structural element

(c) Steel strip

Figure 19. Typical examples of failure observed for the adopted retrofit interventions

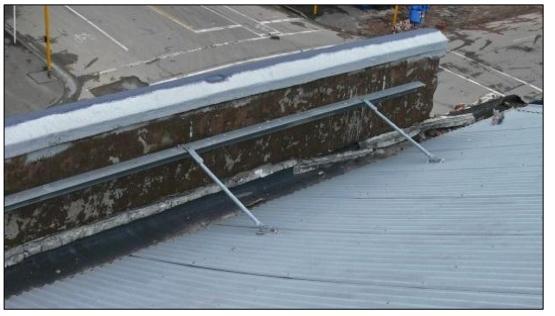
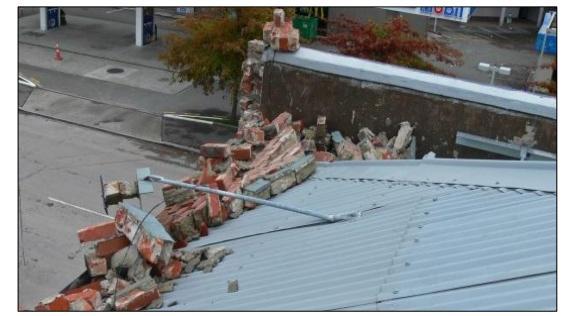
(a) With a horizontal steel beam

(b) Without a horizontal steel beam

Figure 20. Comparison between parapets braced back to a structural element with and without a horizontal steel beam
